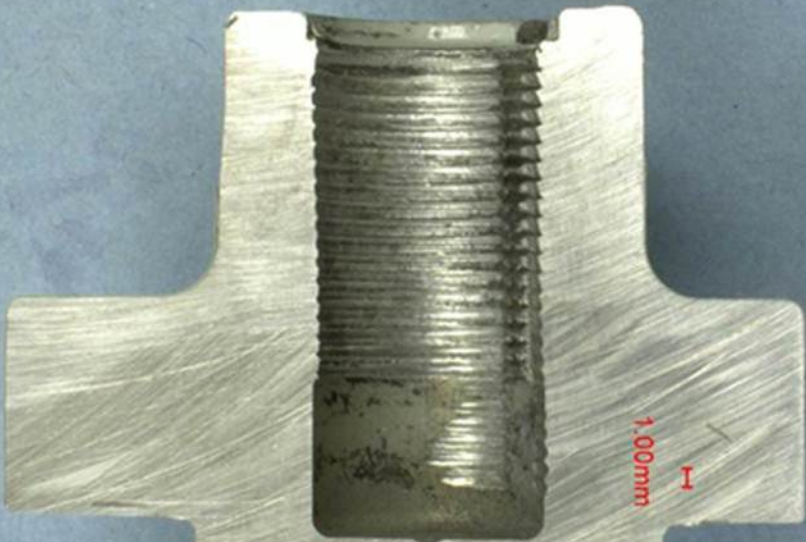
**Heavily worn threads caused by use of an unapproved compound in a threaded rod end installation.**
