OPSB 0166-17R2

To: Operators of Rockwell Collins Flight Management Systems Pro Line 4 and Pro Line 21 FMS 3.3.x through FMS 4.x

Subject: The FMS may turn in the wrong direction after sequencing a “Climb to” altitude that was manually edited or Temperature Compensated

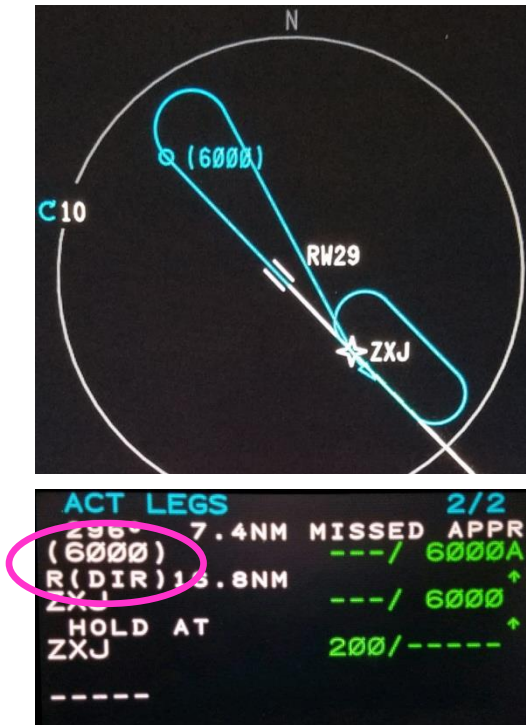
Figures 2a and 2b show the issue for the CYXJ (Ft. St. John, BC) ILS Rwy 29 missed approach. In Figure 2a, on the LEGS page,

- **“Climb to” altitude of 6000 feet** is identified by the parentheses: “(6000)”
- **Turn direction is right**, identified by “R” (Right) for the immediately following leg

Figure 2a. "Climb to 6000 feet followed immediate by Right turn Direct-to ZXJ.

1. If Temperature Compensation is ON, turn Temperature Compensation OFF, and press EXEC.
2. Reselect the procedure (departure or approach), and press EXEC.
3. Do not again manually edit the "Climb to" altitude, and do not re-activate Temperature Compensation.

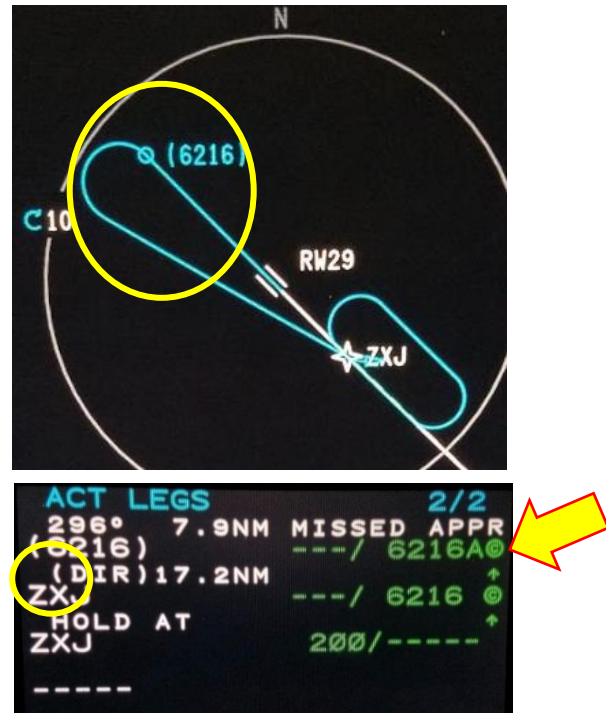
Figure 2b shows that after the crew activates Temperature Compensation, the turn direction is removed, initially on the “non-edit-side FMS” in a dual/triple FMS installation. In other words, if the pilot-not-flying (non-coupled side) makes the edit, the turn direction is initially removed on the pilot-flying (coupled) side. After the active TO waypoint sequences, the turn direction will be removed on both FMSs.

Figure 2b. After the crew uses the left FMS to activate Temperature Compensation, the "R" turn to ZXJ is initially removed (blanked) on the right FMS and will subsequently be removed on both FMSs. The map display may differ from this example.

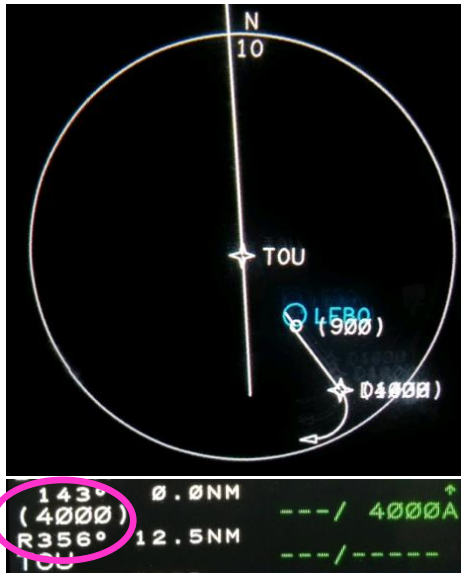
A manual altitude entry immediately removes turn direction on all active FMSs. Figures 3a and 3b show the issue departing LFBO Runway 14L on FIST5A. In Figure 3a, on the LEGS page,

Figure 3a. "Climb to 4000 feet followed immediate by Right turn 356° course to TOU.

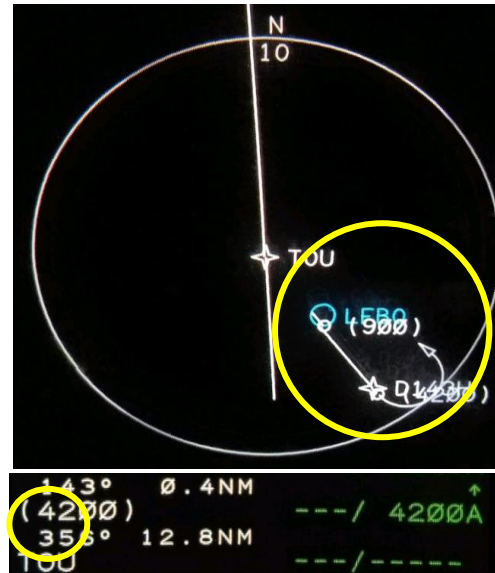
- "Climb to" altitude of 4000 feet is identified by the parentheses: "(4000)"
- Turn direction is right, identified by "R" (Right) for the immediately following leg
- Figure 3b shows that after the crew enters 4200A in place of 4000A as the "Climb to" altitude the "R" (right) turn direction is removed, as shown on the LEGS page
- The shortest turn is currently computed to be left (instead of right), as shown on the map

Figure 3b. After manually entering 4200A (in places of 4000A), the "R" turn direction is removed and the FMS computes the shortest turn direction, left in this case.

The crew should not manually edit "Climb to" altitudes in the FMS flight plan
