SUBJ: Flight Controls; Cable Terminals Used on 14 CFR Part 23 and CAR
Part 3 Airplanes with Mechanical Flight Control Cables

SAIB: CE-19-13
Date: July 2, 2019

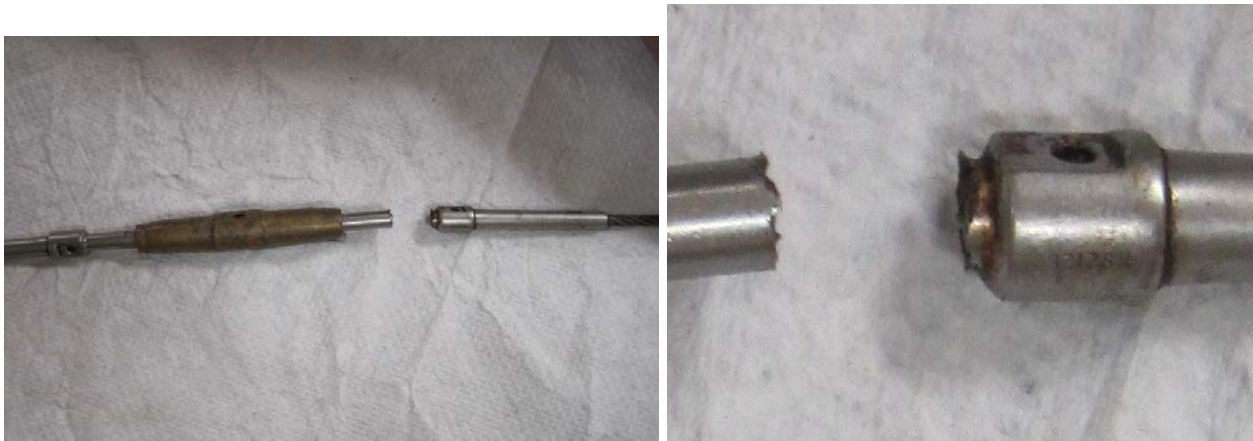
The specific focus of this SAIB is on the connecting fittings that are attached (swaged) to the flight control cables and threaded onto the turnbuckles. These fittings are typically manufactured from a type of stainless steel that is susceptible to stress corrosion cracking under certain conditions over time. Based on multiple part examinations, the stress corrosion cracking originates at general corrosion pits on the surface of the parts. Because the cracks are primarily below the surface, they can be extremely difficult to detect. Because stress corrosion cracking is usually preceded by or accompanied with visible corrosion, any presence of even light or moderate corrosion on these fittings is cause for concern.

Factors that contribute to stress corrosion cracking for stainless steel fittings of this type are exposure to contamination (chlorides) along with being under sustained tensile stress. Heat is also a contributing factor. It is therefore likely to occur more quickly in a warm, humid, salt air environment, and progresses based on calendar time rather than flight time. A number of failures have occurred in areas of the airplane adjacent to heating and ventilating ducts, thus raising the possibility that elevated temperatures and/or condensation associated with the ducting was an aggravating factor. Owners and operators of certain Beechcraft Bonanza and Debonair airplane models should be aware that multiple failures of an aileron cable terminal have occurred in a location just forward of the rear spar and underneath a ventilation/heating duct. This applies to most airplane Models 33, 35, and 36 manufactured between approximately 1964 and 1977, after which the aileron

A picture from a recent incident involving failure of such a fitting is shown in the photographs below. Note the small amount of corrosion adjacent to the fracture location.

- b. Replace any removed safety wire with new safety wire in accordance with normal procedures.
3. If any sign of corrosion, pitting or cracking is present on any fitting, replacement of the associated fitting and/or cable assembly is recommended.

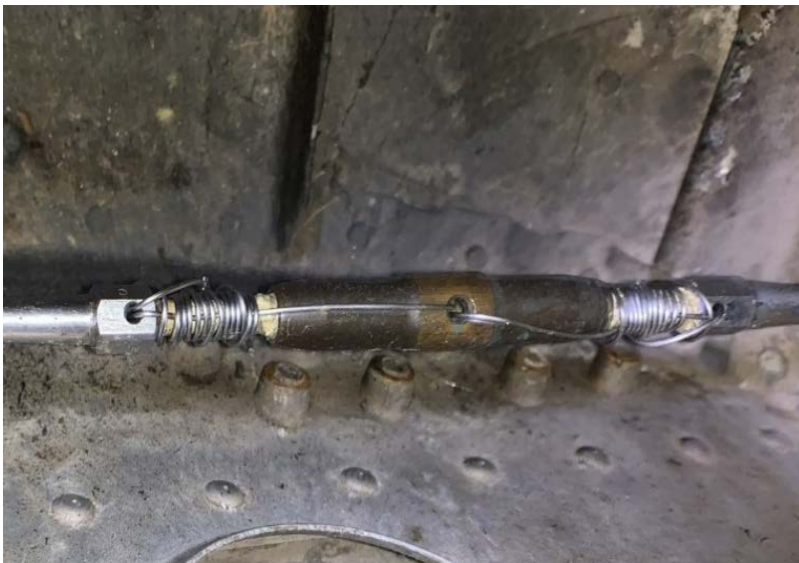
Depending on whether safety wire or a safety clip is used to secure the turnbuckle, any corrosion such as this may be hidden from view by the safety wire, which needs to be removed in order to perform an adequate inspection. The following photograph shows a typical safety wire configuration.

- a. If safety wire is installed such as to prevent examination of the fitting surface, the safety wire must be removed.
Caution: Care should be taken to avoid any adjustment of the turnbuckle relative to the fittings. Otherwise, re-rigging of the affected flight control cables per the manufacturer's instructions should be done before further flight.

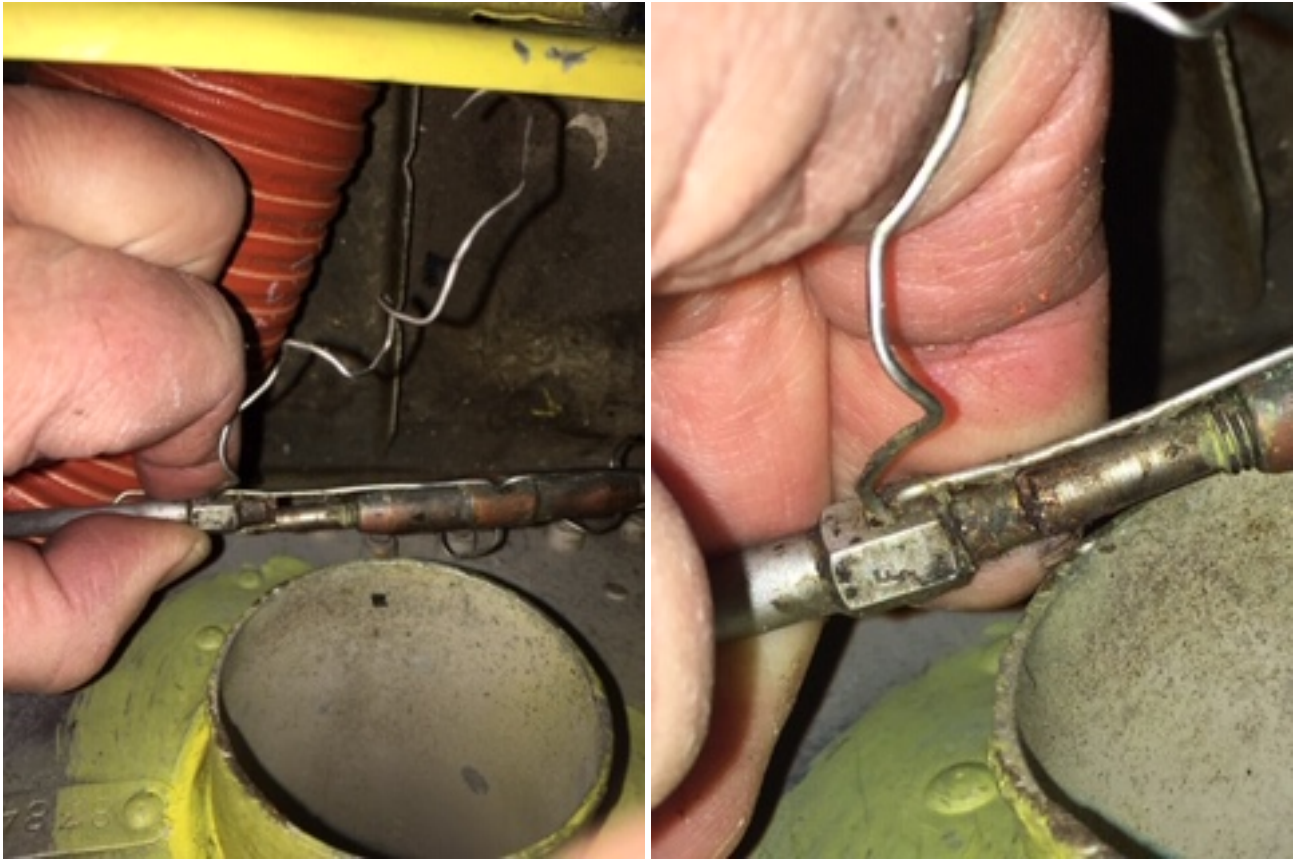
The following photograph shows a failure that occurred on a cable fitting located under a ventilation/heating duct on a Beechcraft Bonanza airplane.

4. For those airplanes with a history of significant exposure to warm, humid, salt air environments, replacement of all primary flight control cables that have been in service for 15 years or longer is recommended. Additionally, replacement of any cable that has a turnbuckle fitting located in an area of the airplane subject to elevated temperatures, the prevalence of condensation, or in close proximity to the airplane battery, and has been in service for 15 years or longer is recommended.

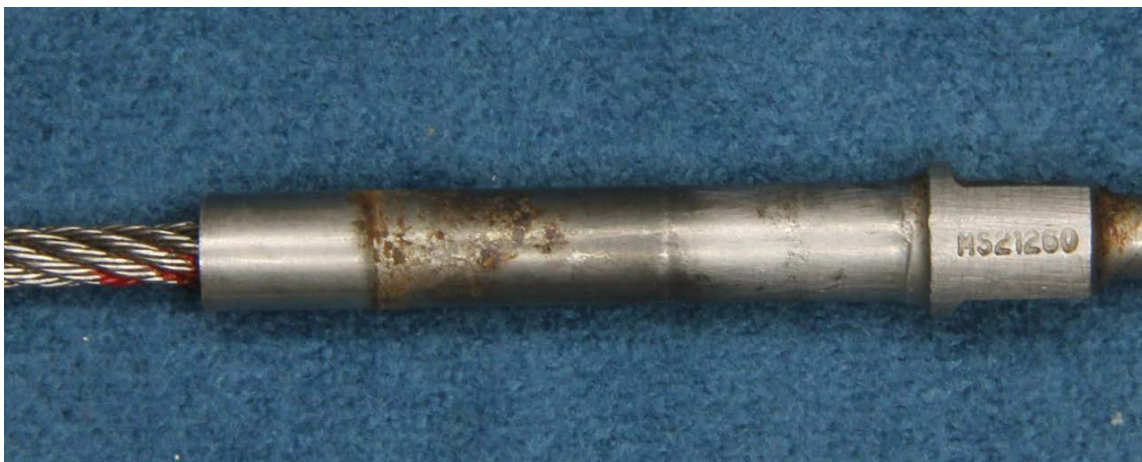
Another aggravating factor is the presence of sleeving or tape that is sometimes installed on the fitting shank for identification as an aid during initial airplane assembly. Corrosion can form more quickly underneath this material and be hidden from view during an inspection as shown in the following photograph. This material has no functional purpose on an assembled airplane.

- b. Examine underneath any sleeving or tape that is installed on the fitting shank.
 - i. Remove and discard any such tape or sleeve material while exercising care not to gouge or scratch the fitting surface. Removal of this material is considered a minor alteration to the airplane and should be documented by an appropriate logbook entry.
