U.S. Department of Transportation

Federal Aviation Administration

Airworthiness Concern Sheet

Reply to: Name: David Swartz Title: Senior Engineer Office: Anchorage Aircraft Certification Office Department: Street Address: 222 W 7 th Ave City, State, ZIP: Anchorage Alaska, 99513 Telephone: 907-271-2671 Email: Dave.swartz@faa.gov	Make: Piper/FS2003 Corp Model / Series: J-5A, J-5B, J-5C, J-5D, AE-1, HE-1, PA-12, PA-12S, PA-14, PA-16, PA-18, L-21, PA-20, and PA-22 Serial Numbers: All Reason for Airworthiness Concern: In flight failure of rudder just above the upper hinge.
--	---

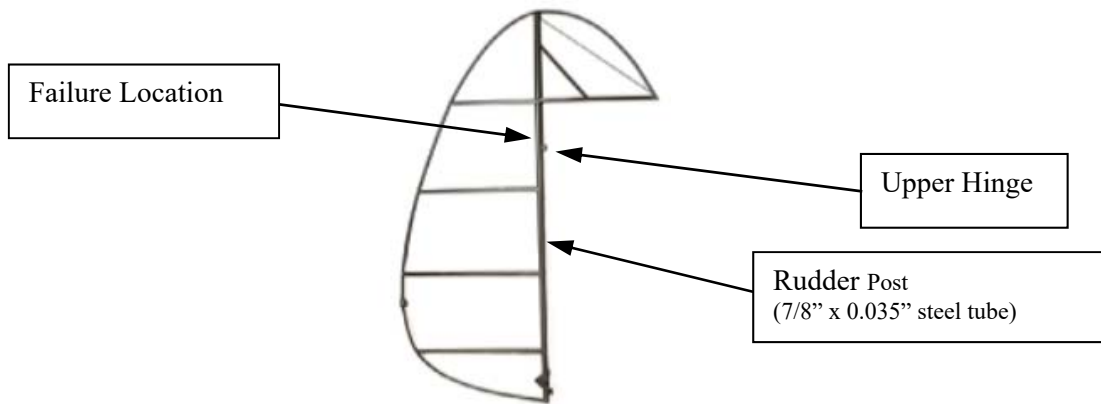
Recently an accident occurred where the rudder on a PA-12 failed in flight. The airplane was a seaplane equipped with a 160 hp Lycoming O-320 engine. The original tail surfaces had been replaced with PA-18 tail surfaces in accordance with a Supplemental Type Certificate (STC). The broken upper part of the rudder post broke just above the top hinge and the upper part of the rudder folded over the tail brace wires in such a way that rudder control was severely limited and as to effectively create an additional horizontal tail, driving the tail down and the nose up. It was possible for the senior flight instructor to control the airplane in pitch, but required a lot of the available elevator deflection to do so. By dropping the water rudders, some directional control was established and the airplane was able to return to base and land, but with difficulty.

At this time, it is not clear whether the rudder was an original Piper part, or one of the several PMA replacement parts available from aftermarket manufacturers. The accident airplane was equipped with an LED beacon on top of the rudder. The rudder had been overhauled about 6 years prior to this accident and some minor corrosion had been blended out from the exterior surface of the rudder post and the rudder had been powder coated. The inside of the rudder post was blackened, indicating the corrosion prevention oil that was applied there during original manufacture had burned off during the powder coating process. The inside of the tube exhibited some very minor corrosion pitting but was otherwise unremarkable other than evidence that corrosion prevention oil was burned off during the powder coating operation. This rudder has been submitted to the NTSB laboratory for further evaluation.

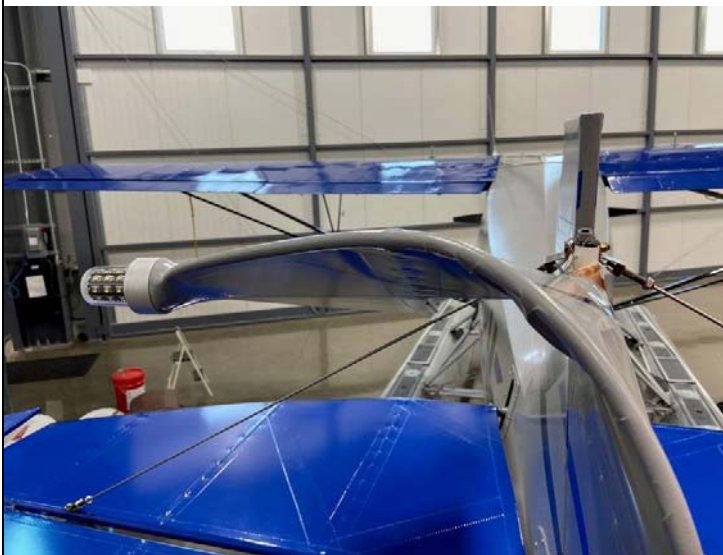
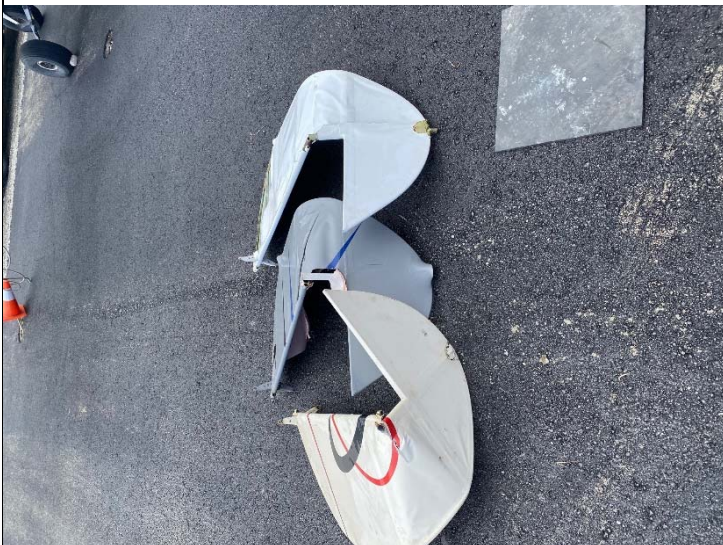
FS2003, the current type certificate holder for the PA-12 airplane, is aware of two rudder failures of the front rudder post, above top hinge, on PA-12 airplanes. One was caused by a cable strike. The other was caused by previous damage not being detected after the airplane went over on its back while operating on skis in deep snow.

At some point in the production of these series rudders, a change was made in the manufacture of these rudders to make the subject rudder post tube out of 4130 Condition N tubing as opposed to 1025 mild steel. We believe that rudders manufactured after about June 1974 will have been made out of 4130. The NTSB will be analyzing the failed rudders they have to see if they were 1025 or 4130.
