AIR-22-02

January 10, 2022

Structural Failure of Piper Part Number 40622 Rudder Posts Made of 1025 Carbon Steel

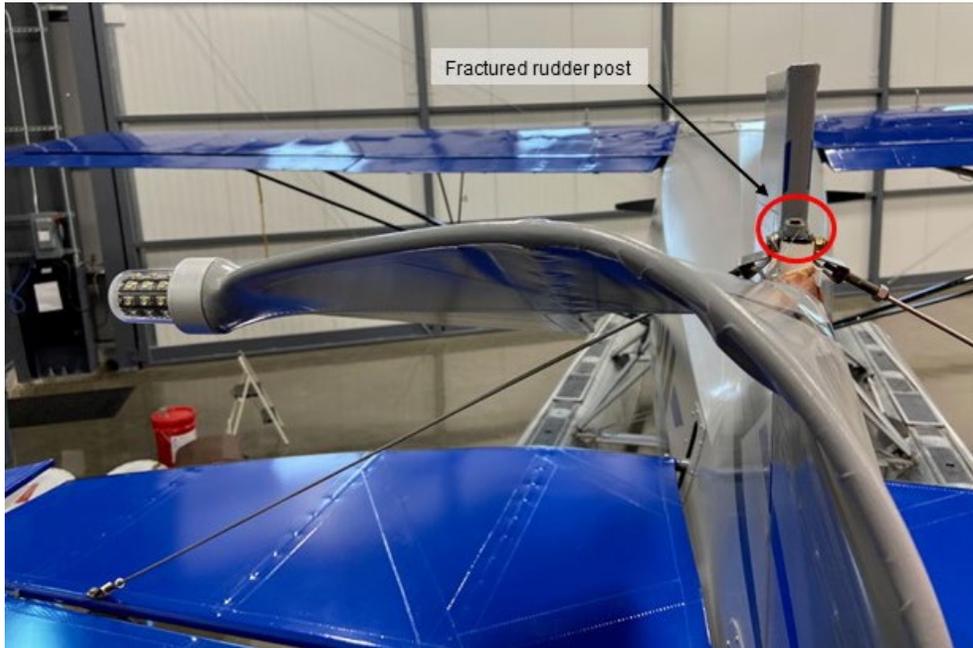
Through examination of the rudders involved in these accidents, the NTSB has determined (1) the rudders were consistent with Piper part number 40622, and (2) the rudder posts were made of AISI 1025 carbon steel.⁵ The NTSB has also determined that in both accidents, the airplane's rudder post fractured above the upper hinge, and the top portion of the rudder folded over the upper tail brace wires (see figures 1 and 2).

Figure 1. Photograph showing the fractured rudder post from N3188M (case number ANC20LA059).

Further NTSB examination identified evidence of a progressive fracture mechanism such as fatigue on each of the rudder posts, including fatigue fracture features on three of the rudder posts. The fracture surfaces on the other two rudder posts were too damaged to identify the specific fracture mechanism. Corrosion, scratches, or surface roughness features were found on all five of the rudder posts. The fracture origin areas were damaged, but corrosion pits or scratches on the exterior surface were associated with fatigue origin areas on two of the examined rudder posts.

Issue an airworthiness directive that describes the safety risk associated with the continued use of Piper Aircraft Inc. part number 40622 rudders equipped with a post made of American Iron and Steel Institute (AISI) 1025 carbon steel and that requires owners and operators to address the unsafe condition, such as by replacing them with rudders equipped with a post made of AISI 4130 low-alloy steel or its equivalent. (A-22-3)

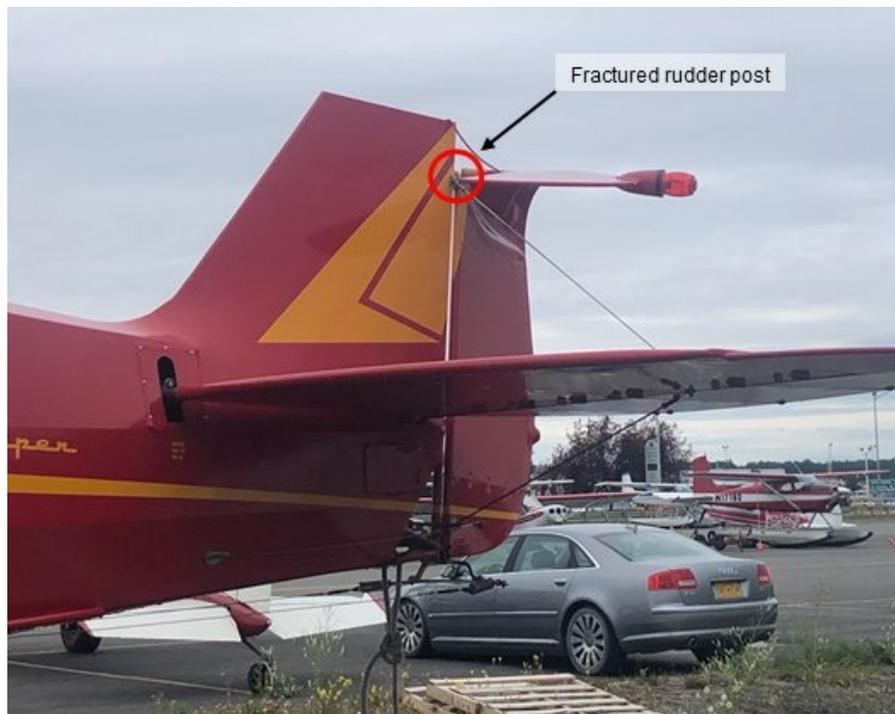
Figure 2. Photograph showing the fractured rudder post on N4206H (case number ANC21LA064).
