SUBJ: ENGINE COWLING SYSTEM,
Quarter-Turn Fastener Maintenance Information

SAIB: AIR-22-10
Date: April 29, 2022

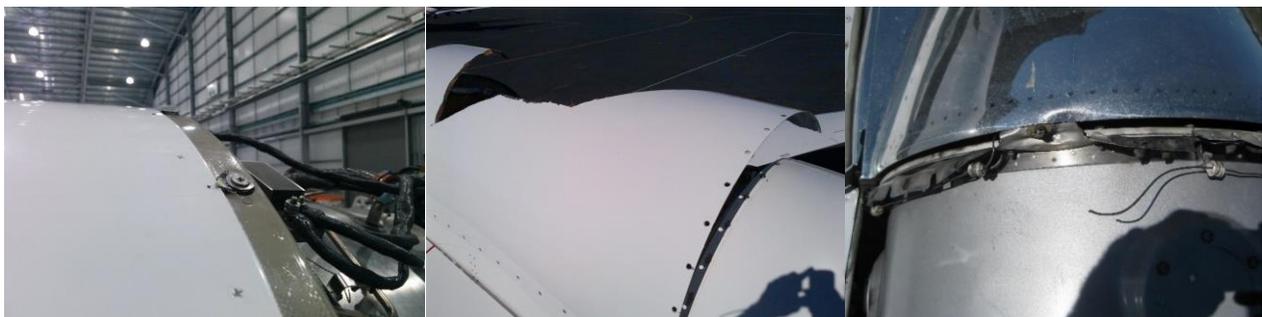
Figure 1: Examples of damage attributed to quarter-turn fastener problems

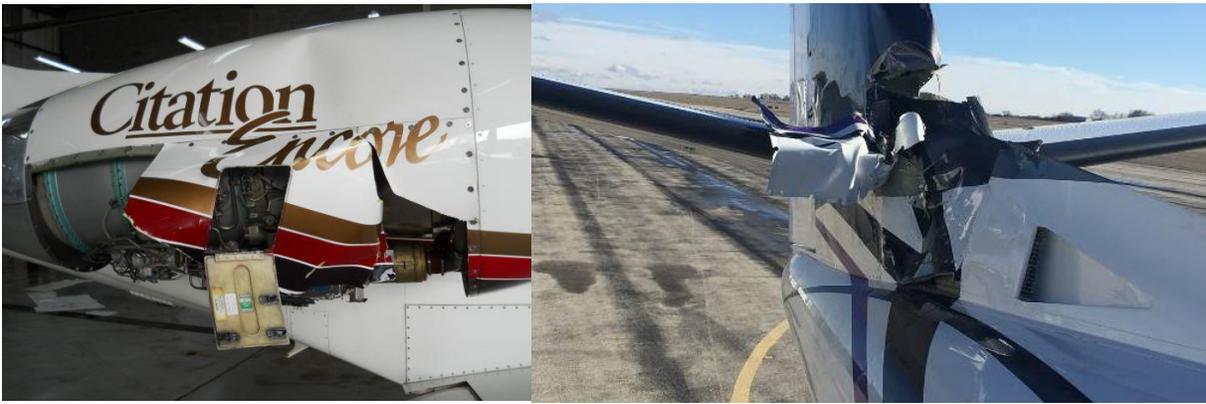
Figure 2: Additional examples of damage attributed to quarter-turn fastener problems
