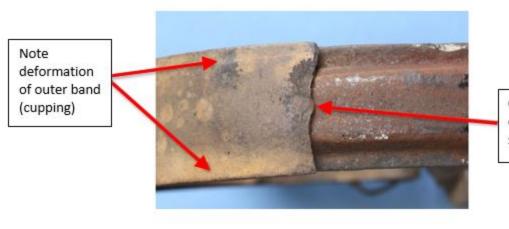
Crack origination at spot-weld.
