# Airworthiness Concern Sheet

**Subject Line:** Worn Fuel Primer Pumps Lead to  
Loss of Engine Events

**Reason for Airworthiness Concern:** Worn manual fuel  
primer pump locking mechanisms

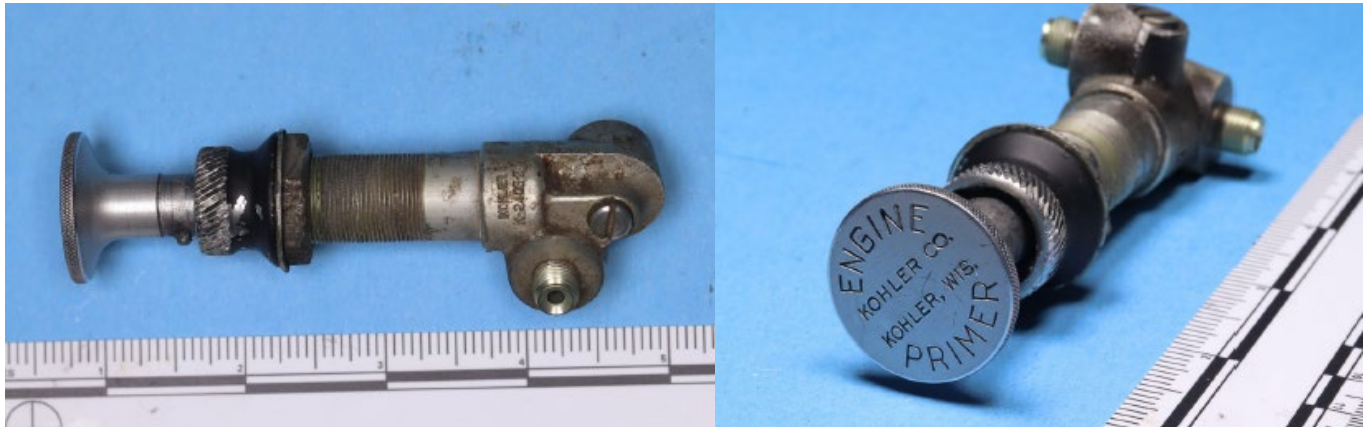
On June 21, 2023, an accident occurred on a Champion 7EC Traveler equipped with a Continental Motors C90-12F reciprocating engine. The pilot noticed a decrease in the engine rpm during the takeoff climb and eventually lost engine power. Shortly after, the pilot performed a forced landing resulting in substantial damage to the right wing and the fuselage. The probable cause of the accident, as documented in National Transportation Safety Board accident no. CEN23LA250, was a worn locking mechanism on a manual fuel primer pump, resulting in excess fuel being pulled into the engine.

Fuel primer pump as received after the accident.

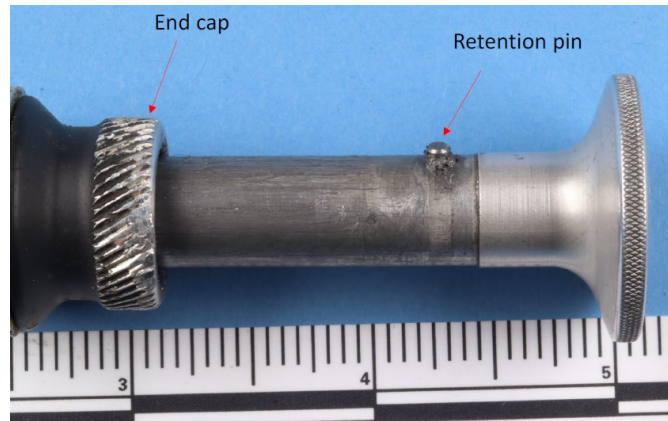
Piston with retention pin and pump housing end cap (piston in extended position).

To keep the pump in a locked position, the retention pin is pushed past the end cap and must be twisted either left or right. There should be a retention lip at the base of the end cap, keeping the retention pin in place which locks the pump.

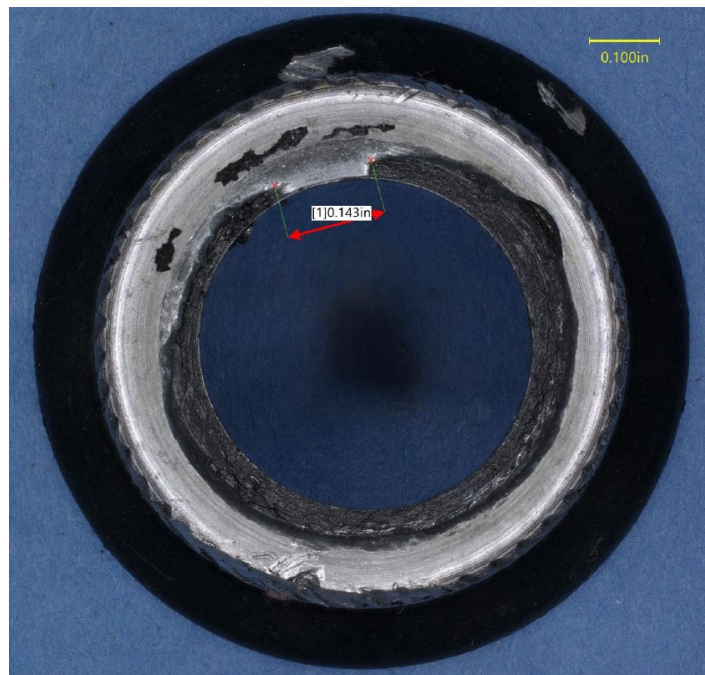
End cap exhibiting worn retention lip.

If the retention pin was pushed past the end cap and twisted, it may appear to be in the locked position. Given the wear of the end cap, minimal force, if any, could remove the retention pin from the lip and leave it in an unlocked position.

If the pin does not engage, and the plunger works its way out slightly, the plunger will not shut off fuel through the primer system. The primer system allows fuel to bypass the carburetor and its metering functions. This could result in extra fuel being introduced into the cylinders that are primed. Because not all systems prime all the cylinders or prime them evenly, this can result in one cylinder burning rich and others burning lean.

The FAA is releasing this ACS to make owners and operators aware of a worn retention lip on the end cap of manual fuel primer pumps. Wear of this retention lip can cause the pump to unlock unintentionally and may lead to complete loss of engine power in flight.
