FEDERAL AVIATION ADMINISTRATION

Aviation Maintenance Alerts Template

Cracked Upper and Lower Wing Strut Fittings on Cessna 208 Airplanes

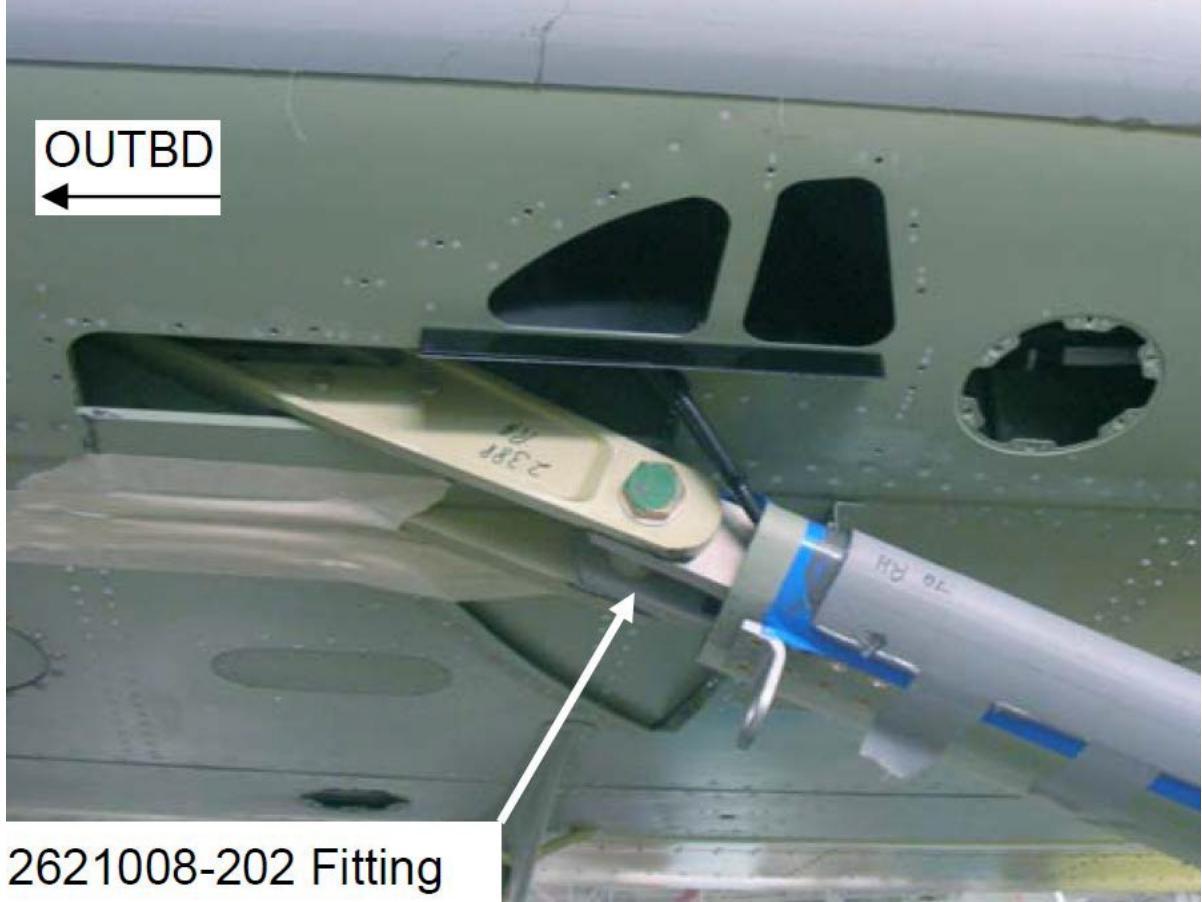
The location of the Upper Wing Strut Fitting, P/N 2621008 is displayed in the Figure 1 photograph and in the Figure 4 schematic. The Lower Wing Strut Fitting, P/N 2621009-1 and -2, is shown schematically in Figure 5. Cracking has occurred in the lower fitting. The crack, shown in Figure 2 and Figure 3, was found during a scheduled inspection. Only about a quarter-inch of material remained where the crack ended. Figure 2 shows indentation damage caused by the spacer, part number 2621013-2, and Figure 3 shows dark rub marks, a slight twist, and a few white-colored linear scratches. The schematics in Figure 6 and 7 show where the maintenance mechanic should do the Eddy Current Inspection on the Upper and Lower Wing Strut Fittings.

Figure 1 View looking Aft of the Upper Wing Strut attach location on a Cessna 208. Also shown is the bolt head of the S3461-77 Bolt MPI Upper Attach

The FAA recommends that Maintenance Technicians pay close attention when they inspect the Upper Wing Strut Fittings, part numbers 2621008-1, -2, -3, -201, -202, -203 (Please Note: -201, -202, -203 are spares); and the Upper Wing Strut Lift Fittings, part number 2622246-1, -2, -7, -8, -15, -16, -201, - 202 (Please Note: -201, -202 are spares). The Maintenance Technicians will inspect the fittings for cracks and corrosion.

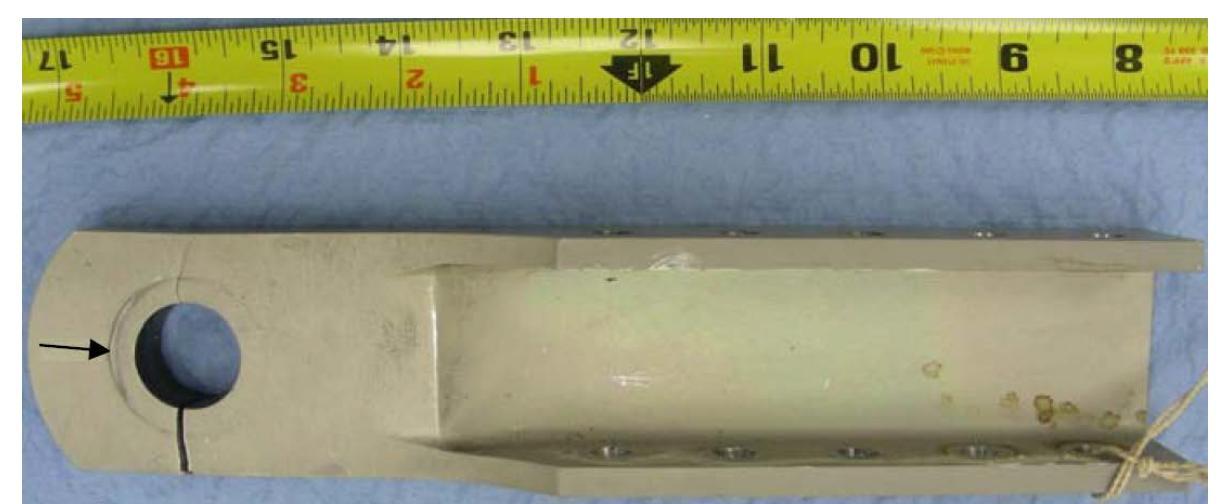
Transport Canada informed the FAA of a Service Difficulty Report (SDR) that described where a right-hand Upper Wing Strut Fitting (Part Number 2621008-202) was found cracked during an inspection of a Cessna 208 airplane on June 25, 2012. The Cessna 208 had 5,667 flight hours. The airplane operated on Wipaire Floats using Supplemental Type Certificate (STC) SA1311GL that allows it to operate at heavier weight than the Cessna certified airplane in Type Certificate Data Sheet (TCDS) A37CE. As reference, see page four (4) of the Transport Canada's Feedback for issue 4/2013.

Textron Aviation Material and Process (M&P) lab report, dated July 26, 2012 regarding the cracked Upper Wing Strut Fitting, stated: "Presence of closely spaced fatigue striations indicated that the mode of cracking was by *high-cycle fatigue*."

Figure 2 View of the forward surface of the fitting, showing indentation damage due to contact with the 2621013-2 spacer (see arrow)

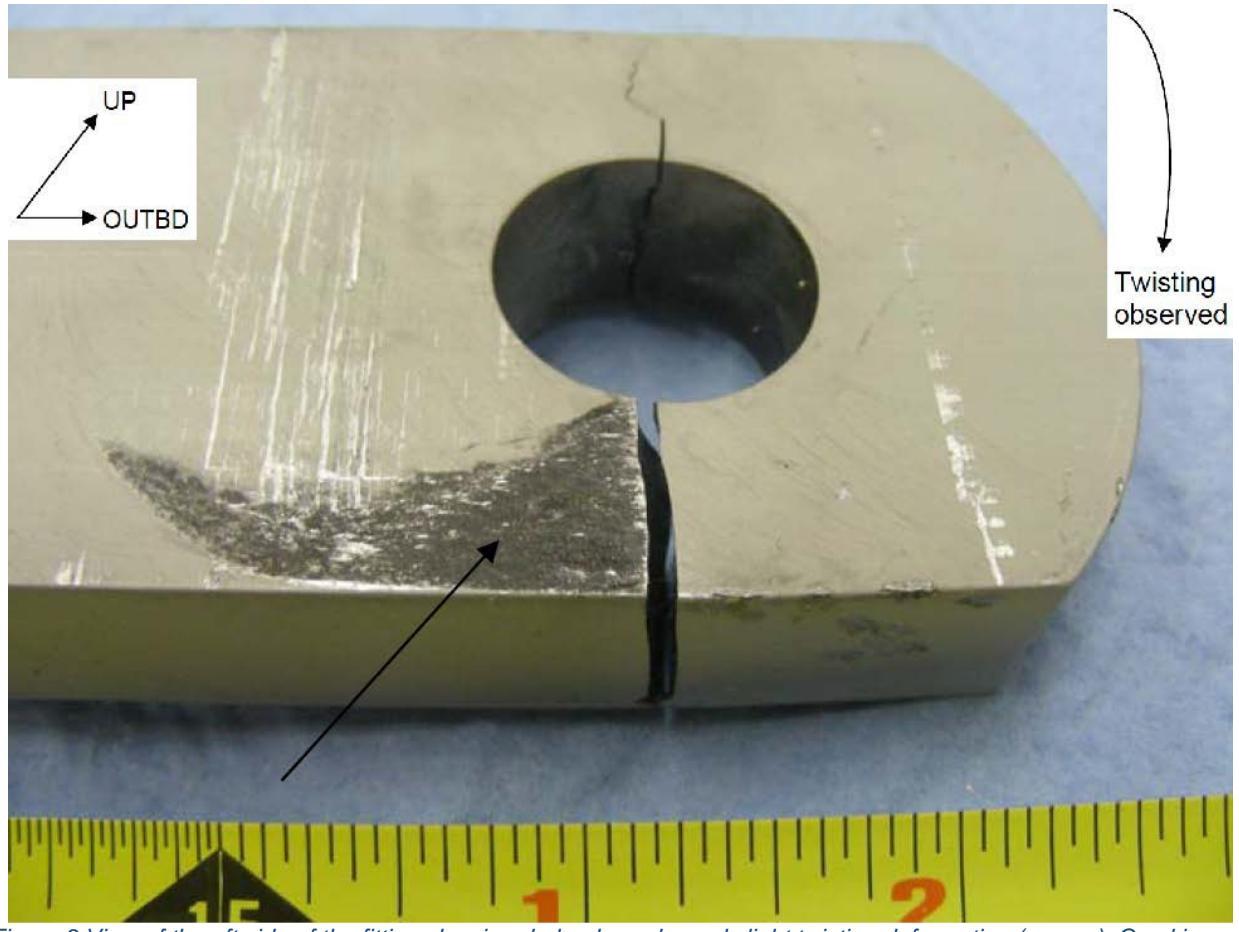
Figure 3 View of the aft side of the fitting showing dark rub marks and slight twisting deformation (arrows). Cracking extended all the way through the lower ligament, and approximately 80 – 90% through the upper ligament

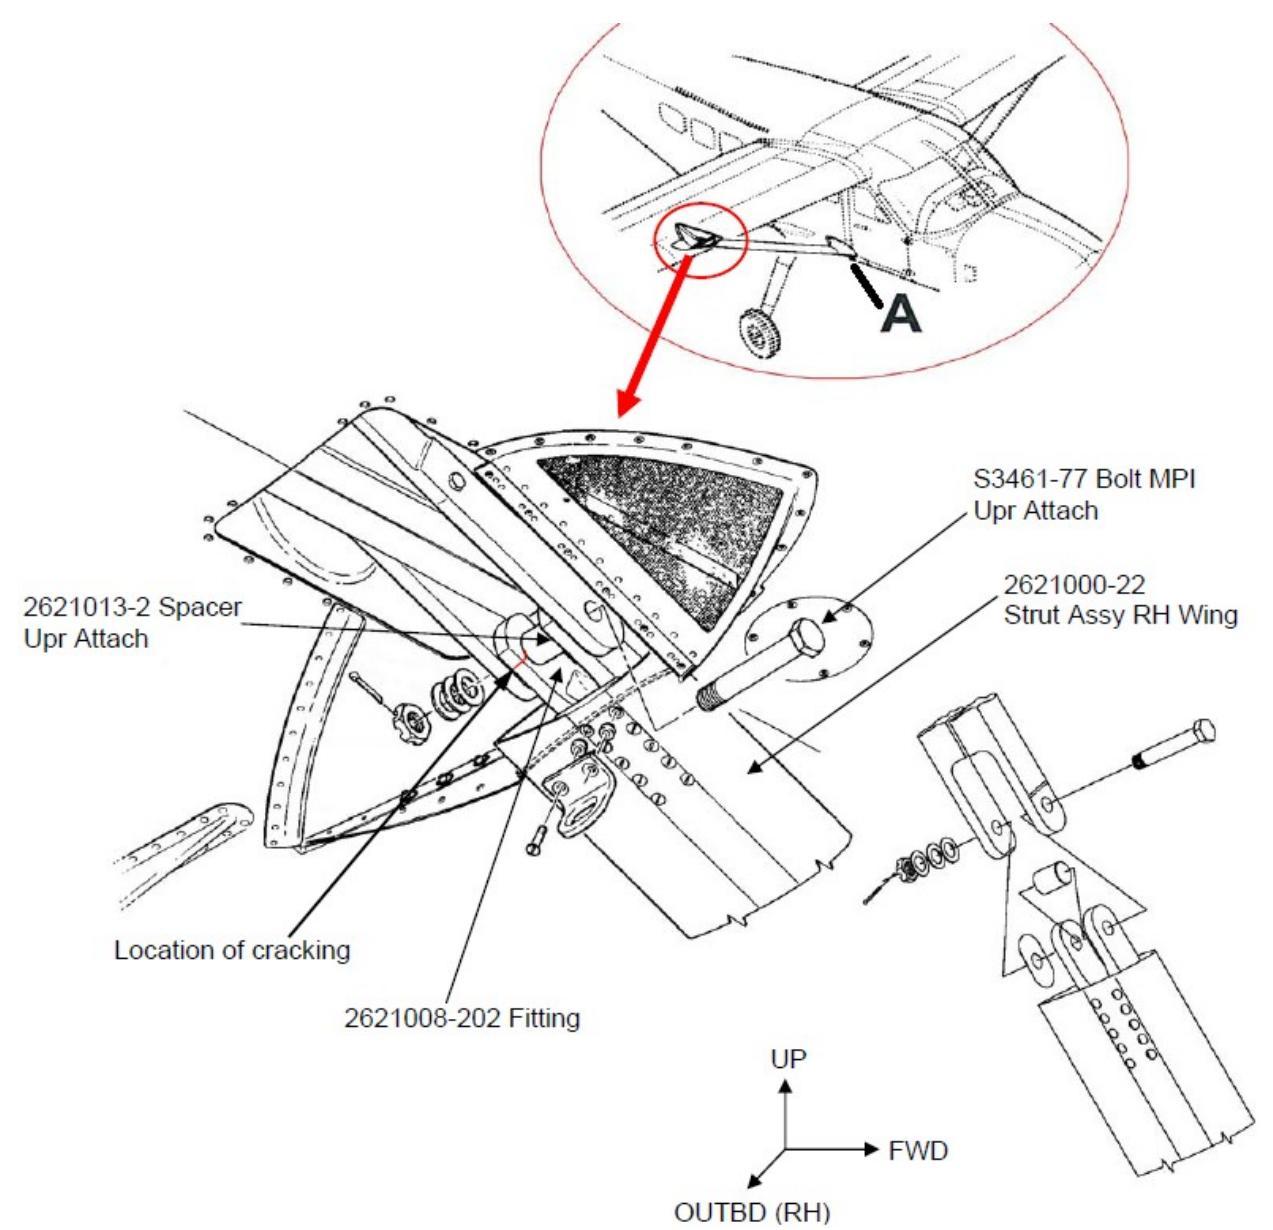
Figure 4 The Schematic displays the location of the Upper Wing Strut Fitting, part number 2621008-202. The Schematic also shows the S3461-77 Bolt MPI UPR Attach, 2621013-2 Spacer UPR Attach, and the 2621000-22 Strut Assembly RH Wing

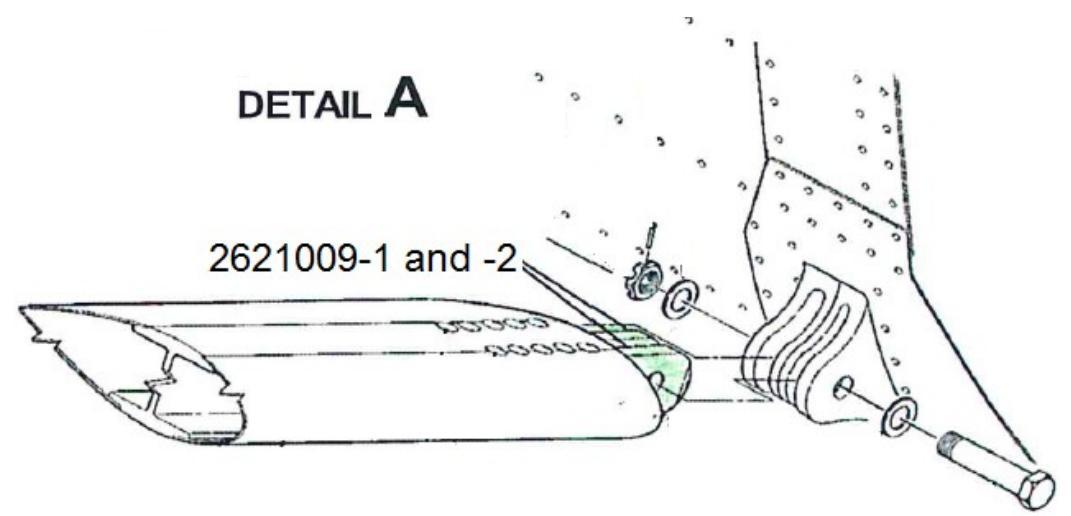
In addition, cracks have been found in the Lower Wing Strut Fittings, part numbers 2621009-1 and -2; and in nuts on attachment bolts, MS17826-12 (Lower Wing Strut) and MS21042L5 (Upper Wing Strut). The Maintenance Technicians will inspect other parts in the area pursuant to the Maintenance Manual. Any airplane operated on floats needs to use "Severe Inspection Time Limits".

Figure 5 The Schematic displays the Lower Wing Strut Fitting (Detail A), part numbers 2621009-1 and -2. (Please Note: Photographs are unavailable for cracked fittings)

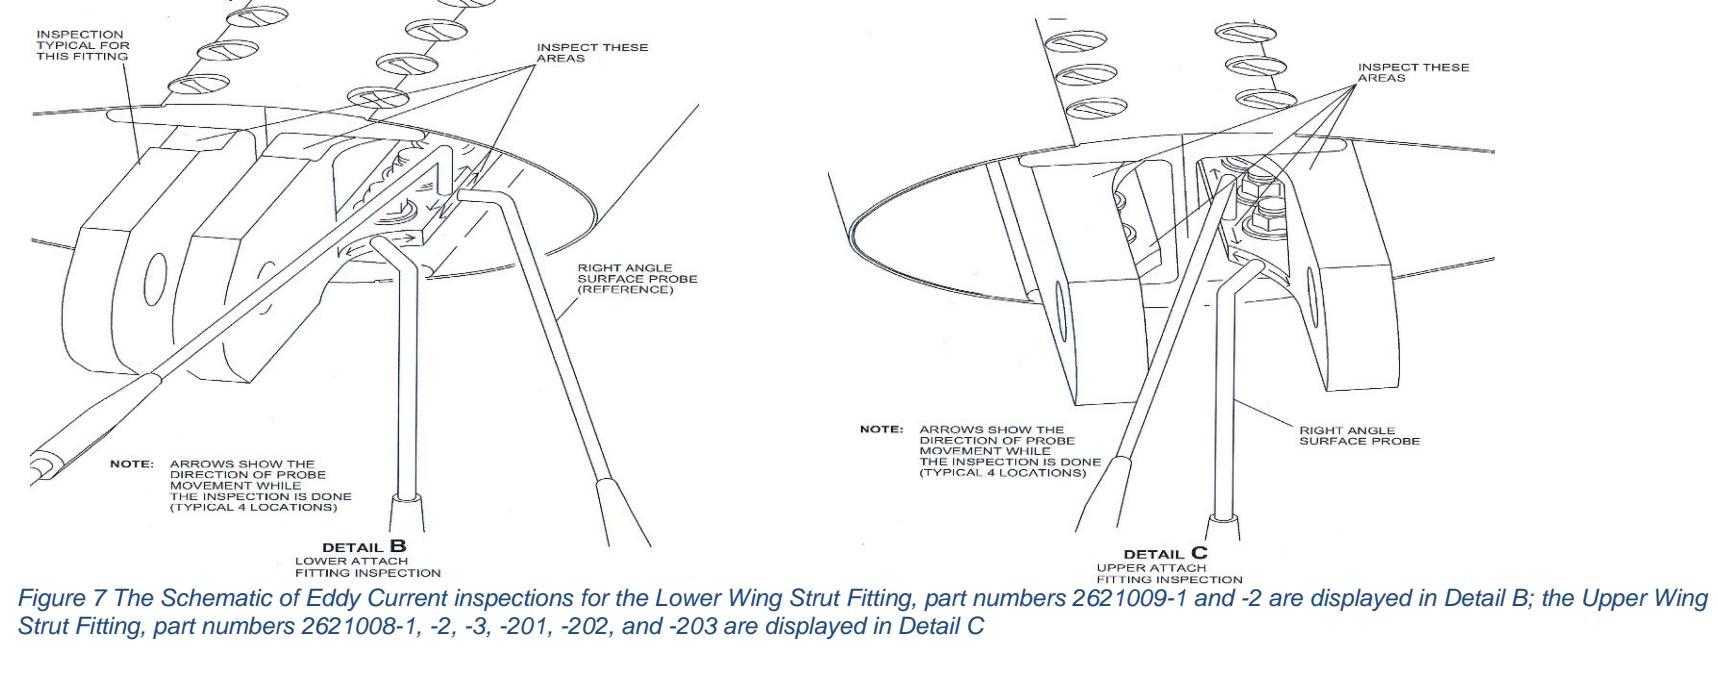
The maintenance manual inspection requirements for typical airplane use are in "**Typical Inspection Time Limits**" where Eddy Current Inspections are to be performed "*at the first 10,000 hours and every 5,000 hours thereafter.*" For severe airplane use, the inspection requirements are in "**Severe Inspection Time Limits**" where Eddy Current Inspections are to be [performed "*at the first 5,000 hours and every 3,600 hours thereafter*".

opposite view)11
Figure 7 The Schematic of Eddy Current inspections for the Lower Wing Strut Fitting, part numbers 2621009-1 and -2 are displayed in
Detail B; the Upper Wing Strut Fitting, part numbers 2621008-1, -2, -3, -201, -202, and -203 are displayed in Detail C 12
Figure 8 The Photograph shows the fractured Upper Wing Lift Strut Fitting prior to removal. The inboard portion of the fitting was
completely separated from the main body of the fitting
Figure 9 References: There are two views of the fractured part. a) Looking at the aft side of the part and b) Looking at the forward side

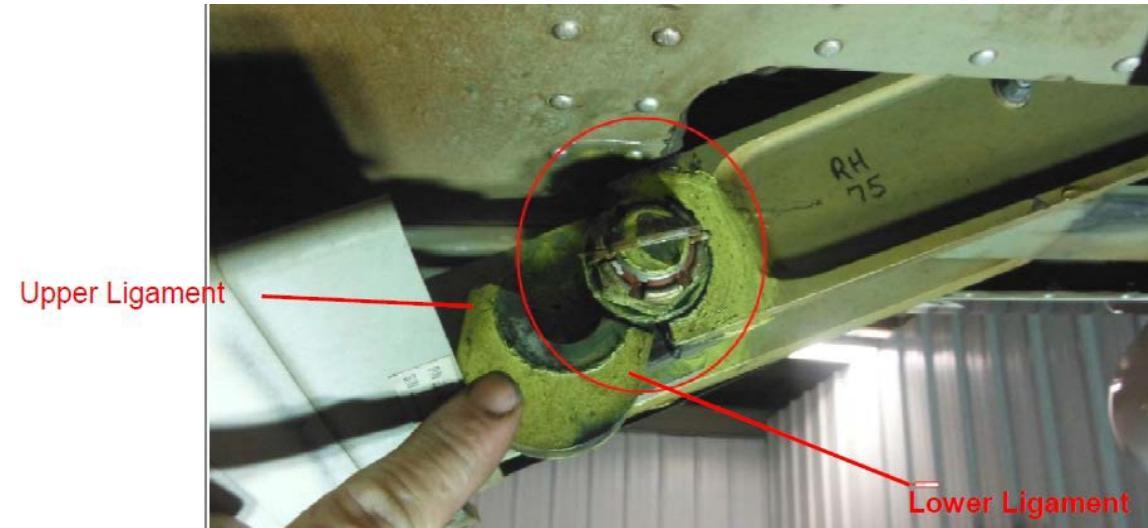
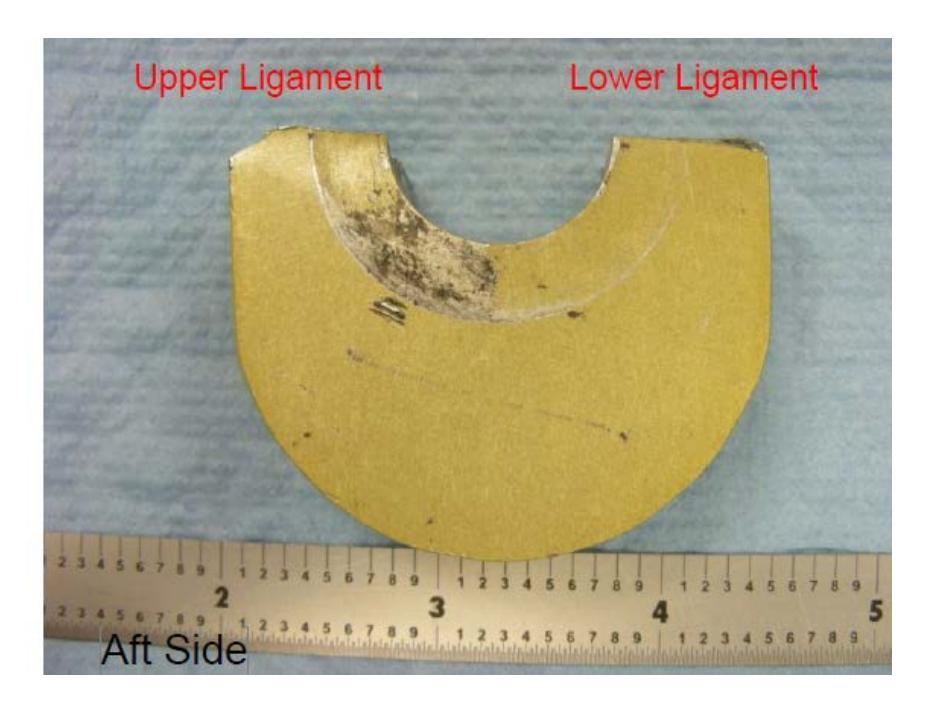
During a normal inspection on March 2, 2013, the aft Upper Wing Lift Strut Fitting (Part Number 2622246-16) on a Cessna 208B was found fractured through the bolt hole that attaches the wing lift strut to the wing. The airplane had accumulated 9,184 flight hours.

Textron Aviation M&P lab report dated July 15, 2013 determined that the "mode of the cracking was due to *fatigue*." "The crack origin was located along the surface of the bore hole."

Figure 8 The Photograph shows the fractured Upper Wing Lift Strut Fitting prior to removal. The inboard portion of the fitting was completely separated from the main body of the fitting

Note: Relative to Figure 1, this view is looking forward instead of aft

Note: The primer shown in Figure 8 was removed for examination.

The Eddy Current inspection intervals for the 2622000 parts are at the **first 20,000 hours and every 5,000 hours thereafter** for standard bolt S3561-77 (typical usage), **4,400 hours thereafter** for S3561-163 (severe usage), and **3,600 hours thereafter** for S3561-164 (severe usage).

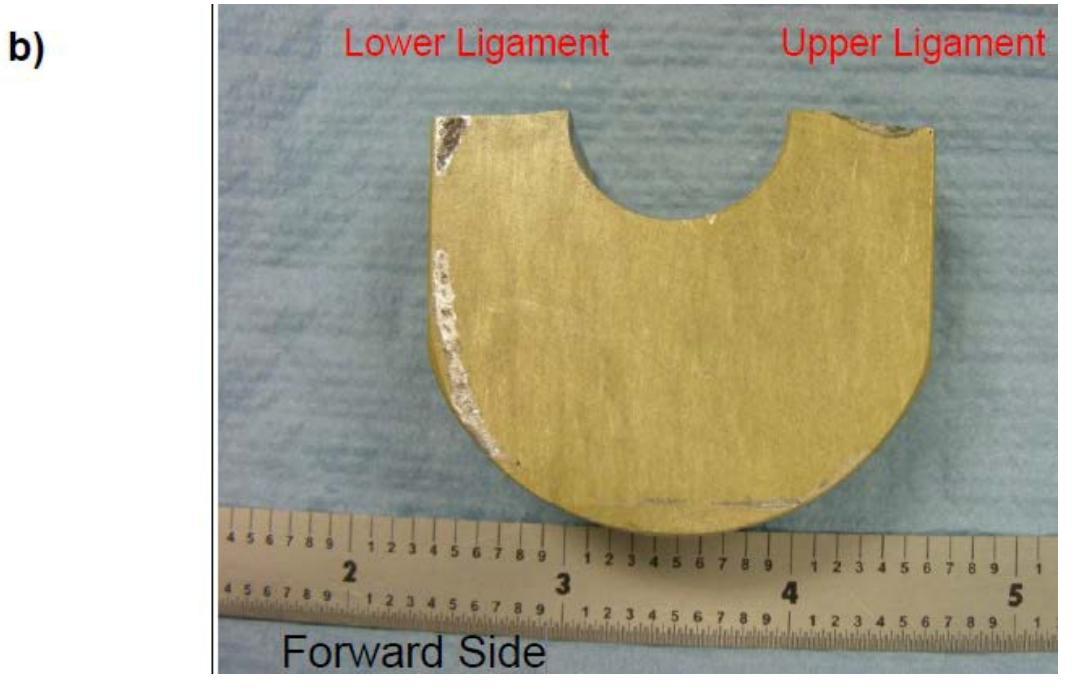
Figure 9 References: There are two views of the fractured part. a) Looking at the aft side of the part and b) Looking at the forward side
