Cessna 182G, Cracked Main Landing Gear Attach Casting, ATA 5343

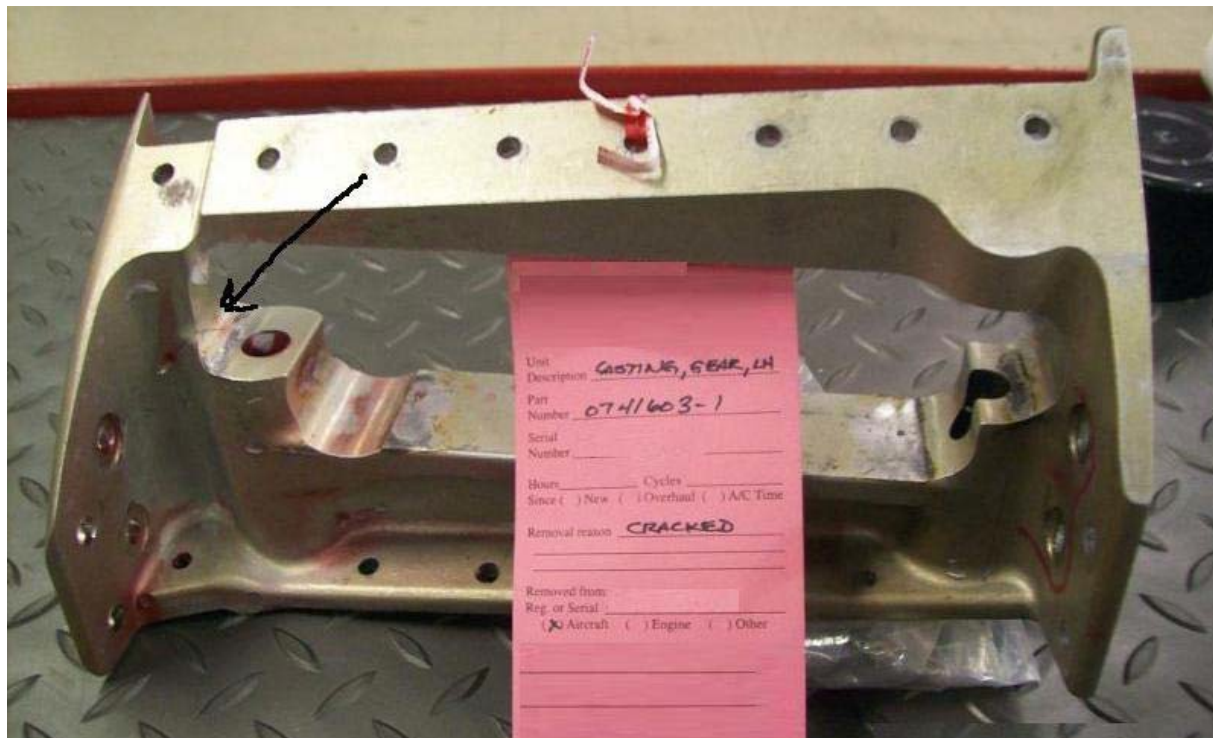
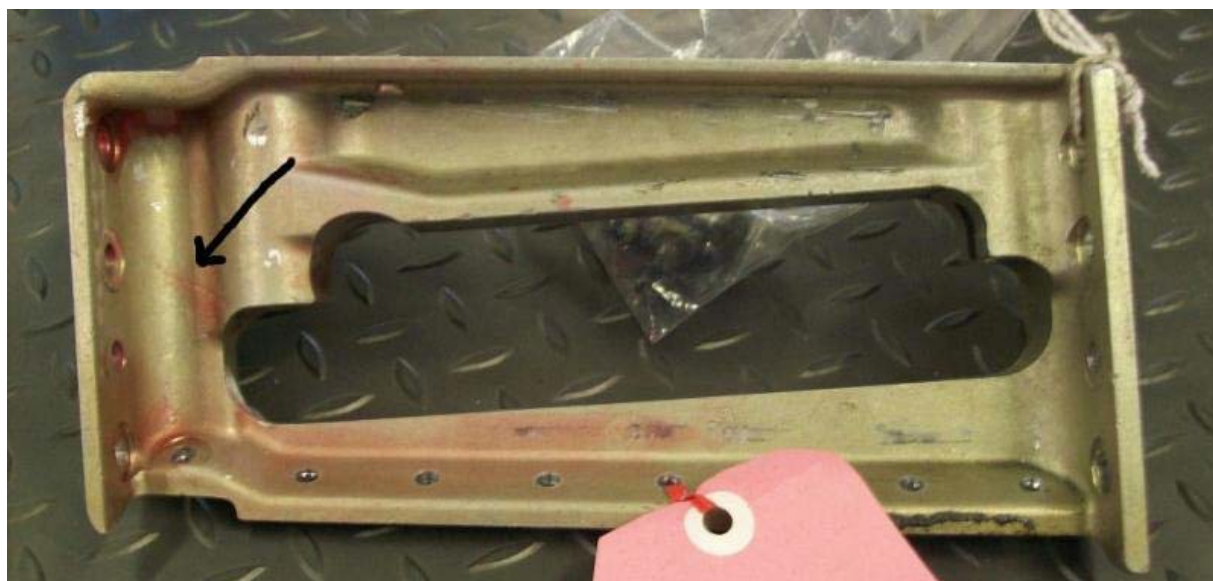
A general aviation submission states, "A casting crack was visually found during the course of an Annual Inspection. The crack is located on the forward end of the support casting (P/N 07416031), (starting) 0.25 inches from the outboard mount holes and ends within 0.25 inches of the mount holes on the inboard side of the casting."

Part Total Time 2,690 Hours
