## **De Havilland: Gipsy Major 1; Broken Valve Cover Bolt, ATA 1430**

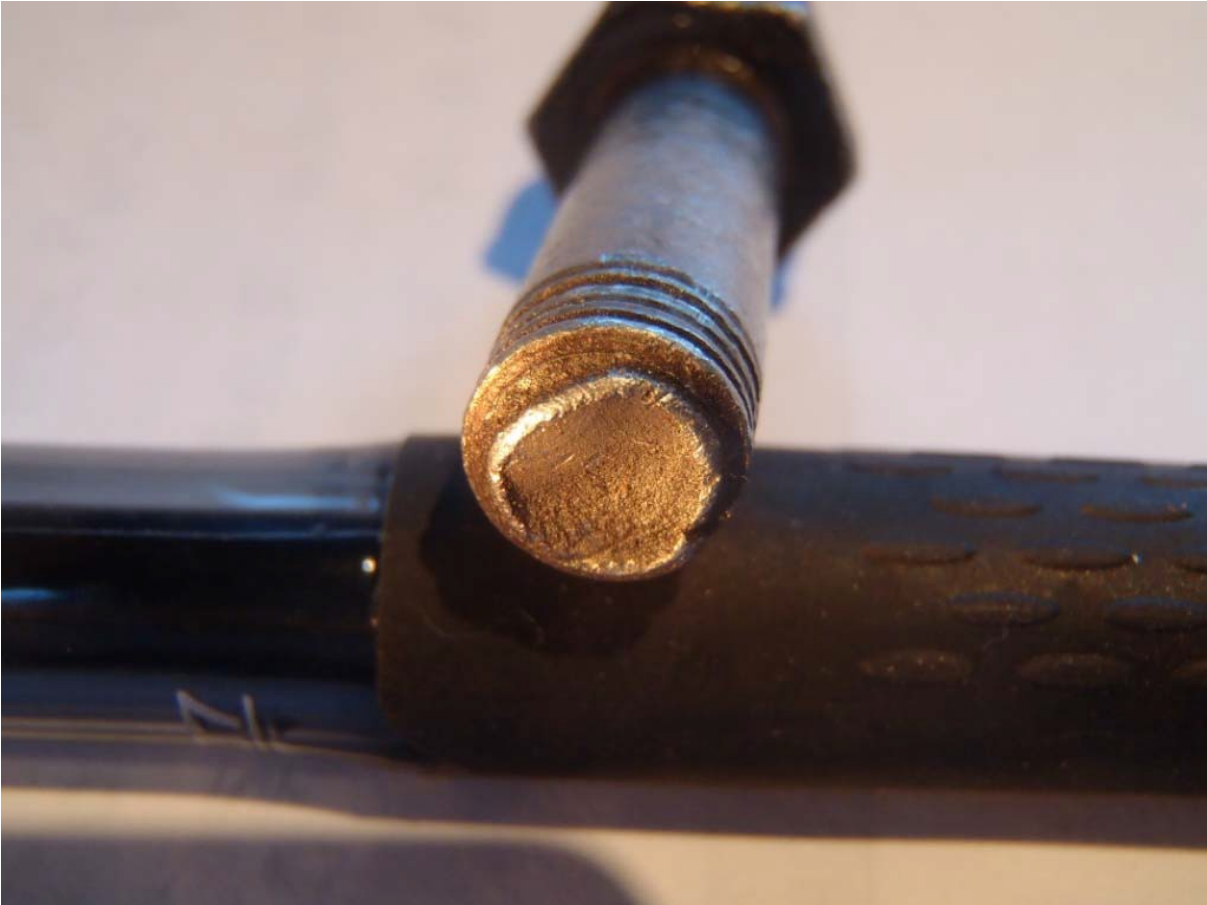
This general aviation defect report provides a short description. "The bolt (P/N 80285) separated due to heavy corrosion."

Part Total Time: 3,500.0 Hours
