Cessna 172S, Loosened Seat Lock Attach Screws, ATA 2510

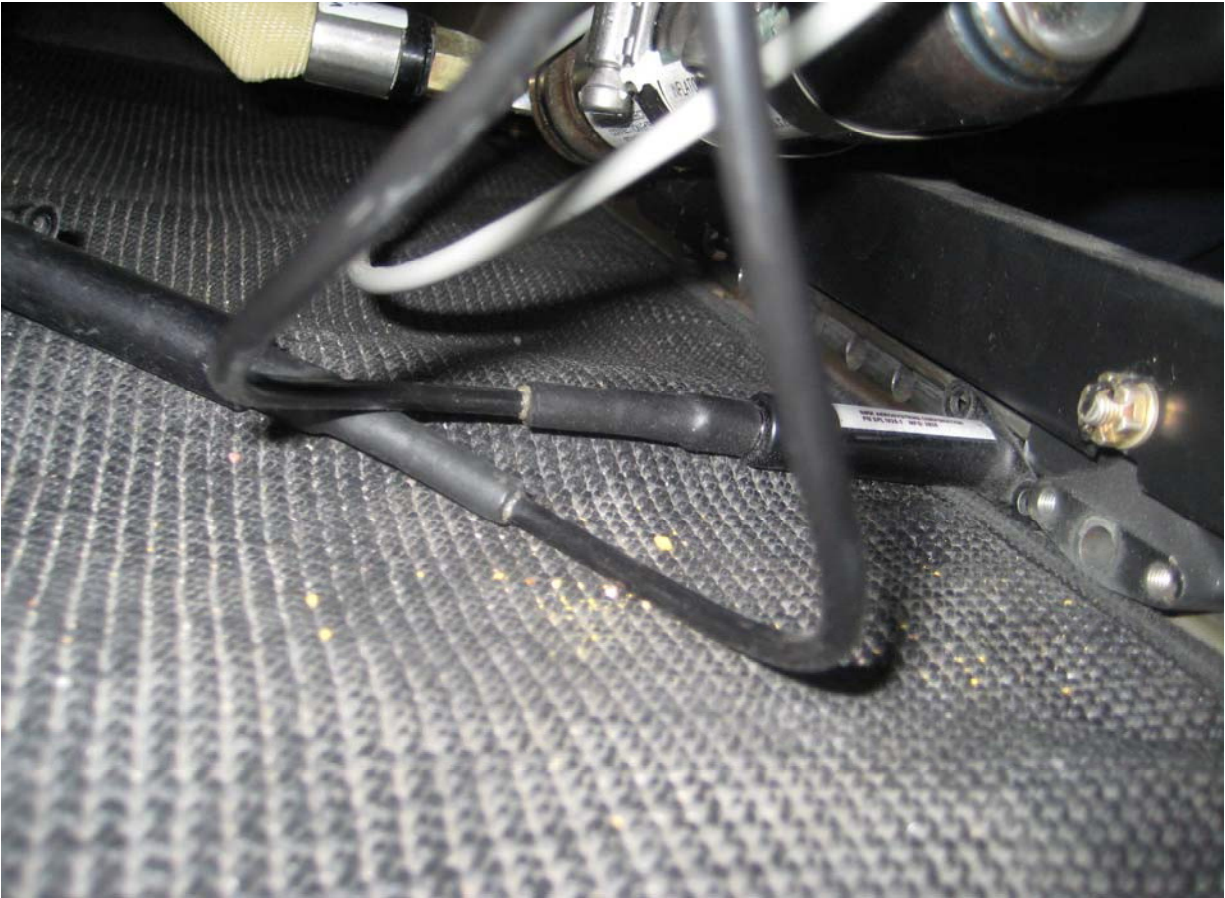
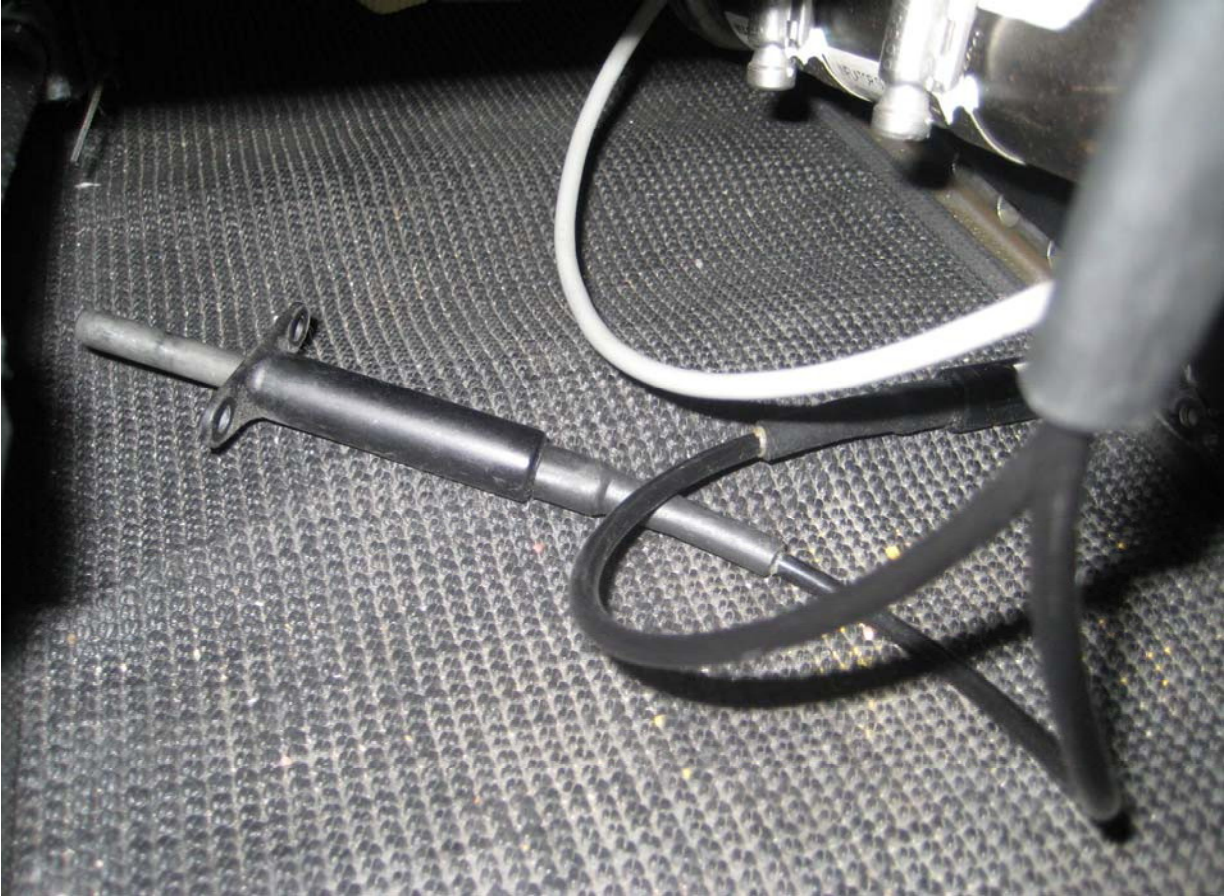
Cessna 172S, Loosened Seat Lock Attach Screws, ATA 2510

A writer says, "During a training flight the student pilot reported his seat would not lock into position. The aircraft returned to base without incident. Upon troubleshooting the problem a maintenance technician found the attachment screws of the left and right seat stop pins had backed out, allowing them to be detached and ineffective. A check of the other aircraft in the fleet found six *(additional)* aircraft *(having)* loose attachment screws *(P/N MS35207256)*. All loose screws were removed, inspected, and reinstalled with Loctite 242 as per the manufacturer's suggestion." *(Component name, P/N, and manufacturer: Seat Latch Assembly; SPL19251; Birk Aerosystem.)*
