Cessna 172P, Cracked Seat Frame, ATA 2510

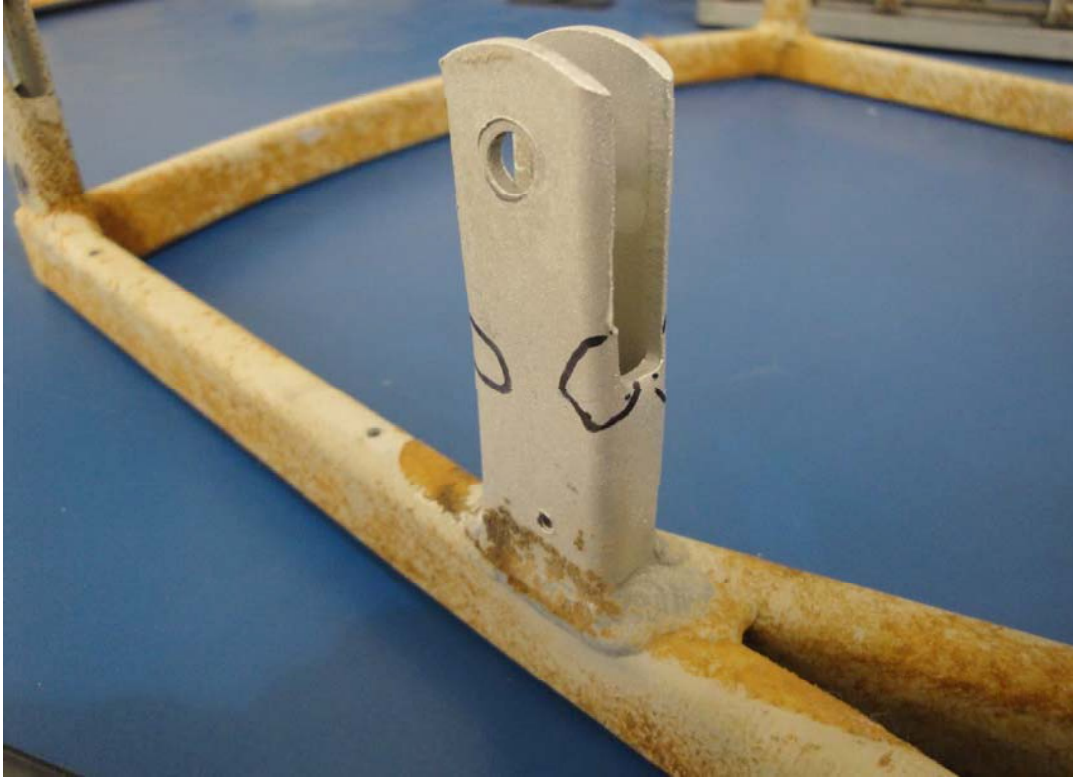
A general aviation submitter writes, "The pilot's lower seat frame support legs cracked at the frame rail cut outs (where they attach to the seat height adjustment arms)." (*Seat frame P/N: 05142047.*)

Part Total Time 5,150 Hours
