Cessna 208B, Cracked Inertial Vane Shaft, ATA 7160

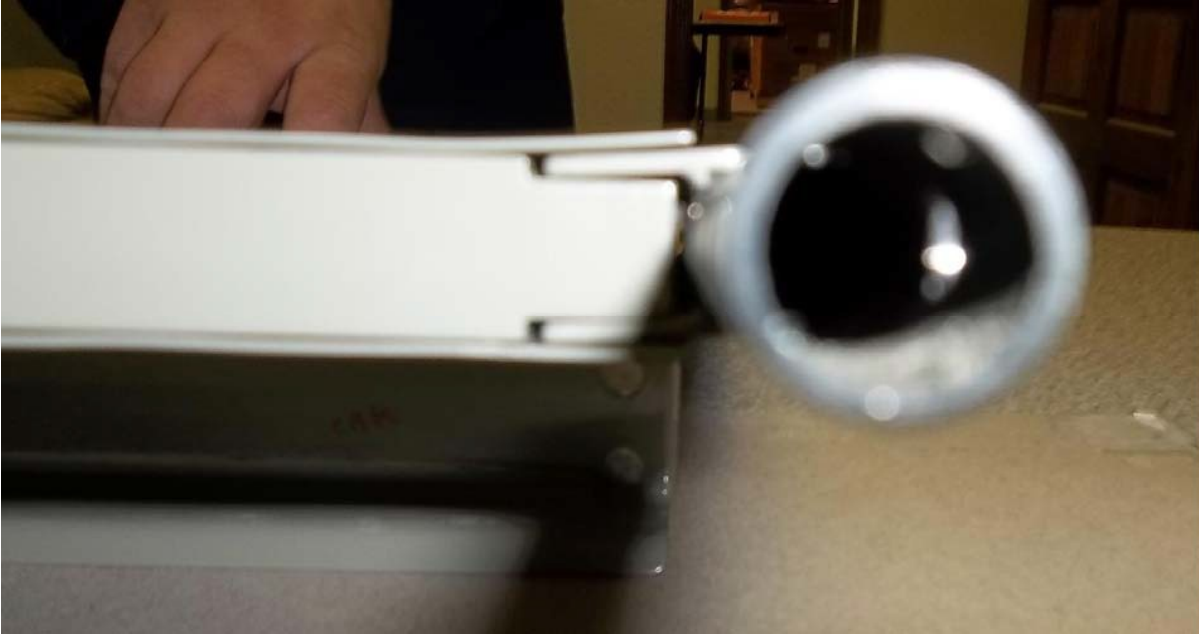
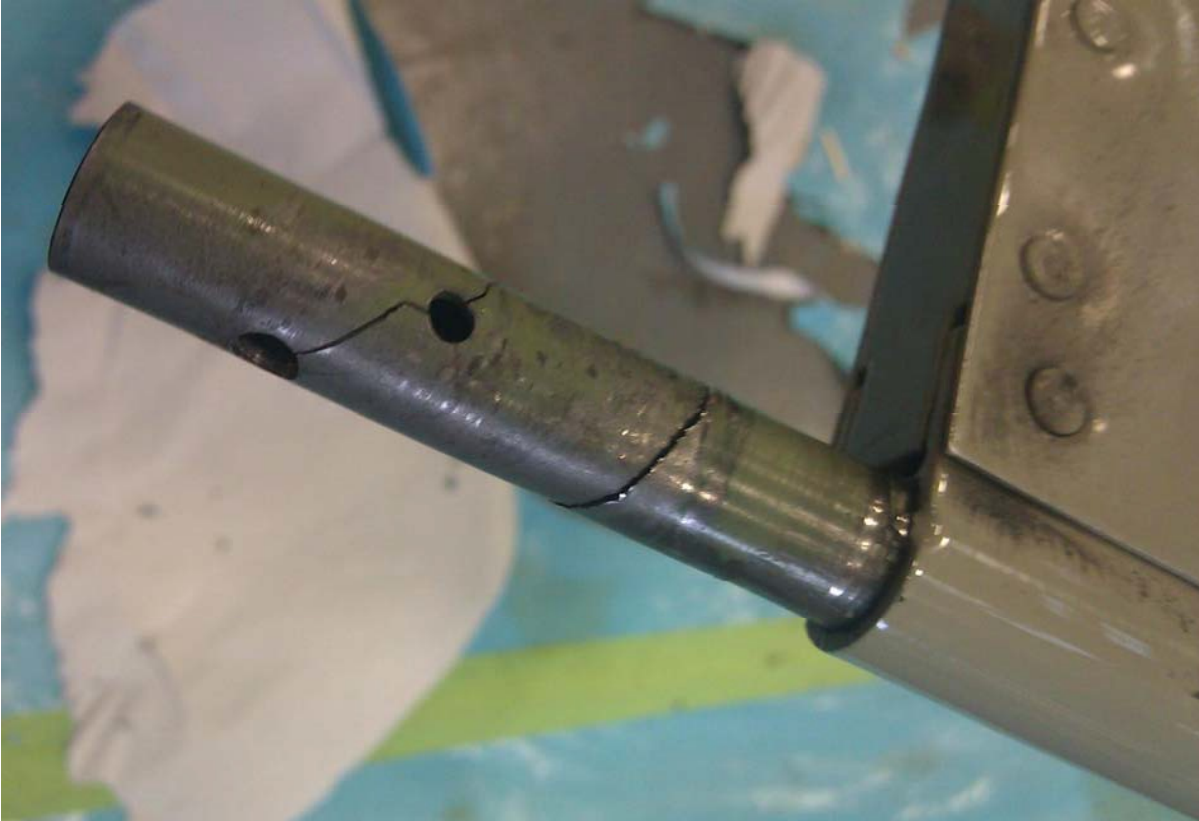
"Bypass door loose—will not close all the way," states this report from a Part 135 operator. "Upon investigation, we found the shaft cracked on the forward inertial vane assembly (P/N 200803511002). The mechanic also noticed the inlet splitter (P/N 200803511002) was cracked at its two ends, and one attach angle was broken."

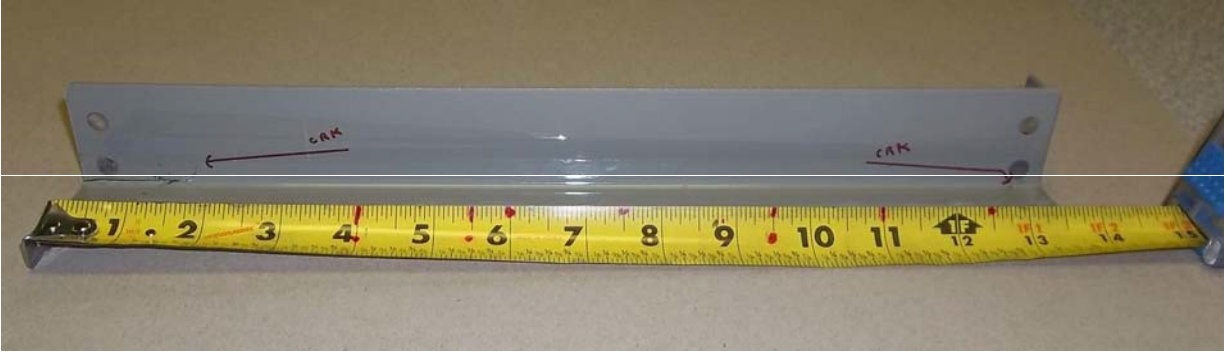
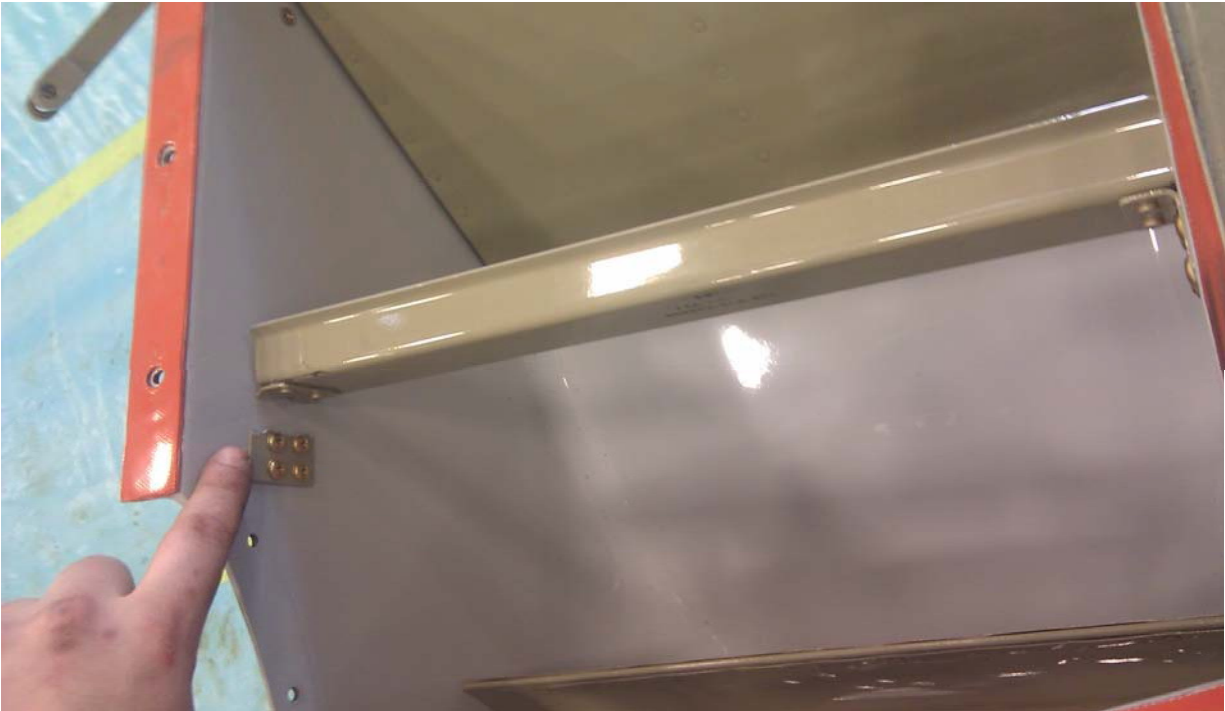
Cessna 208B, Cracked Inertial Vane Shaft, ATA 7160

Total Part Time: 140.0 hours
