Cessna 208B, Frayed Flap Cable ATA 2750

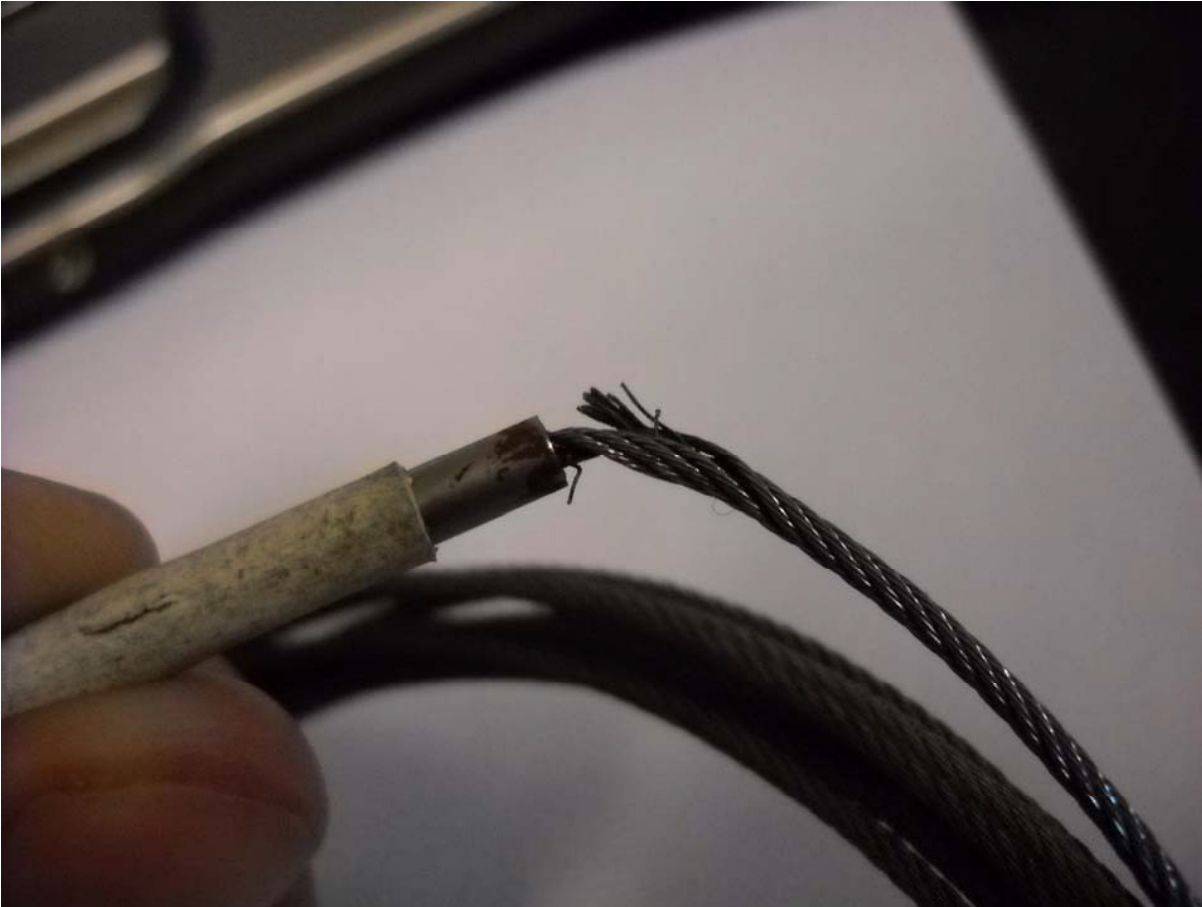
A mechanic stated, "During a routine inspection, *(I)* found a flap cable *(P/N 2660001105)* frayed at the connection to the fairlead—about 30 percent of the *(strands)* were broken. *(It)* runs from the inner bell crank to the outer end of the flap. This cable was original as far as can be traced back—the original P/N tag was still installed. *(And)* judging from the slip mark, the cable had not *(moved from its swaged fitting)*."
