Cessna 404, Damaged Elevator Mount Brackets ATA na

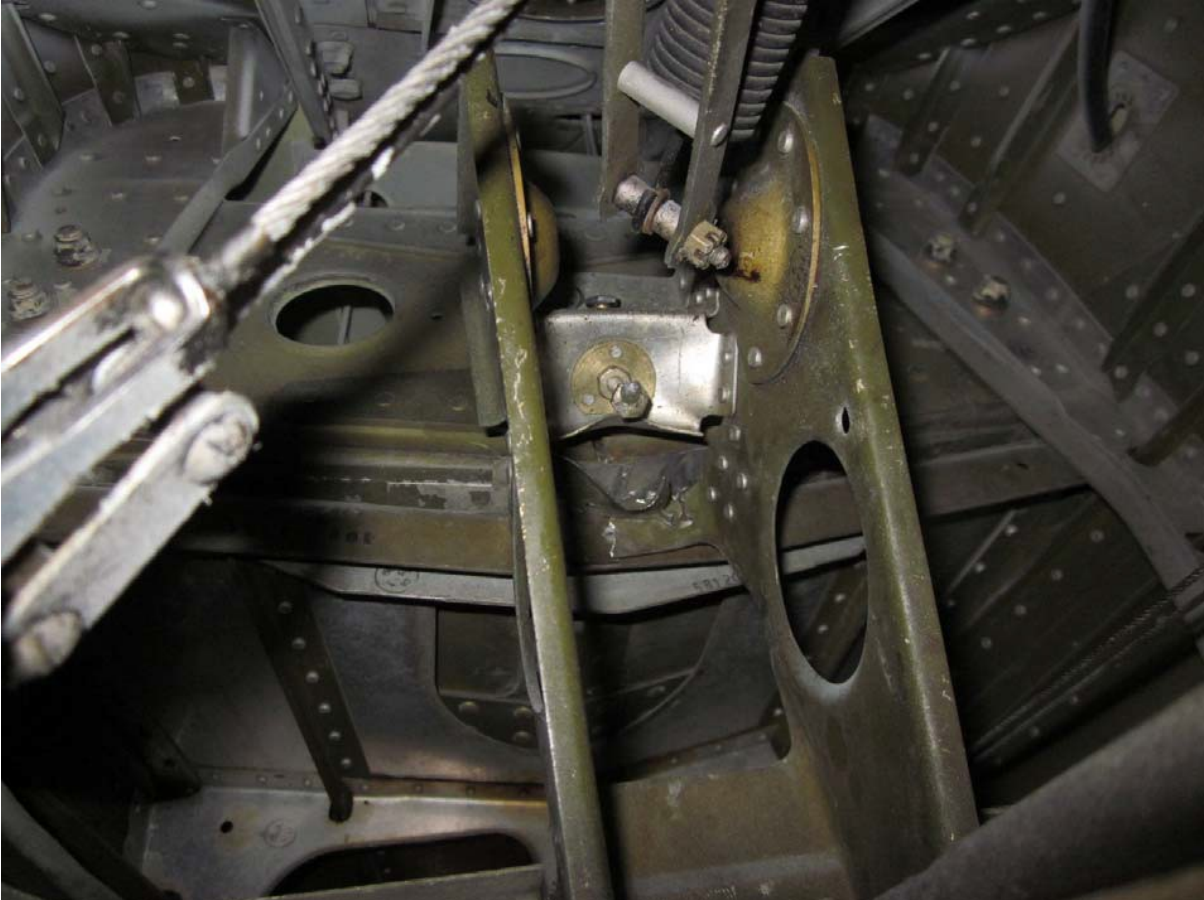
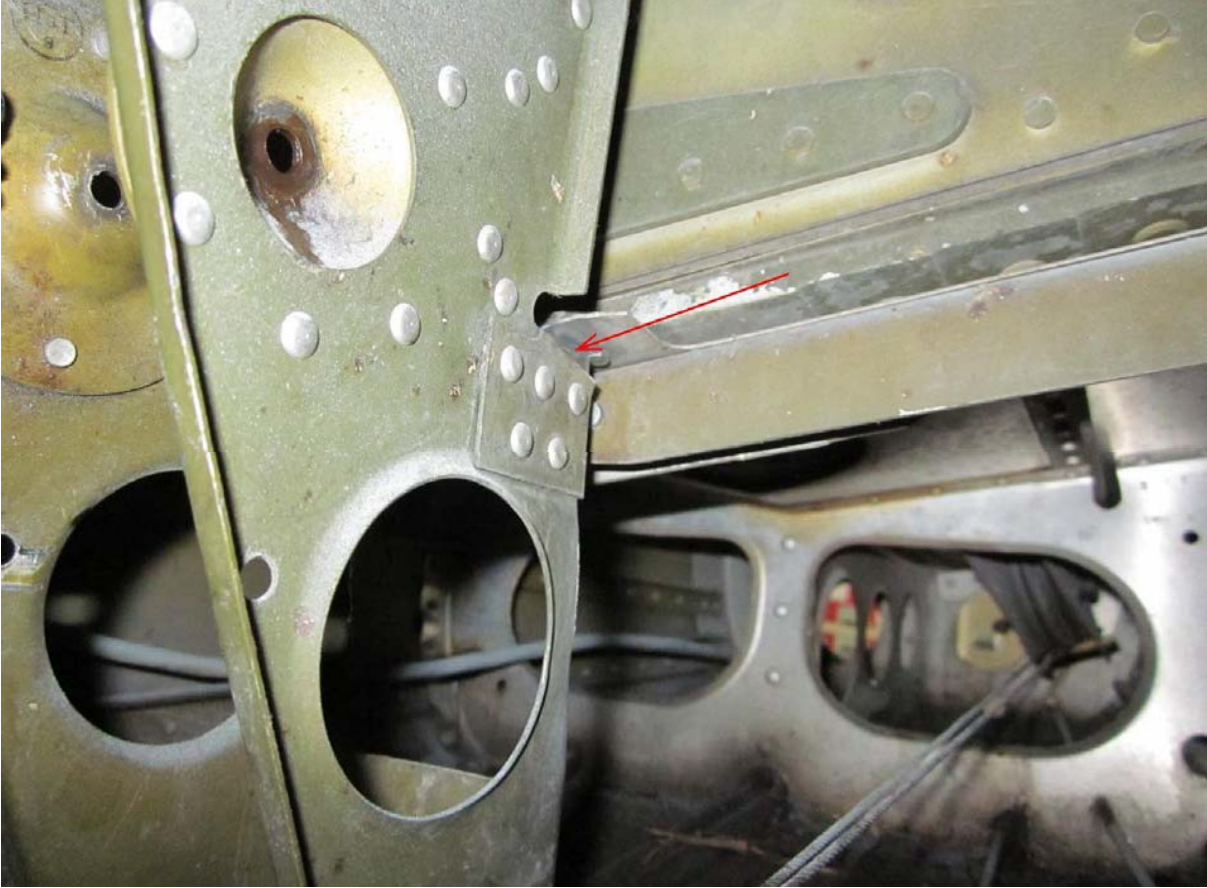
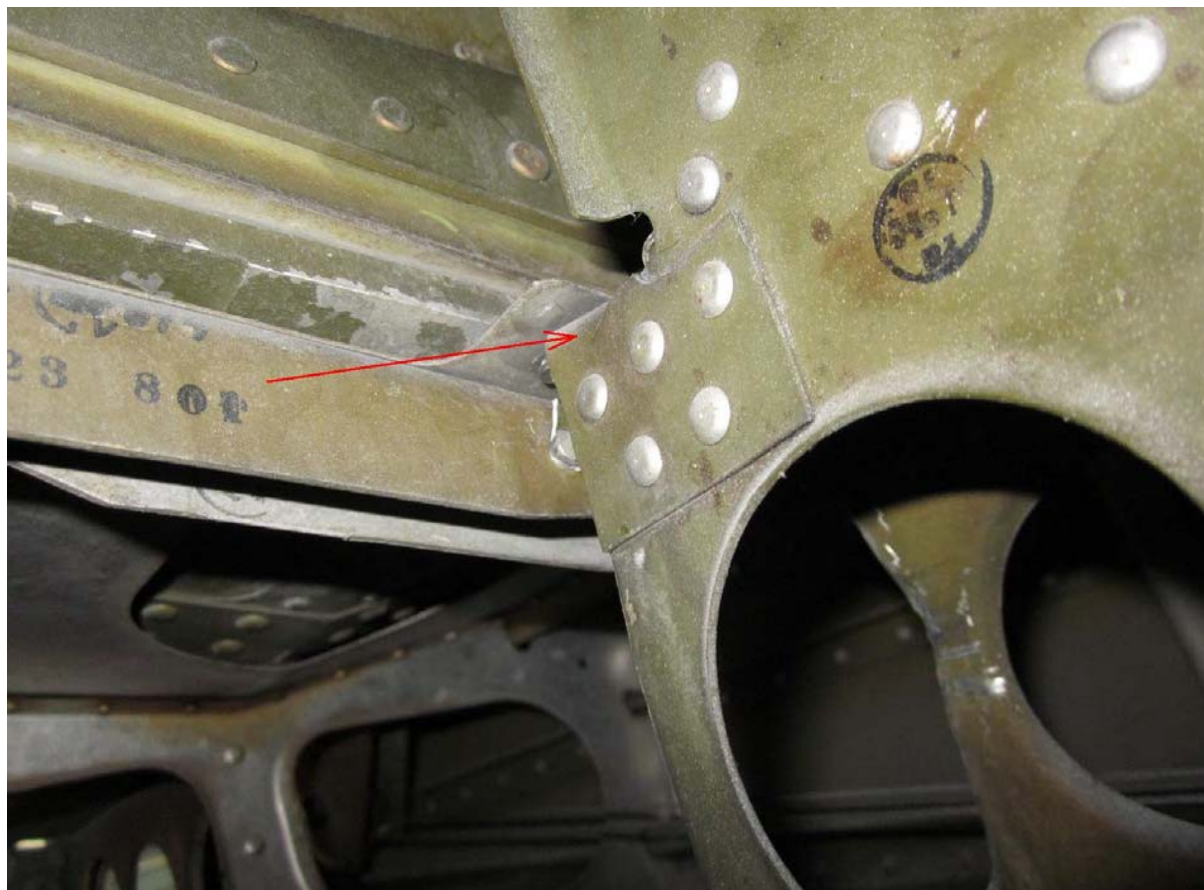
"While this aircraft was tied down," says a submitter, "the control wheel was secured in the full up position with a seat belt—instead of the approved gust lock device. This (*ad hoc arrangement*) allowed the elevators to have some movement—high winds prior to the intended flight (*allowed the elevator*) to hammer its lower stop until the bracket's upper mounts failed.

"The pilot stated he conducted a flight control check prior to taxi—everything felt fine. It was not until the control surface (*incurred*) an air load that he discovered a problem and aborted the takeoff."
