Cessna: 550; Cracked Seat Belt Assembly

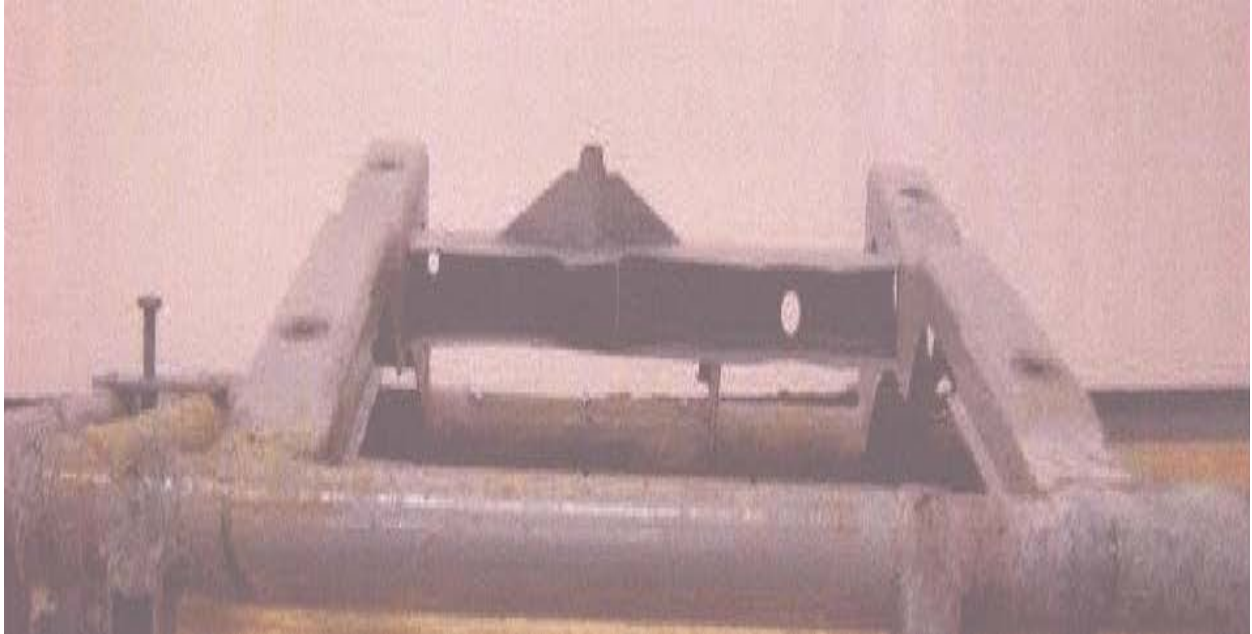
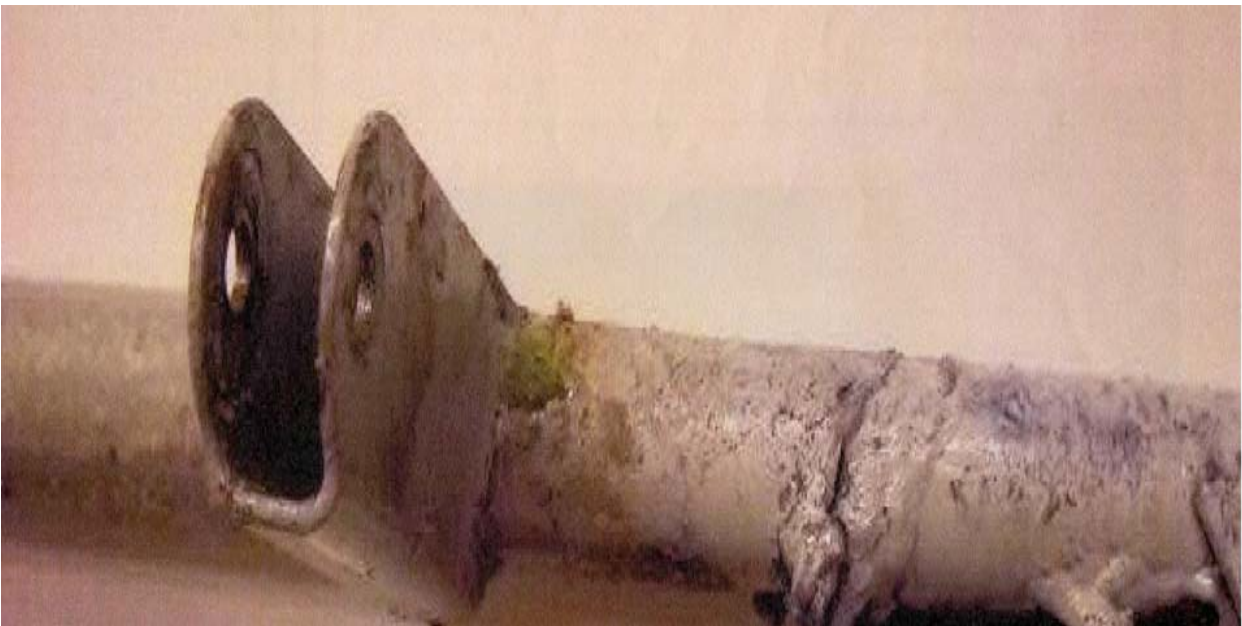
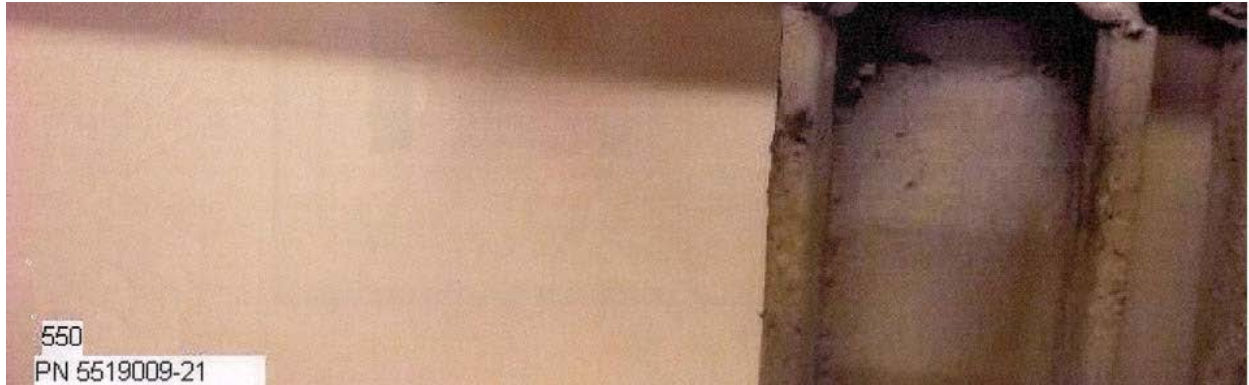
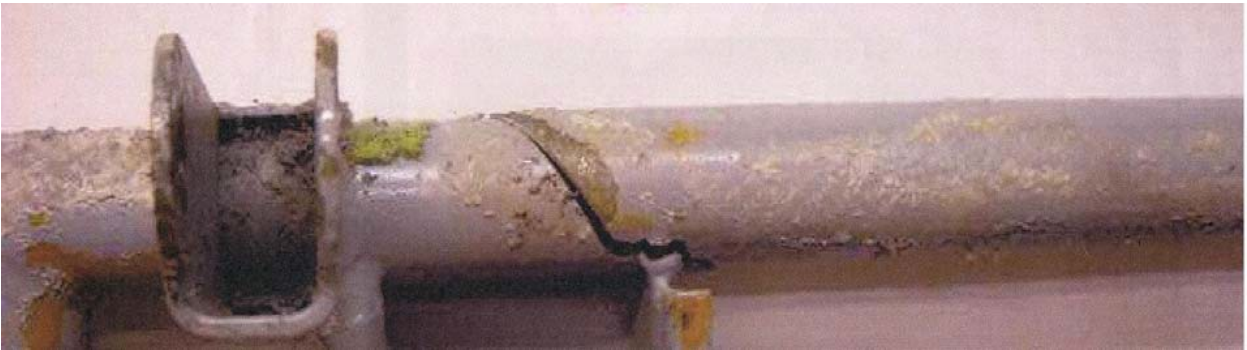
The upper Seat Base Assembly (*P/N 5519015—15*) was found cracked at the chair back attach points, states this repair station mechanic. "Stress on the chair back and metal fatigue are the probable cause. Also observed was a previous, inappropriate repair.

"This chair was repaired in accordance with STC ST01042WI." (*Seat base P/N: 5519009-21.*)
