### **Gulfstream 690B, Cracked Main Gear Strut, ATA 3213**

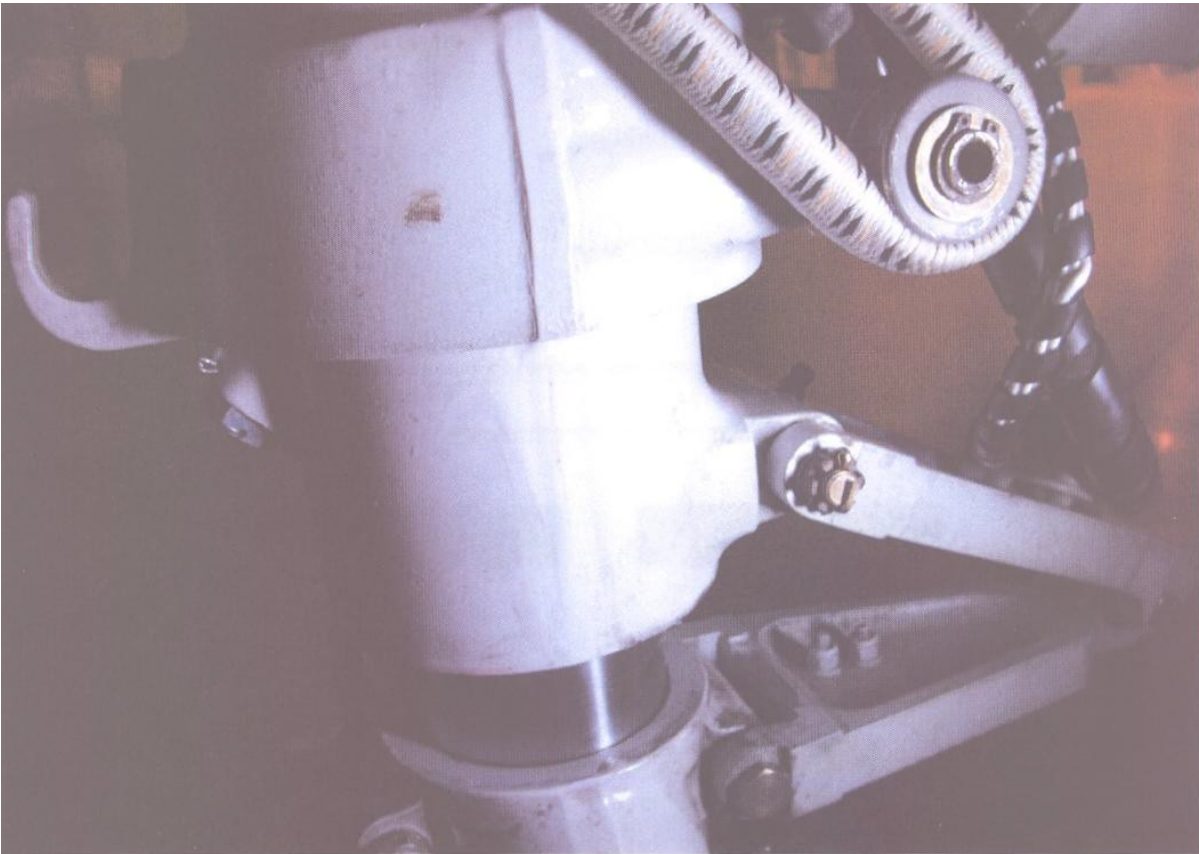
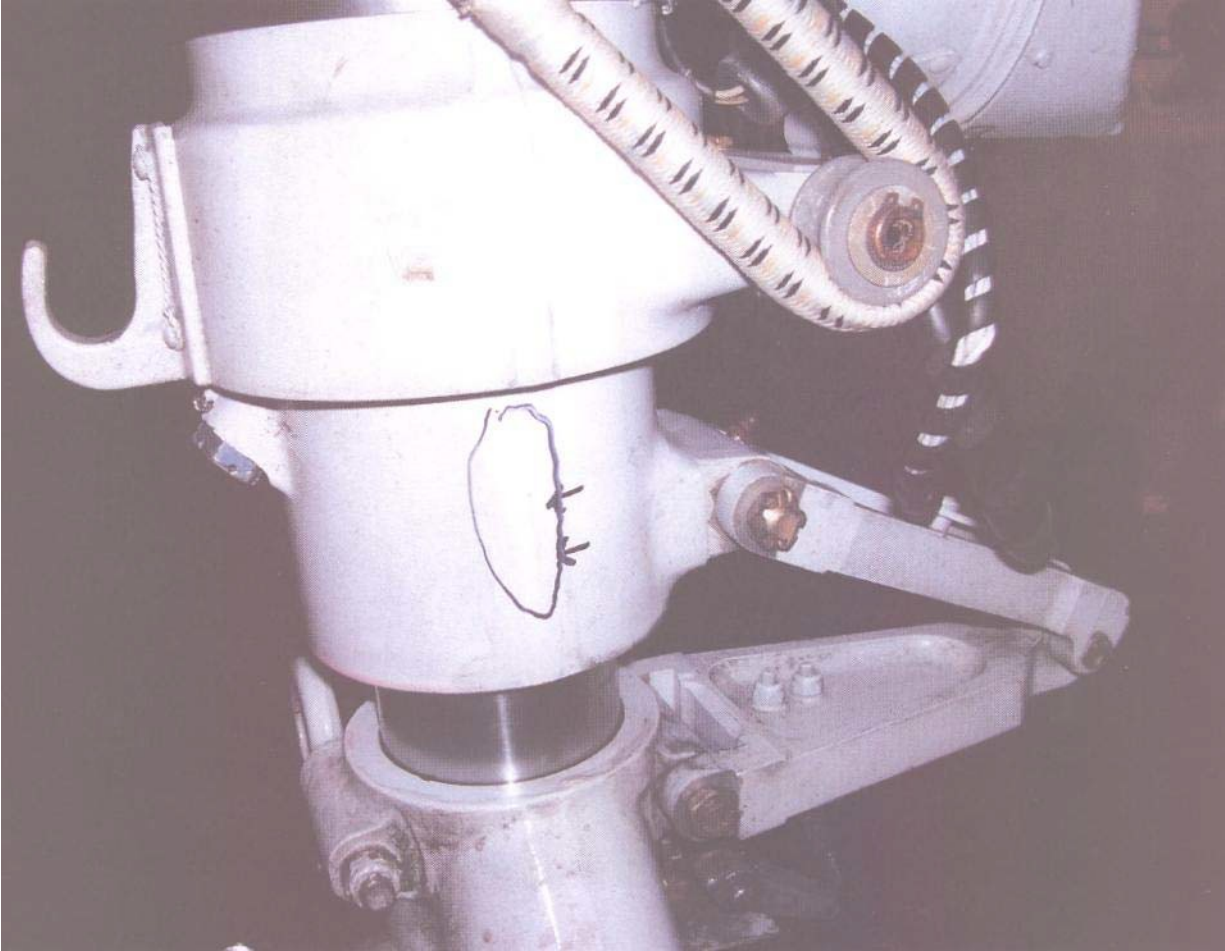
**Gulfstream 690B, Cracked Main Gear Strut, ATA 3213**

"The left main gear strut was flat," writes a technician. "(We) tried to service (*the strut*), but when we applied nitrogen pressure, hydraulic fluid came out of a three-inch crack in the strut body and bearing assembly...." (P/N: ES12394.)

Part Total Time: 6,842.0 Hours
