## Hawker 800XP, Cracked MLG Door Bracket, ATA 5280

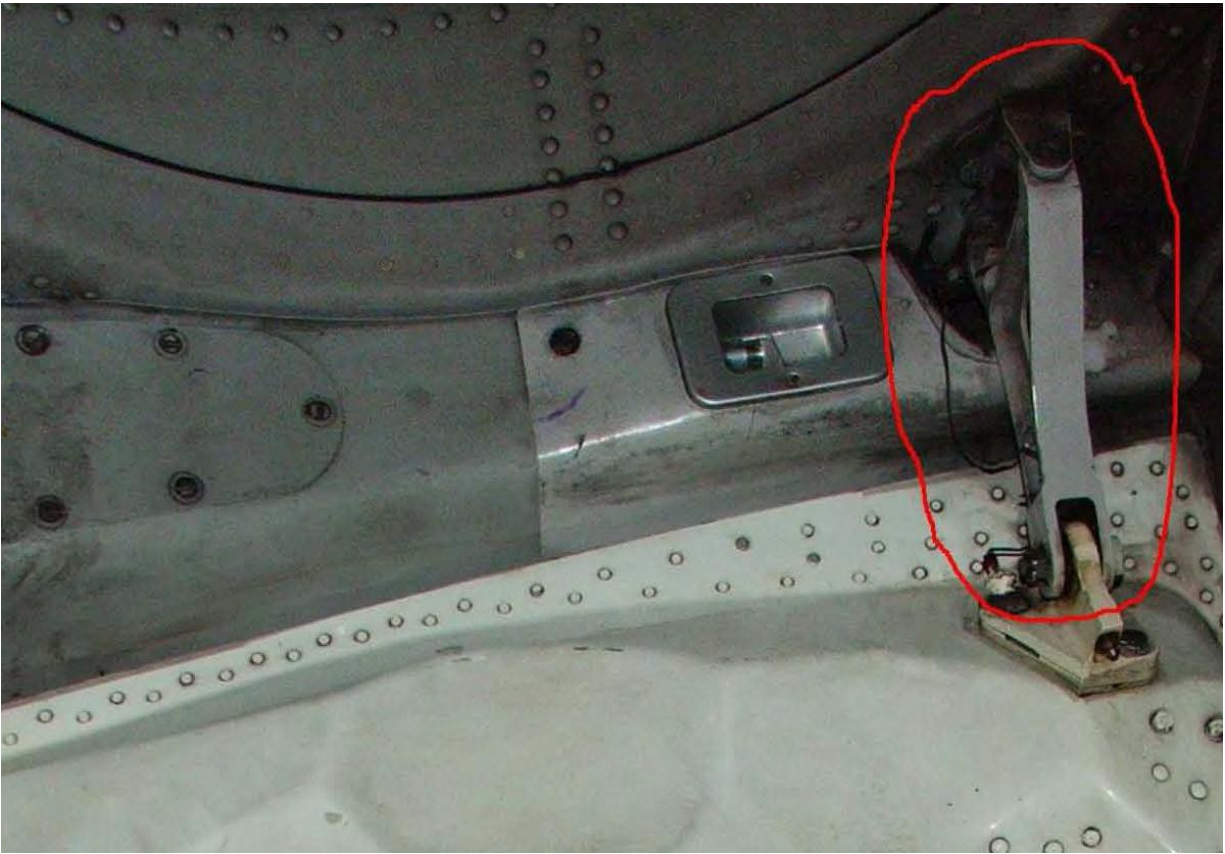
A general aviation submitter writes, "During base maintenance, (we) found the R/H main landing gear door support cracked (P/N 25FC5804)."
