Bell 206B, Failed Transmission Oil Sight Indicator, ATA 6320

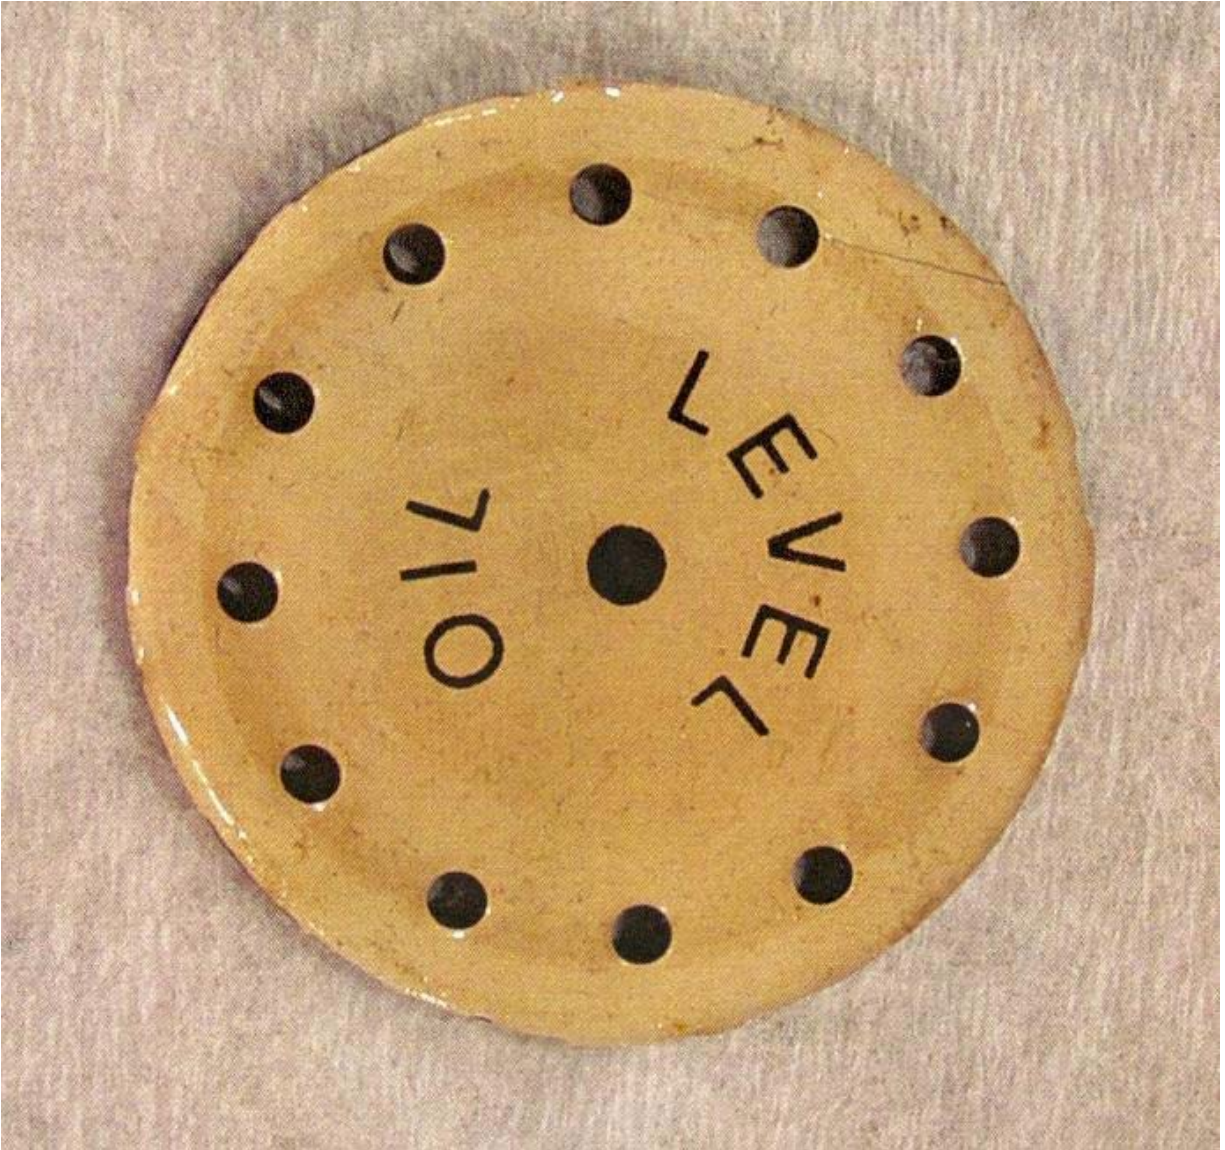
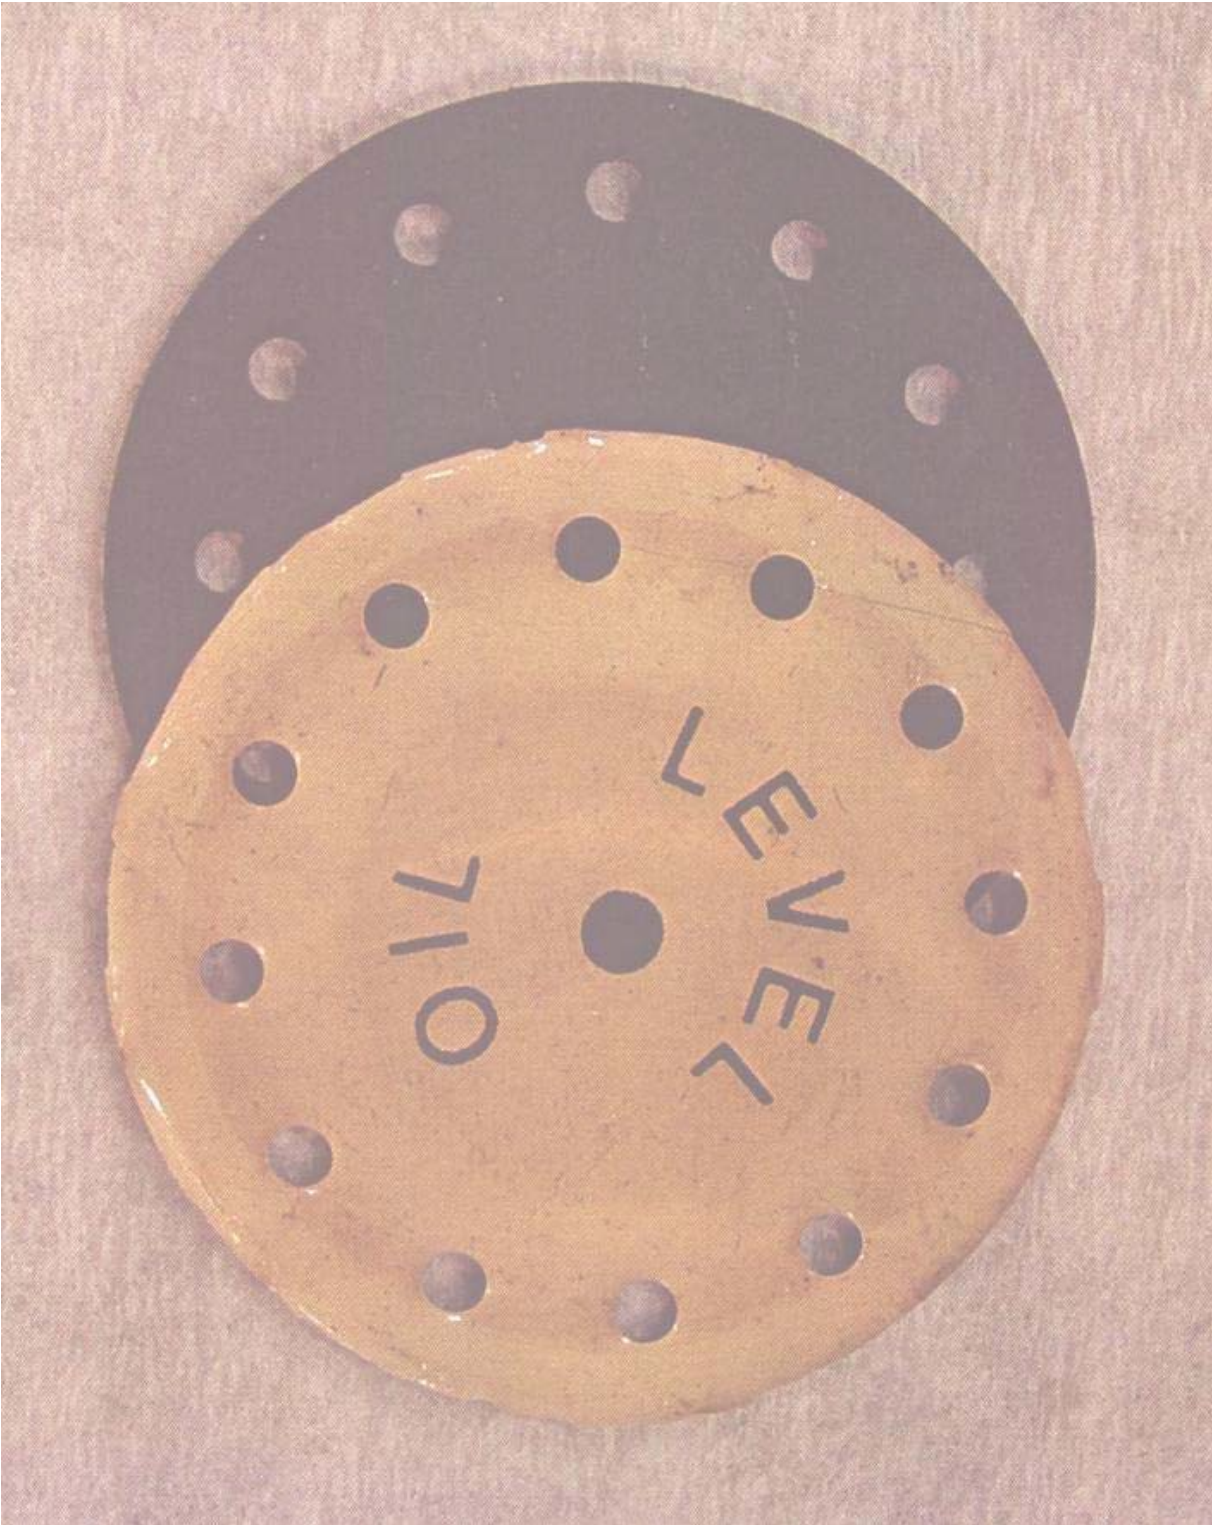
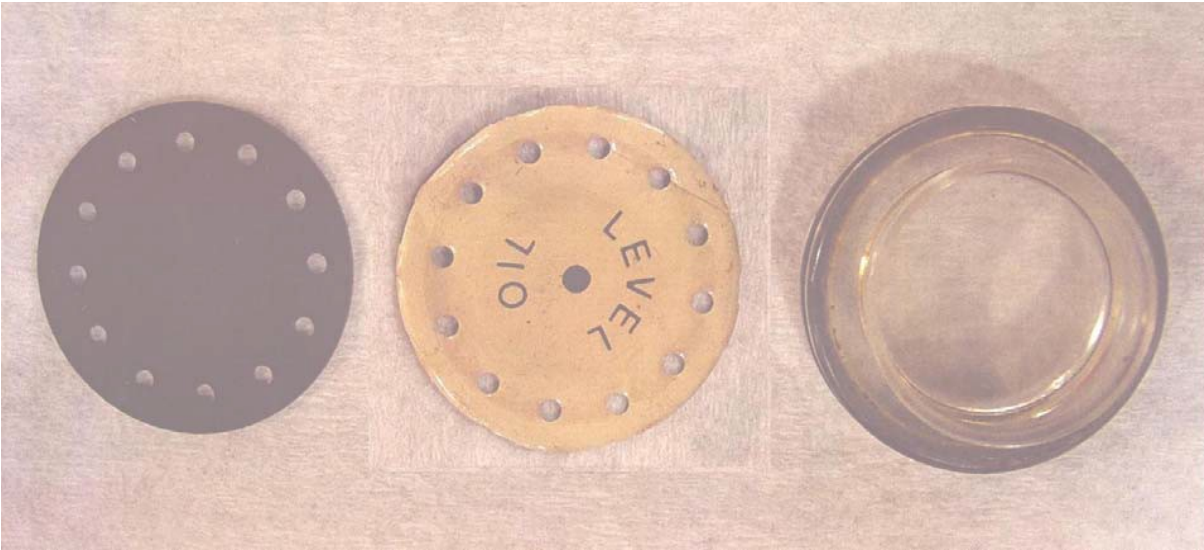
Bell 206B, Failed Transmission Oil Sight Indicator, ATA 6320

"During a routine inspection," says this repair station submission, "(we) discovered the oil level indicated 'full'—after the main rotor transmission oil was drained. After removal, inspection of the indicator (P/N 206040093001) revealed the coating with the 'level markings' had separated from the metallic back plate. There is a ring of holes on the circumference of the indicator. These were not aligned with the holes in the 'level mark' coating on the back plate. This condition would not allow oil to drain from the sight glass—the only means to determine (*correct*) oil level in the main rotor transmission. Improper servicing of the transmission presents a potential for serious problems if left undetected."

Part Total Time: 4,143.0 Hours
