Bell: 206L.1; Improper Governor Assembly; ATA 7323

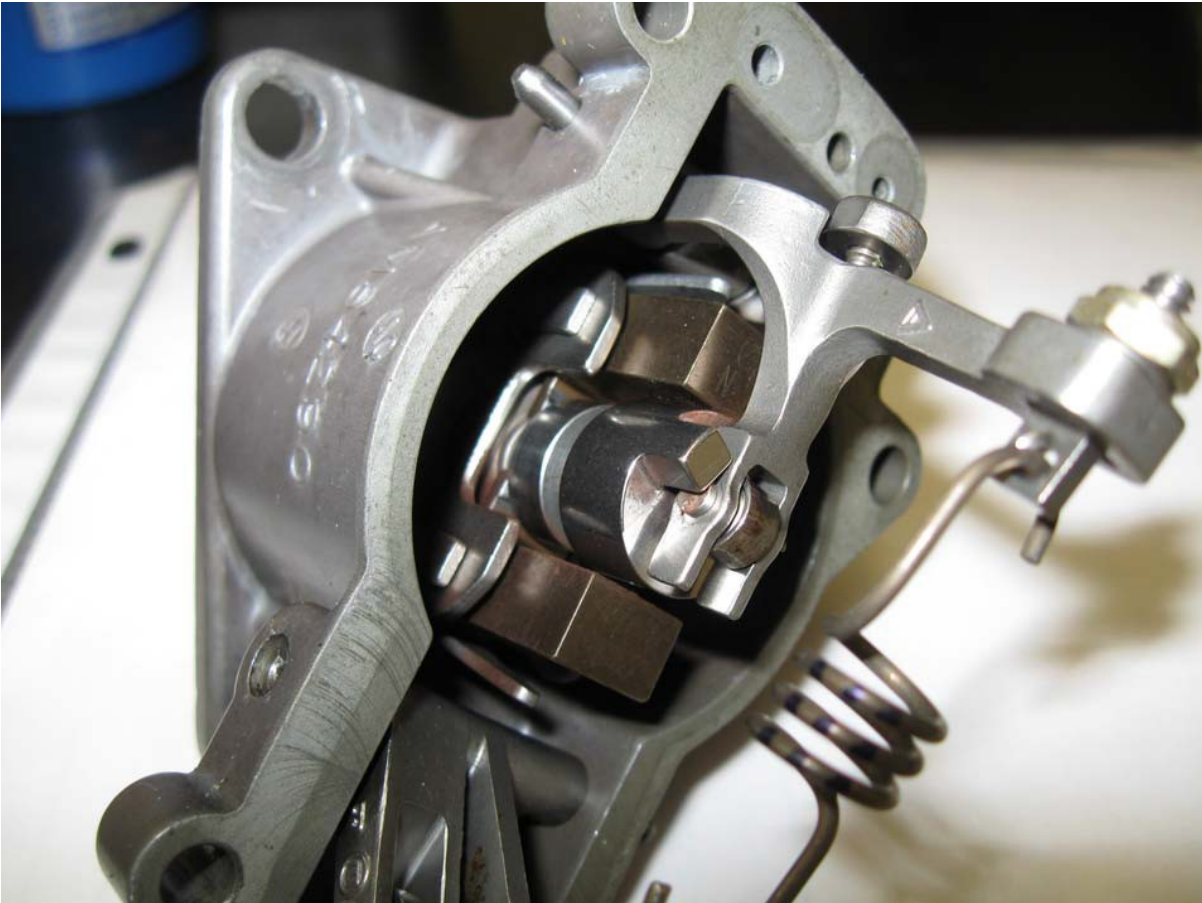
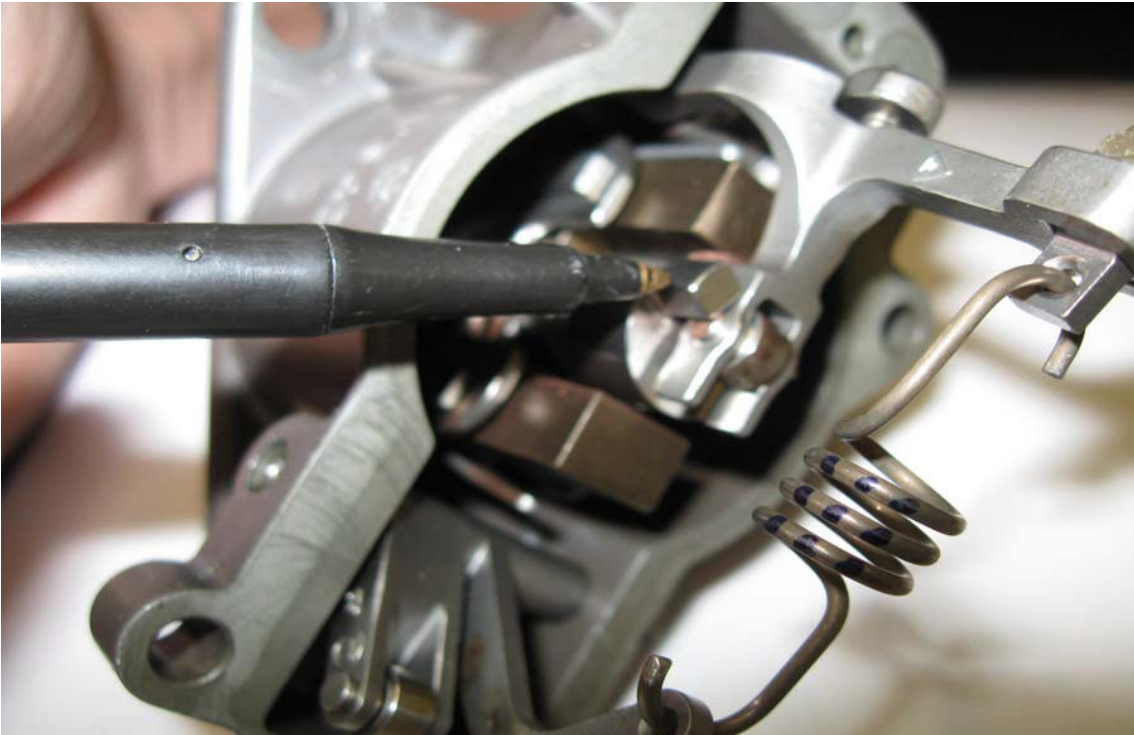
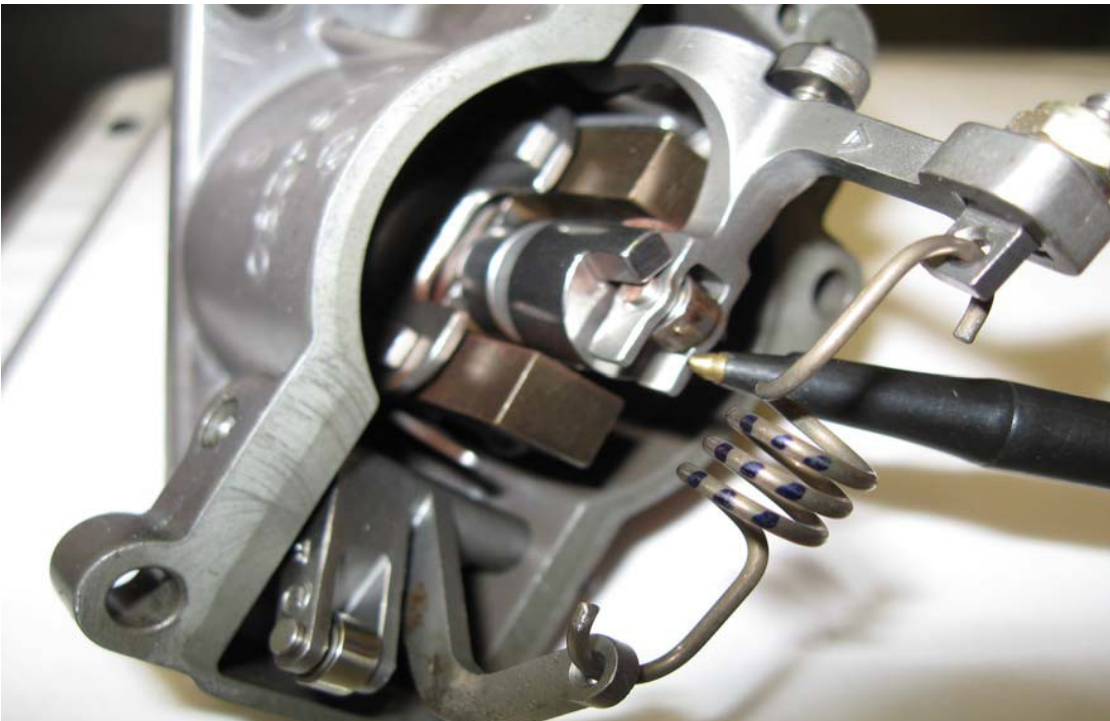
The governor allows the engine (Allison 250C28) to over-speed," says a mechanic. It failed the shop test. Engine was disassembled and found it improperly assembled. The spool bushing anti-rotation tang was engaged in the lever slot." (There are 16 SDRS database entries for the Honeywell Governor P/N: 252469211, and 6 entries for the Bushing Assembly P/N: 2526146
