Eurocopter AS350, Loose Oil Reservoir Cap, ATA 7261

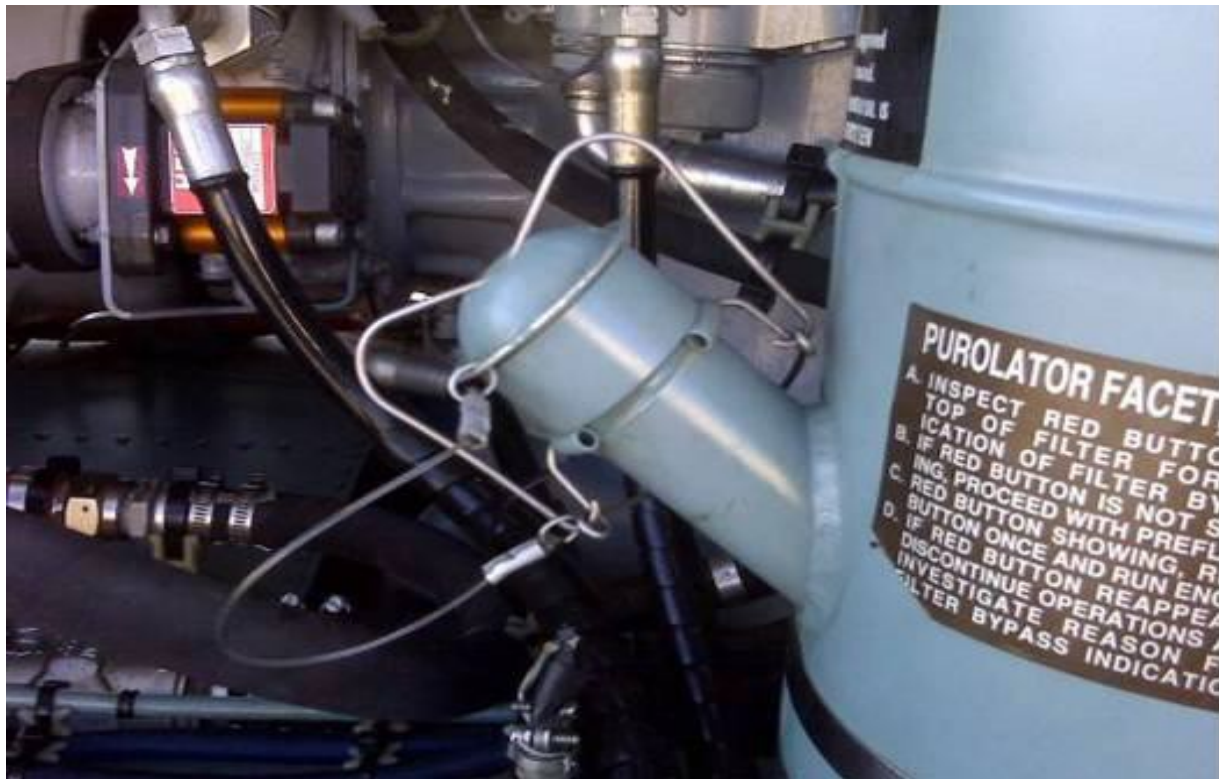
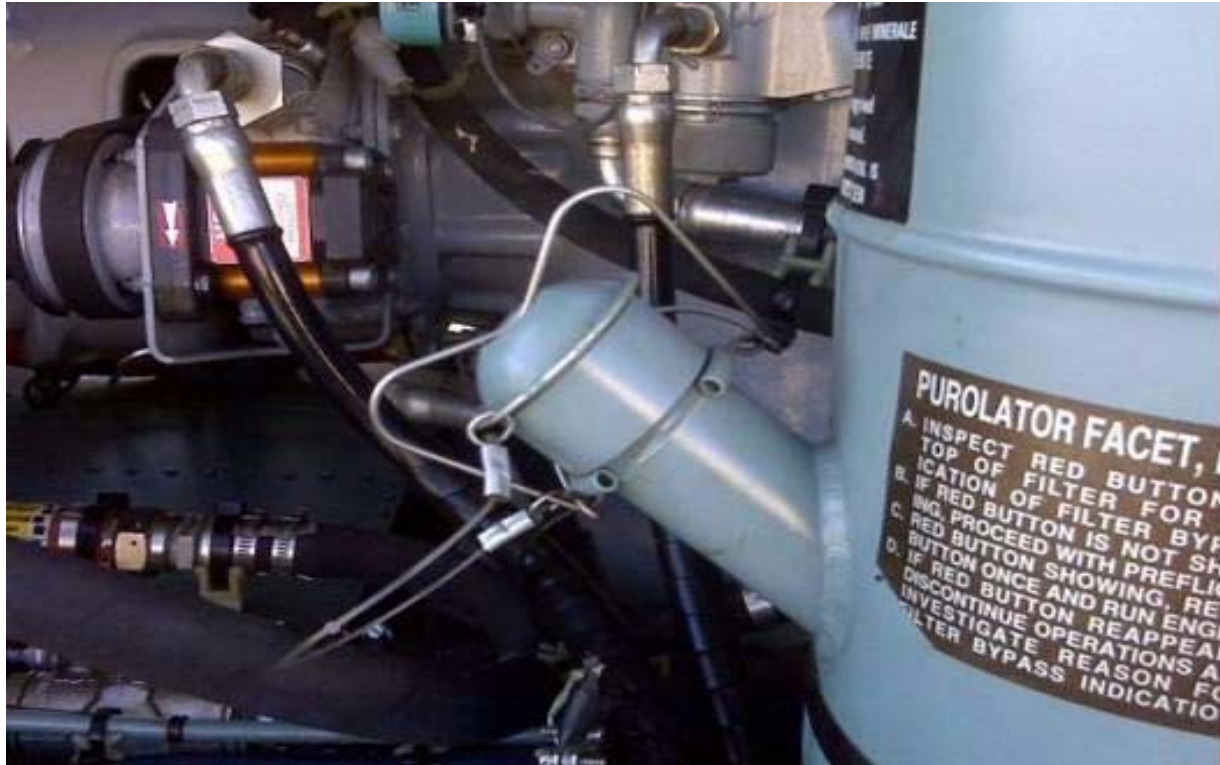
Eurocopter AS350, Loose Oil Reservoir Cap, ATA 7261

The engine oil reservoir cap came off in flight, says this submitter, "resulting in significant oil loss. The helicopter returned to base with no problems encountered. The issue is Eurocopter's 'unique' retaining mechanism for the oil cap. (*This*) retaining mechanism is easily dislodged, and yet still appears to be locking the cap into place. Unless you are specifically looking at the retaining mechanism during a preflight—and you know what it is supposed to look like when it is in the locked position—it can be easily overlooked. (*I*) recommend Eurocopter devise some type of safety device for their retaining mechanism. Also, this (*item*) should be added to their 'Before First Flight' checklist.
