## **Continental GTSIO520L, Broken Camshaft Gear, ATA 8520**

### **Continental: GTSIO520L; Broken Camshaft Gear; ATA 8520**

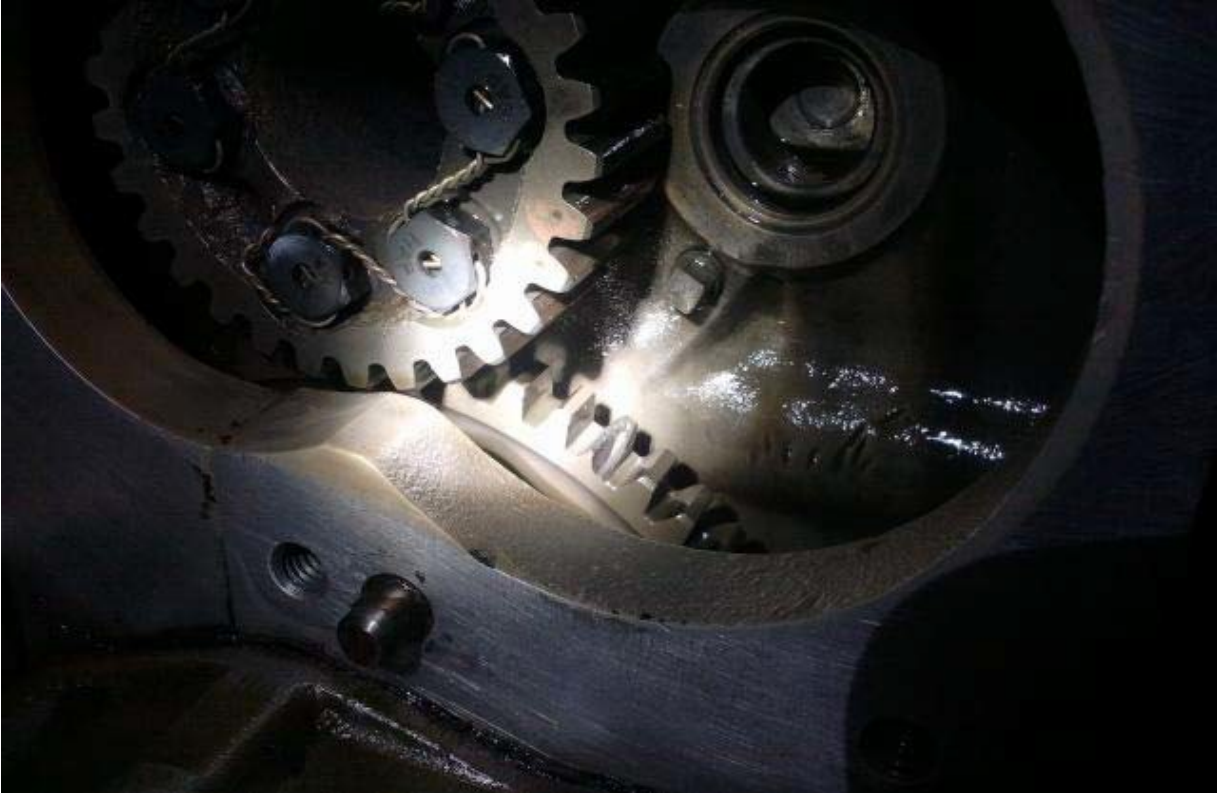
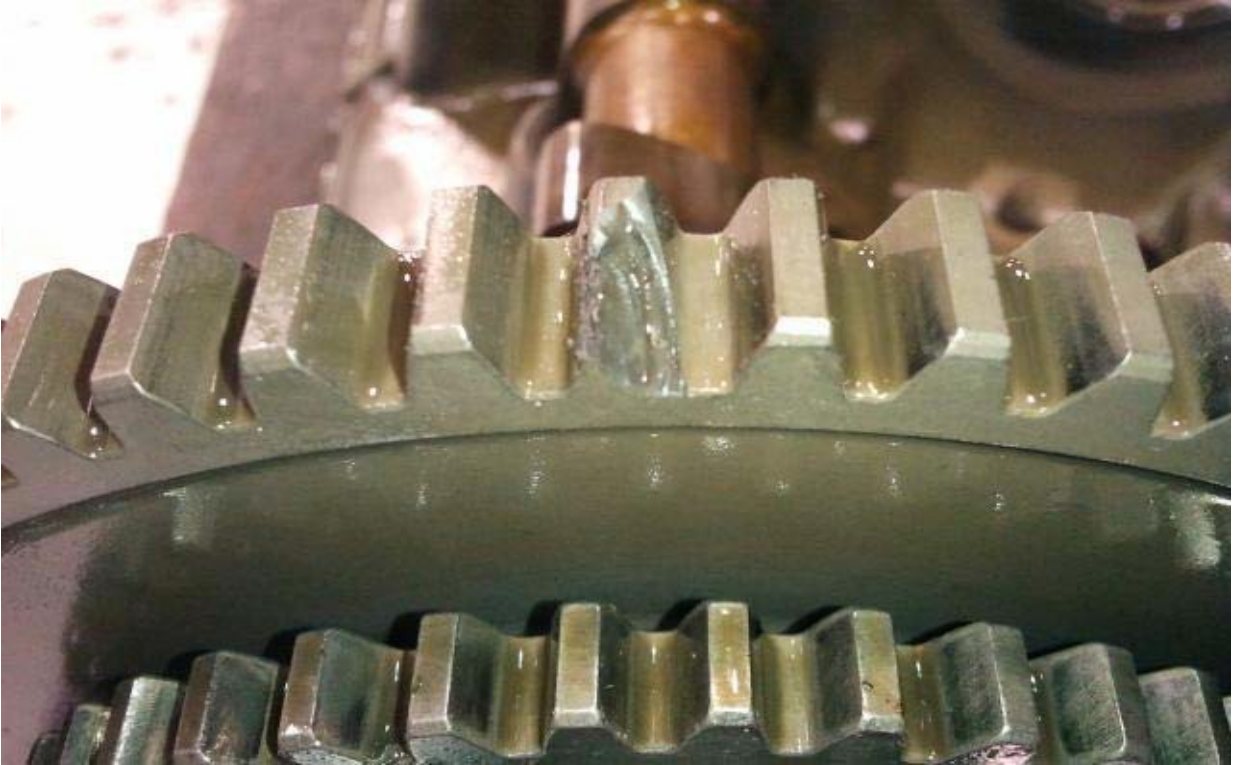
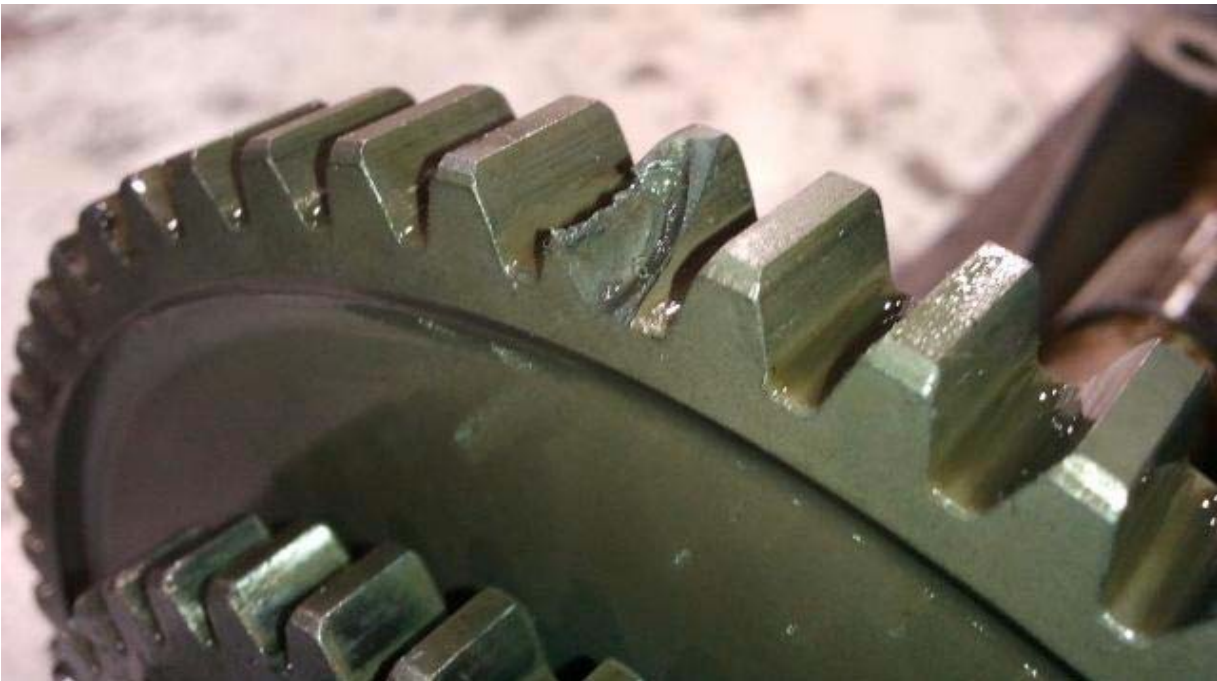
**Continental GTSIO520L, Broken Camshaft Gear, ATA 8520**

"(I) was complying with AD 07-05-15 and performing an Annual Inspection," states this submitter, "when I found one broken tooth on the camshaft gear. No other indications were found of related defects or damage, internally or externally, after the engine was disassembled. And no metal (or the gear tooth) was found in the oil filter or internal to the engine. (Note:) The camshaft gear P/N 656914 supersedes P/N 537432."

Part Total Time: 1,828.0 hours
