## Continental IO550N Cracked Exhaust Manifold (2), ATA 7810

(This is the second of two reports describing defects on the exhaust systems of this Cirrus SR22 aircraft.)

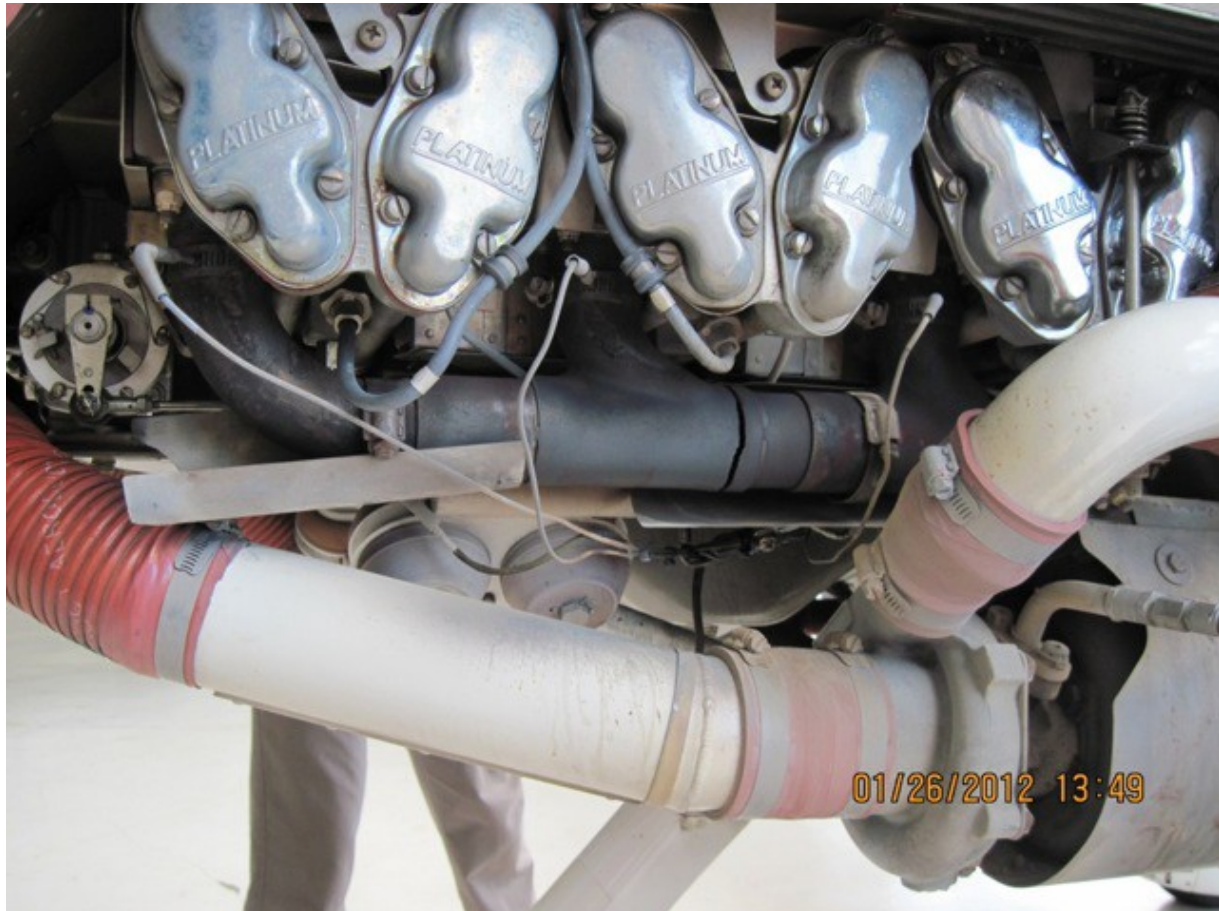
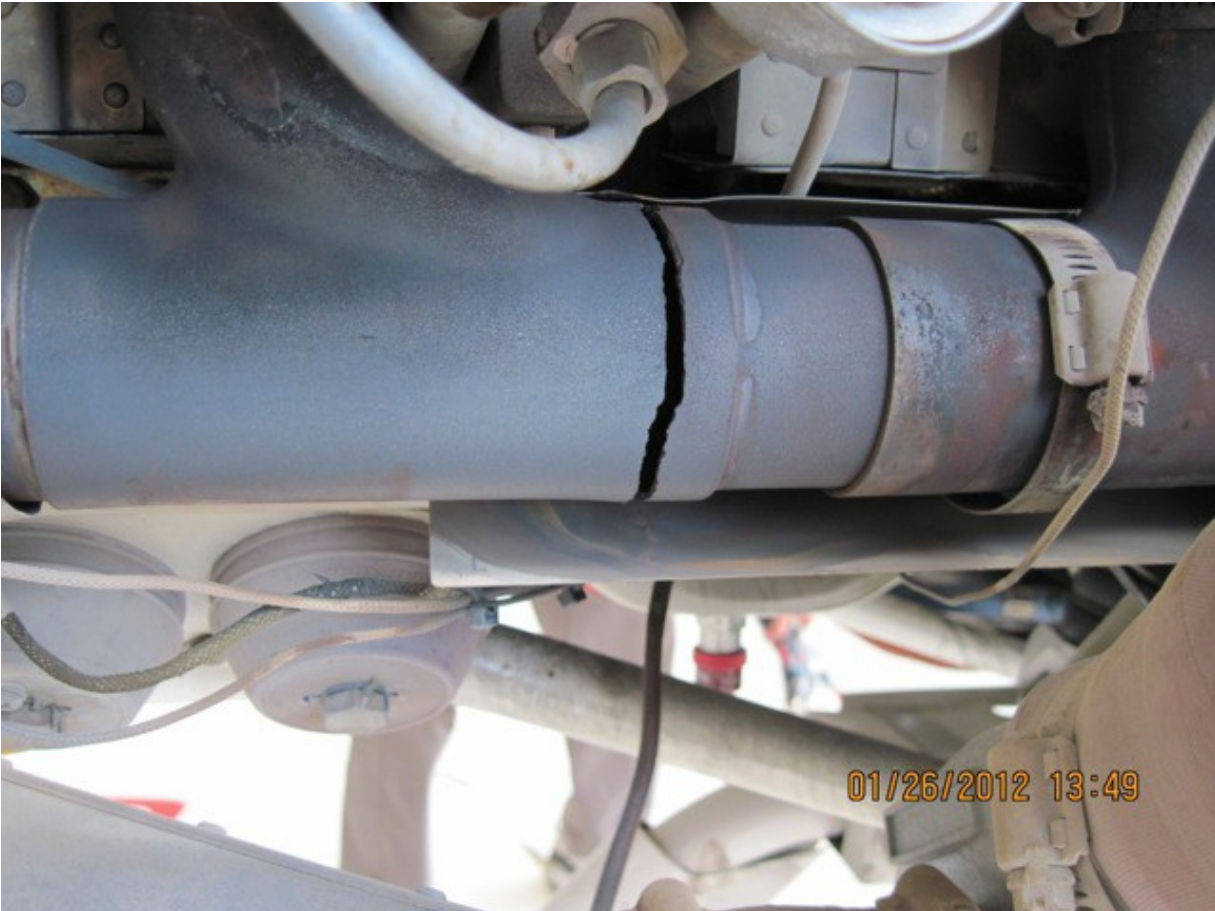
**Continental IO550N Cracked Exhaust Manifold (2), ATA 7810**

More thoroughly described in the previous report, the same submitter provides this second report and photos. "During routine maintenance, (we) found the L/H exhaust manifold had cracked into two pieces between cylinder numbers two and four." (Exhaust P/N: 226850002.)

Part Total Time: 990.0 Hours
