Cessna 182T, Cracked Firewall Doubler, ATA 5412, Report 1

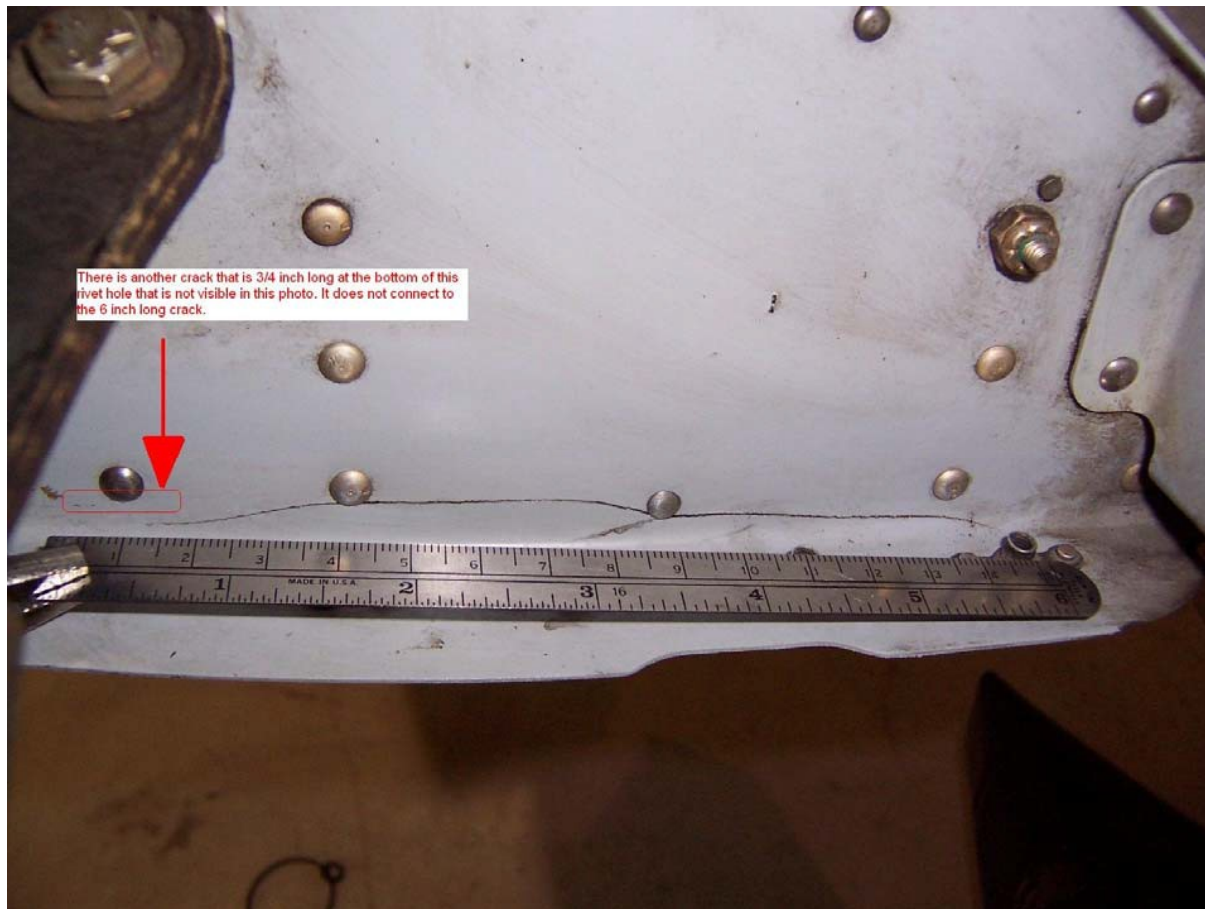
A crack in a firewall doubler (forward side) was discovered during an inspection. The crack is located behind the right hand 'cowl exit ramp' (P/N 0752732-2; see manufacturer's IPC 53-10-00, revision 19; item 241).

The longest section of the crack is six-inches. There is also a secondary crack (3/4 inch long) radiating out from the rivet hole at the center of the six-inch crack. Another small crack (3/4-inch) was discovered just outboard of the 6-inch crack during rivet removal during preparation for repair. This area is very difficult to inspect with the lower cowling removed on a P2 (100 hour inspection) or P3 (Annual inspection), however, it is accessible. There was also substantial dirt and oil build-up in the area behind the cowl exit ramp, making the area harder to inspect.
