Cessna CE-750, Water Separator Corrosion, ATA 2170

November 2012 AC 43-16A

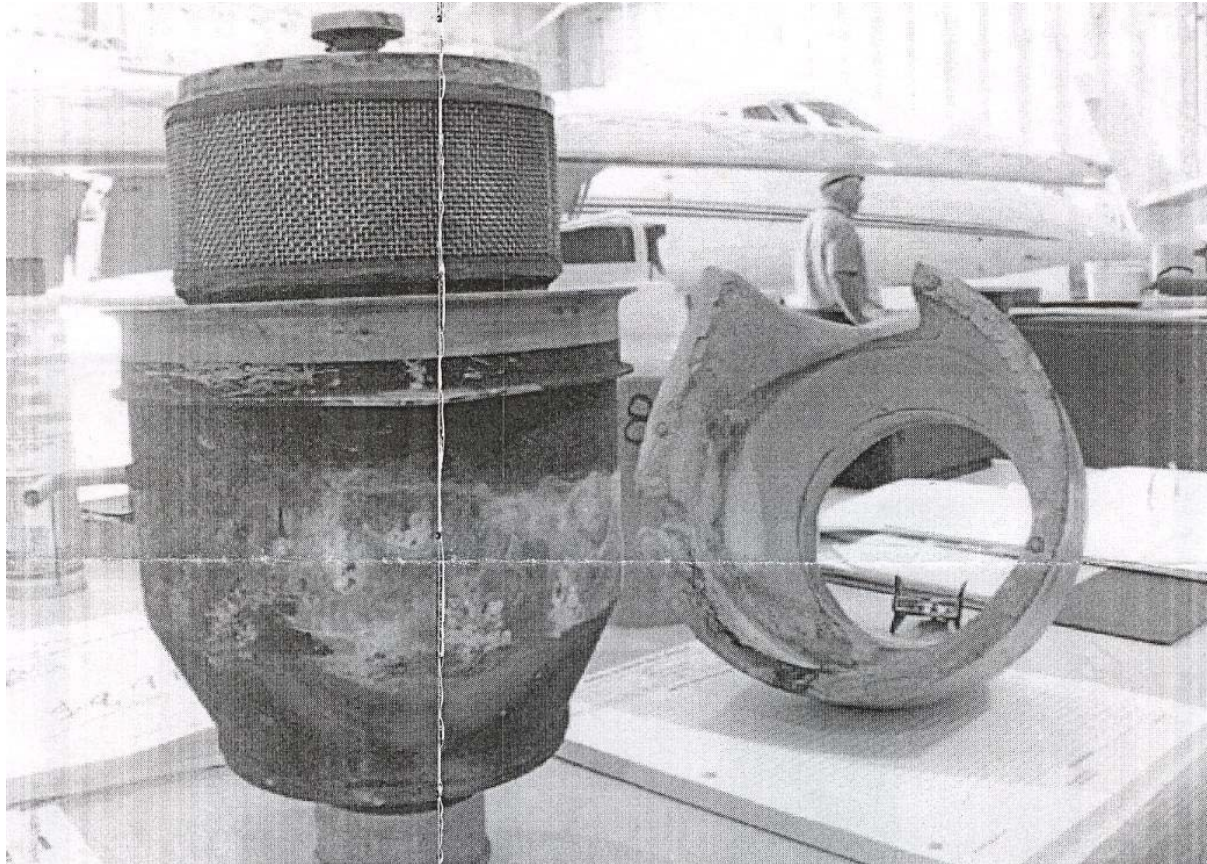
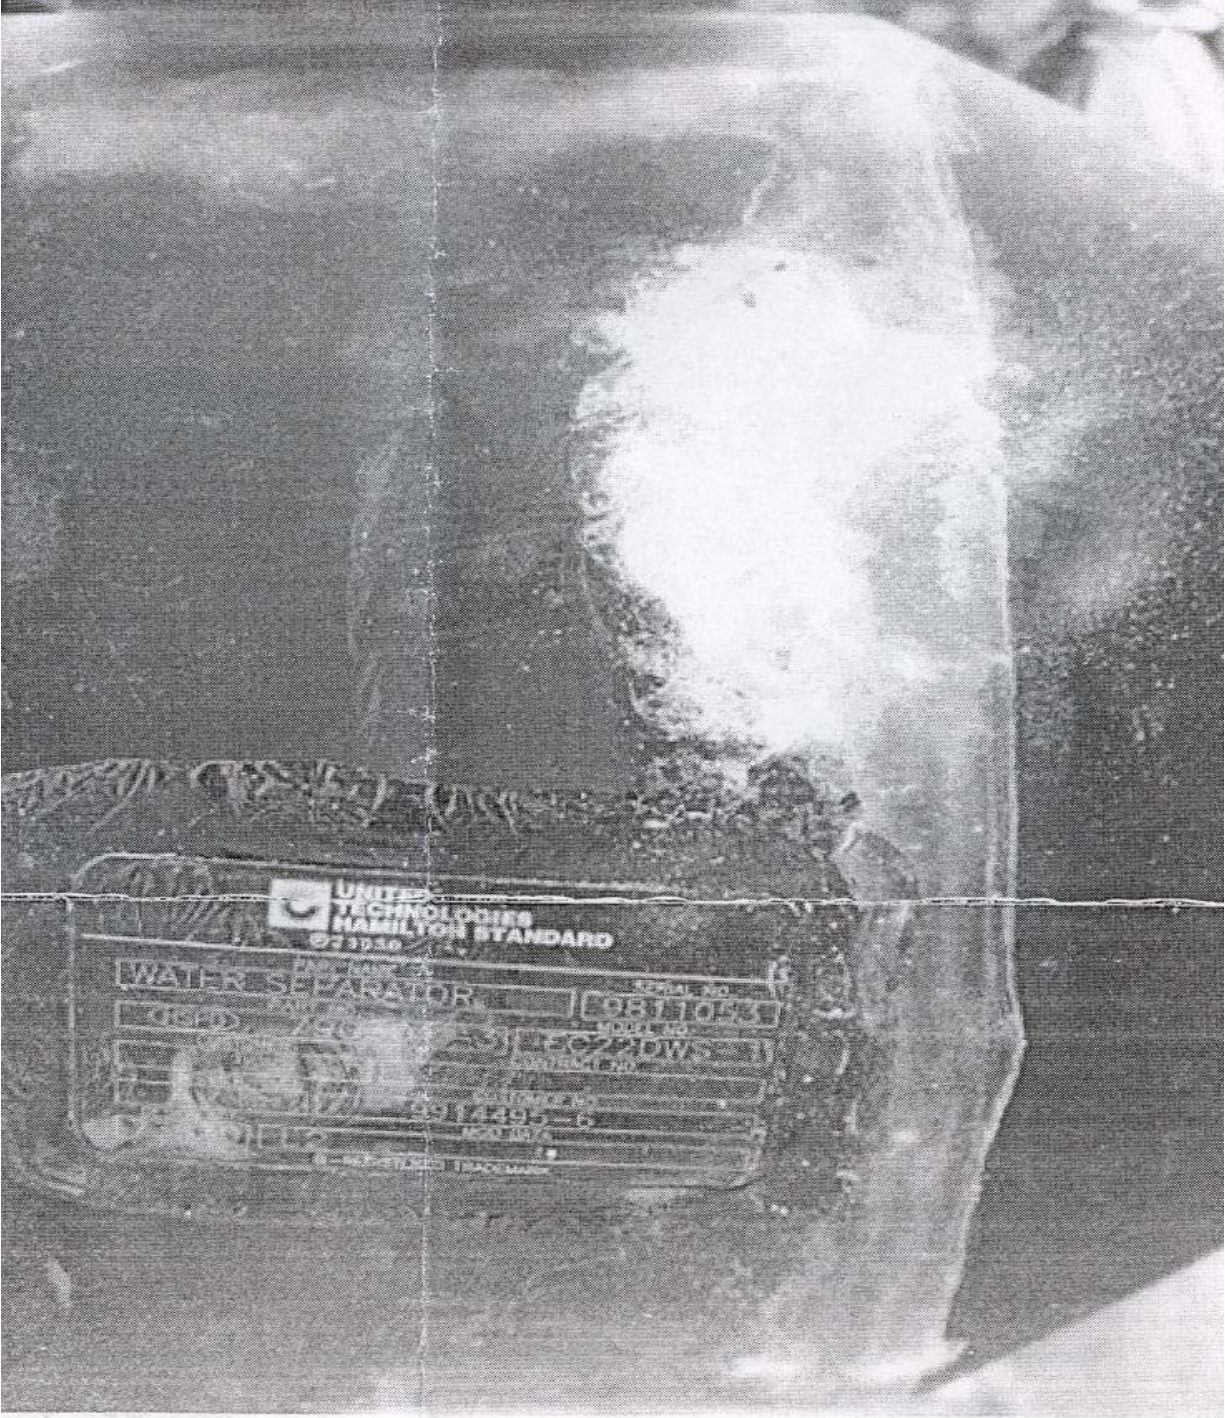
A repair station mechanic states, "Both the L/H and R/H water separators have corrosion under the insulation (P/N 5715526-8). This is an area not normally looked at during the water sock cleaning/restoration." (Reference *United Technologies, Hamilton Standard; model EC22DWS-1; P/N 79030103.*)
