# **Cessna 172S, Frayed Aileron Cable, ATA 2710**

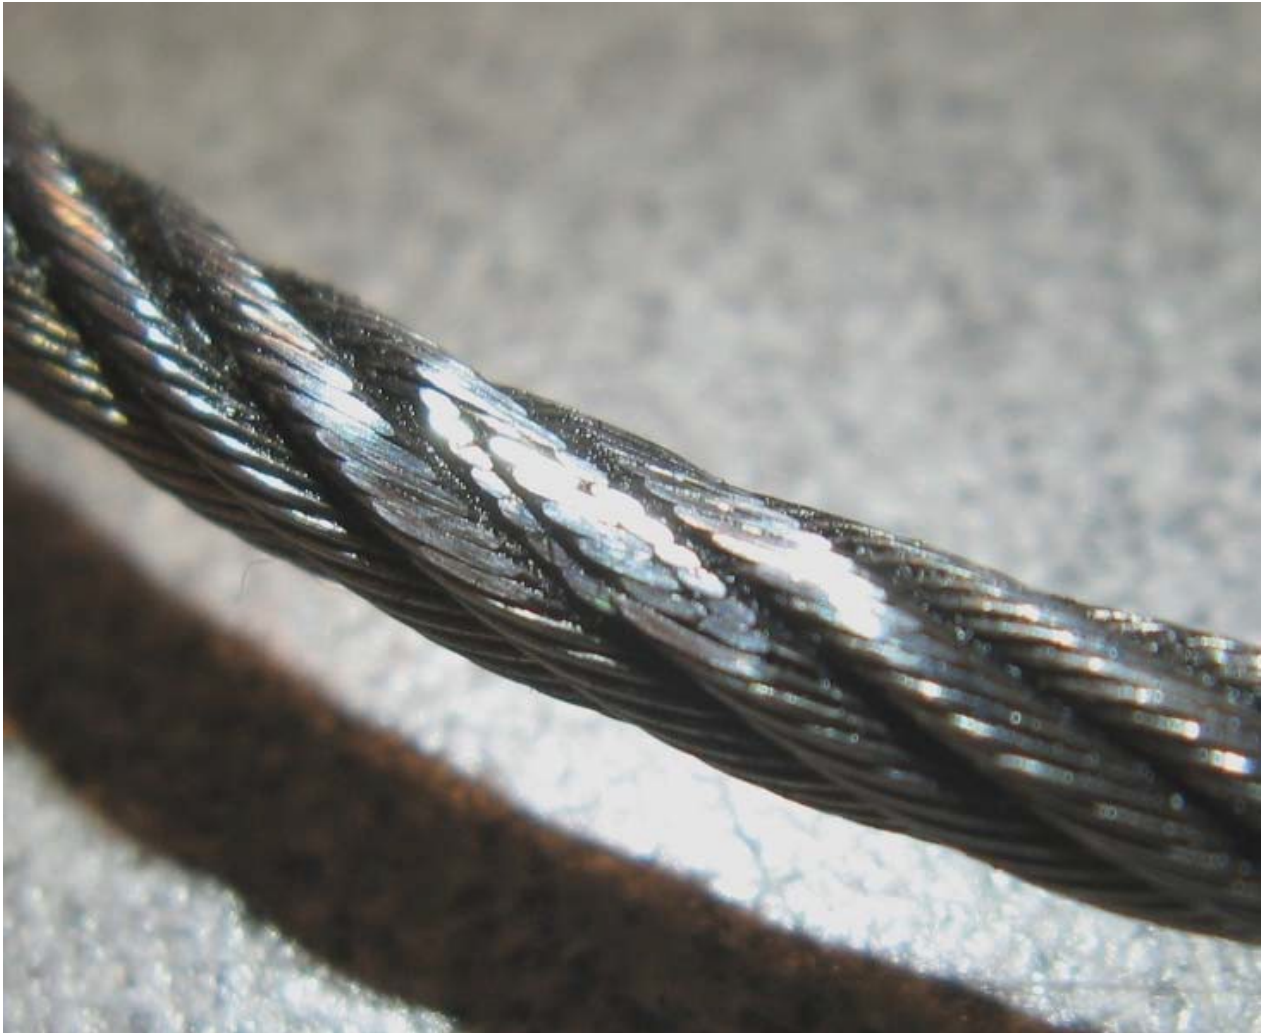
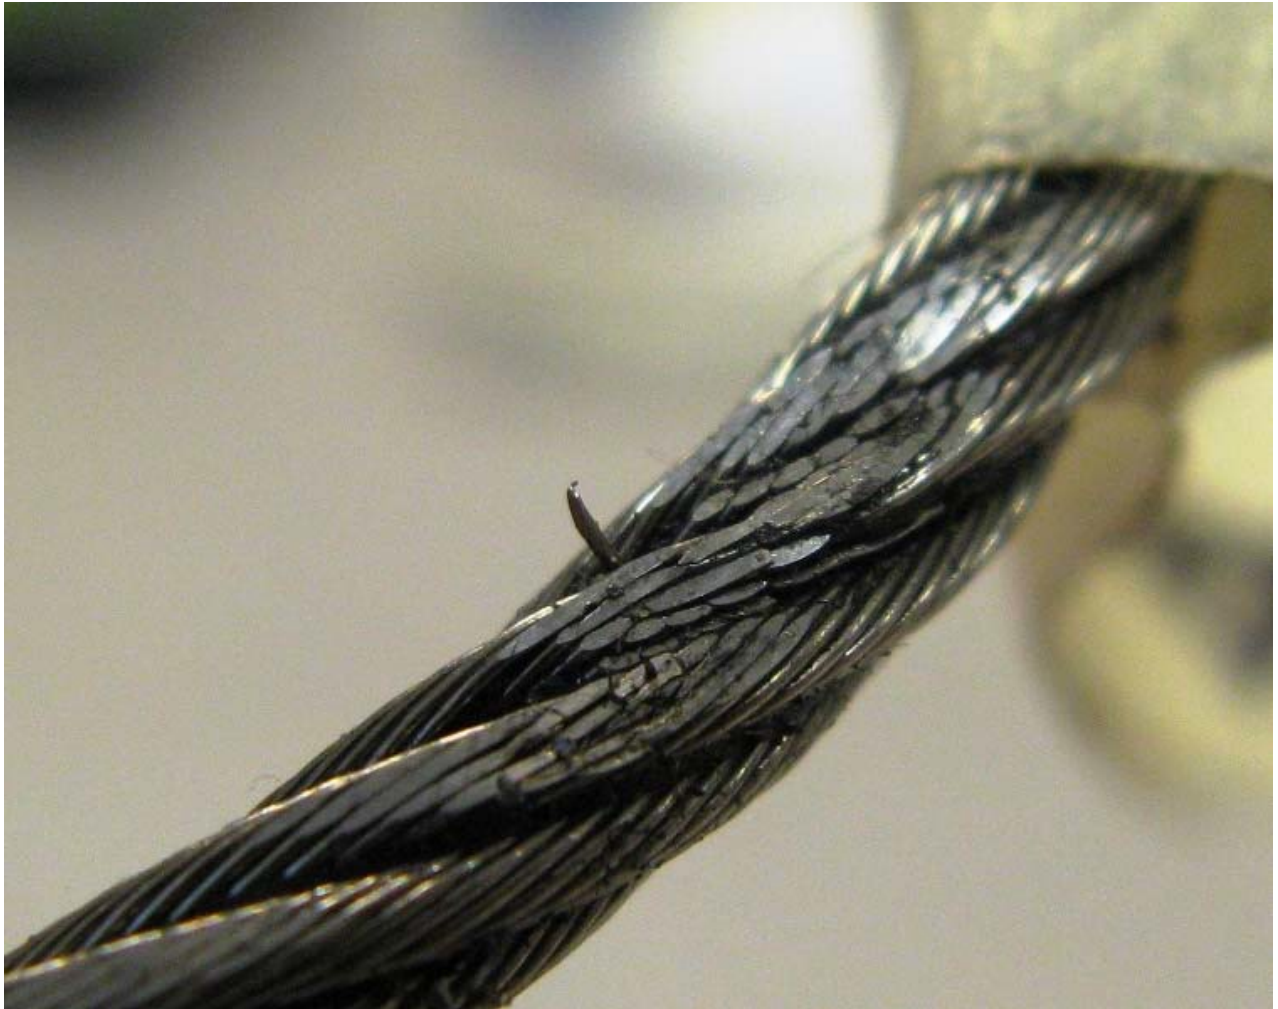
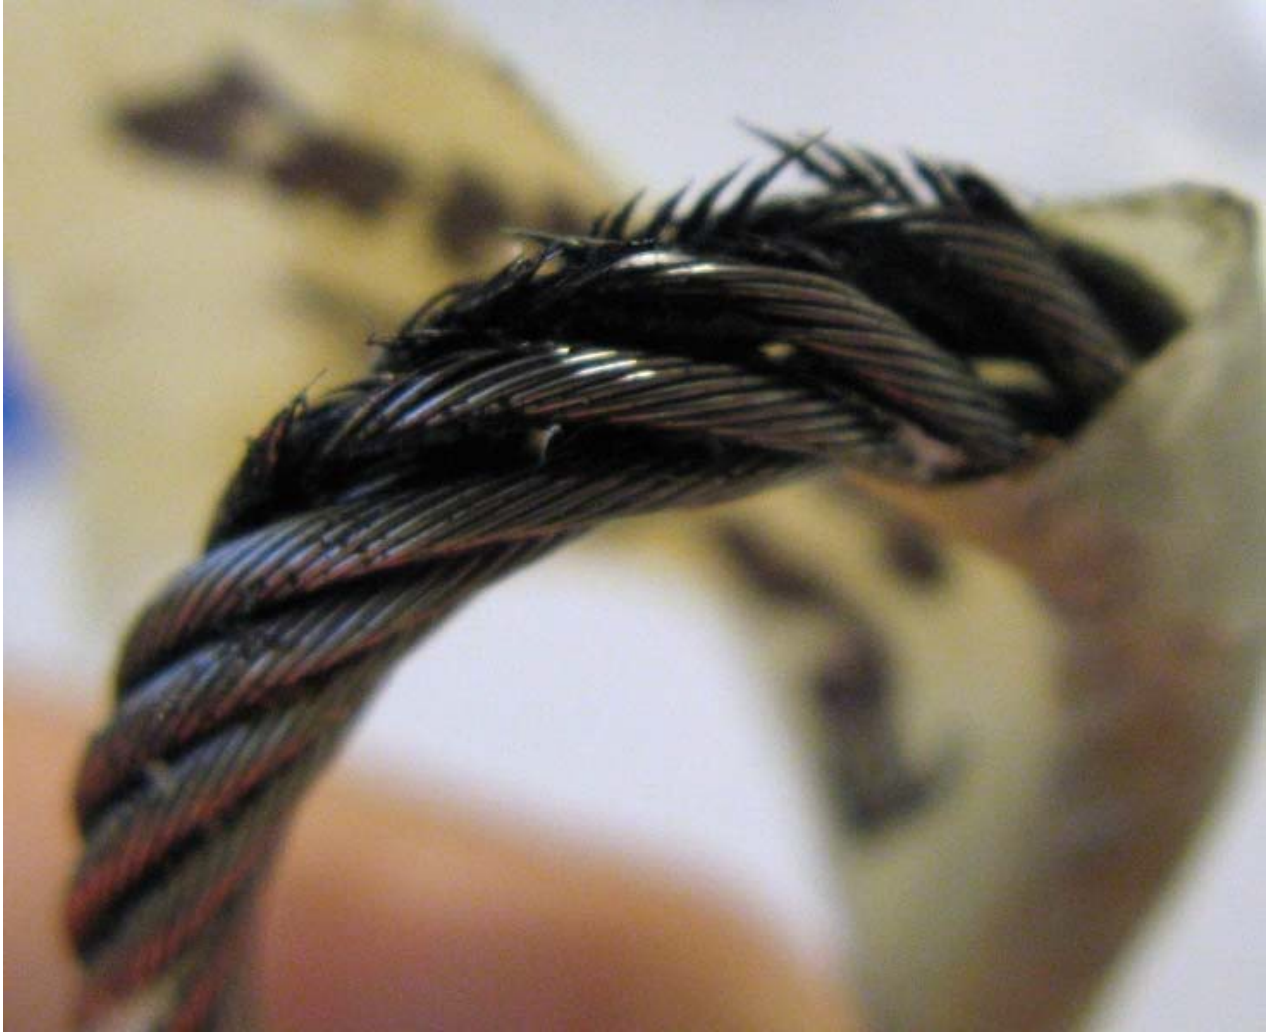
"During a routine inspection," says a flight school submitter," the Aileron Cable (P/N 0510105-364) was found shiny (worn) where it passes through the ceiling pulley cluster. When the mechanic viewed through a strong magnifying glass, he could see many broken strands.

Part Total Time: 2,311.0 Hours
