## Diamond, DA42, Cracked Fuel Tanks, ATA 2810

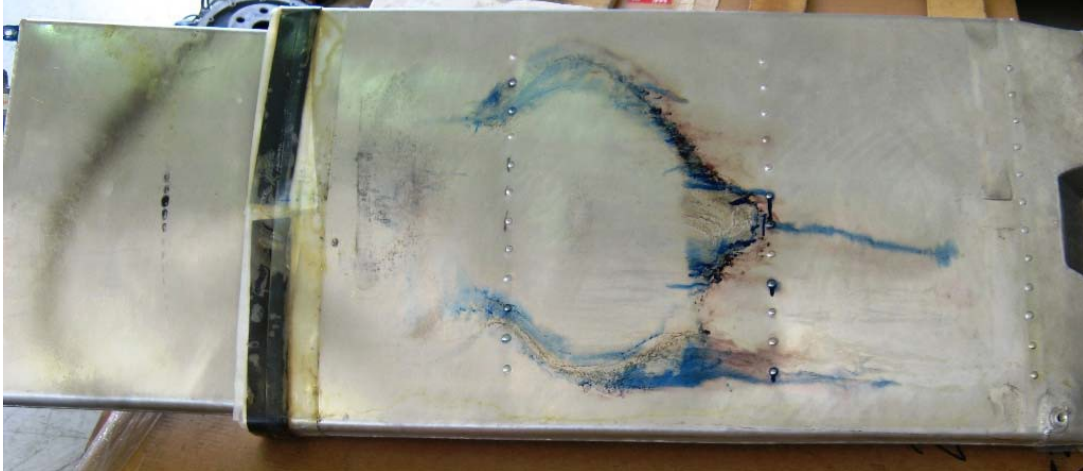
A member of a flight school reported, "During a routine inspection a fuel stain was noted in the left auxiliary tank area. We removed and inspected the tank. There were cracks found at several of the weld points where an internal baffle is welded to the bottom panel of the tank. A new tank (P/N D6028141100) was installed."
