## FEDERAL AVIATION ADMINISTRATION

### Aviation Maintenance Alerts Template

Broken Horizontal Stabilizer Mount Bolts found on three Cessna 208/208B airplanes.

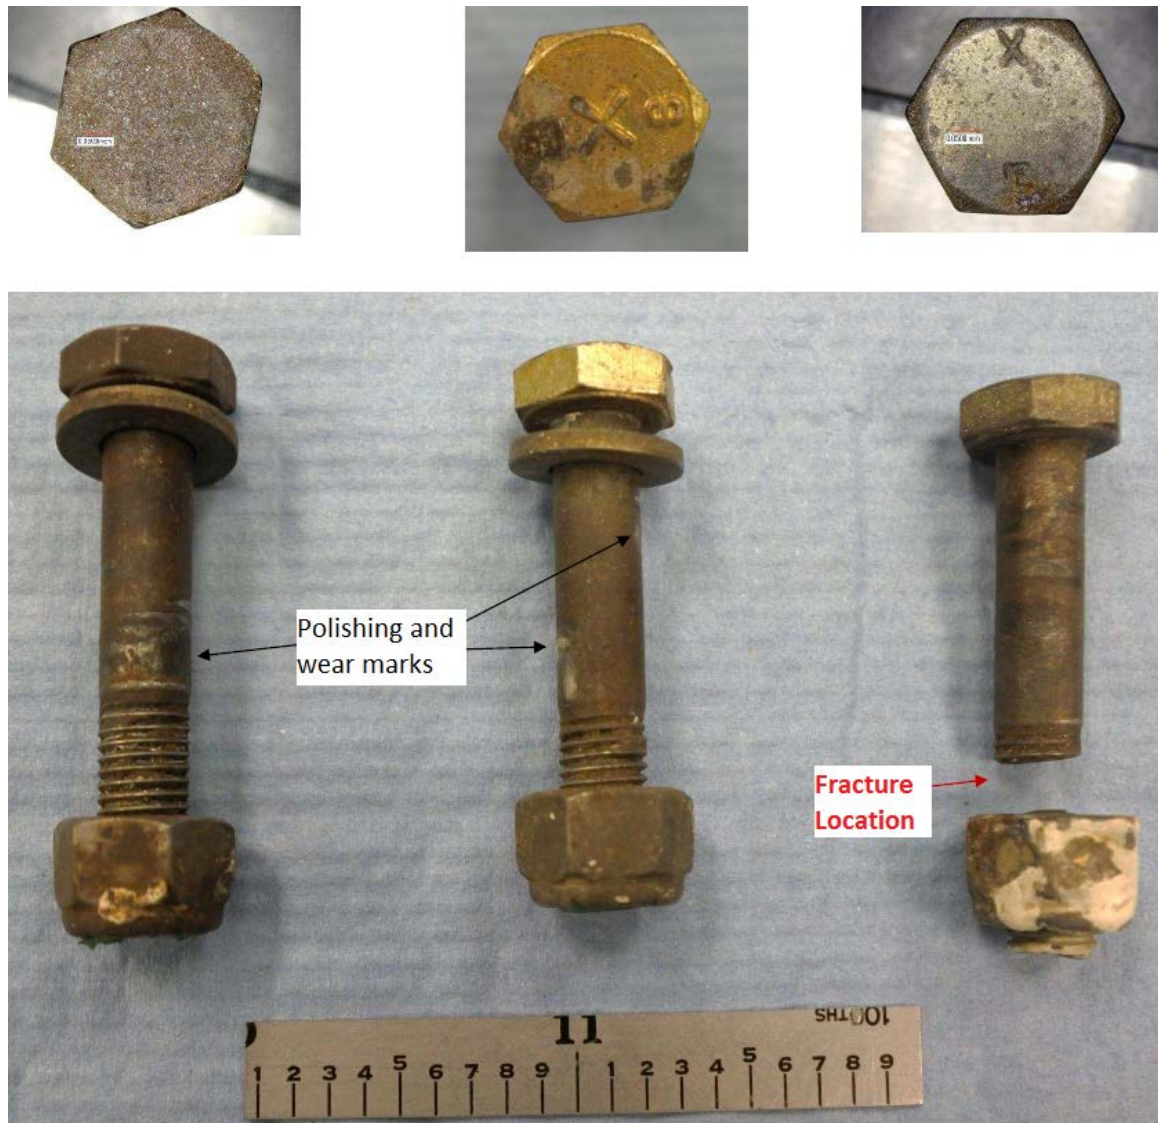
On May 3, 2018, Textron provided their metallurgical results for the broken bolt found in July 2017. Figure 1 shows three AN4-12A horizontal stabilizer aft bolts. The charter operator did not provide the fourth bolt. The bolts all displayed corrosion discoloration. They are non-corrosion-resistant steel bolts with X-marking as shown at the bolt heads at the top of Figure 1. The metallurgical lab report noted corrosion on the fracture surface and on the threads of the broken bolt. The majority of the fracture surface displayed fatigue features. A small region at the end of fracture displayed overload dimples.

Bolts shown in Figure 1 and Figure 2 provide illustrations of the referenced corroded Mount Bolts.

Figure 1 Horizontal Stabilizer Mount Bolts (P/N: AN4-12A). See Figure 6 (green arrows)

Since corrosion and/or inadequate torque can cause the mount bolts to break from fatigue, the FAA recommendation is to adhere to the Cessna 208/208B Maintenance Manual when inspecting for corroded and broken mount bolts, and to ensure that the bolts are adequately torqued per Service Bulletin CAB01-8.

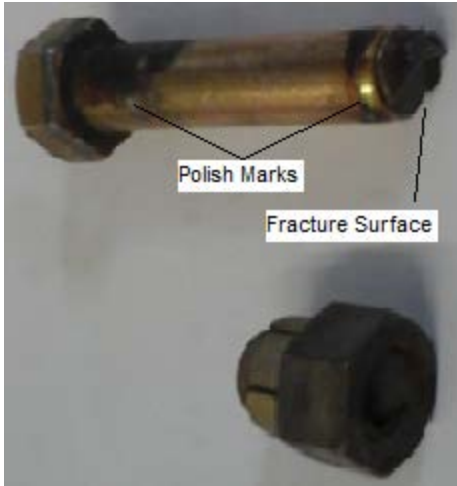
A charter operator in Botswana provided photographs of the S3461-61 broken bolt found in April 2017, shown in upper Figure 2. The broken bolt found in July 2017 was severely corroded; whereas, there was no corrosion found on the broken bolt in March 2006. The photograph of the bolt found in April 2017 and sent from Botswana to the FAA shows corrosion discoloration.

The mount bolt in Figure 3, found in March 2006, is an S3461-61 mount bolt that is broken at the root of the thread. This bolt shows no evidence of corrosion; whereas, the broken bolt in Figure 2, found in April 2017, shows signs of corrosion discoloration. These bolts are located at the 2632018-1 attach fitting (see Item 30 in Figure 6 and Table 1). The bolt in Figure 3 was found in March 2006 on a 1995 Cessna 208B in Australia with 12,000 flight hours. Textron Aviation examined this bolt in 2006 and concluded that the broken bolt was due to reverse bending fatigue. The polish marks on the bolt indicates relative movement between the bolt and the attach fitting. The cause of this bolt fracture is believed to be insufficient torque applied when the bolt was installed. Cessna Service Bulletin CAB01-8, "Horizontal and Vertical Stabilizer Attach Bolt Inspection", dated May 7, 2001, addresses this condition and provides the torque values for these mount bolts.

Figure 2 Polish Marks and Fracture Surface on Bolt, Found in April 2017
