## Champion 7ECA, Cracked Wing Spar, ATA 5711

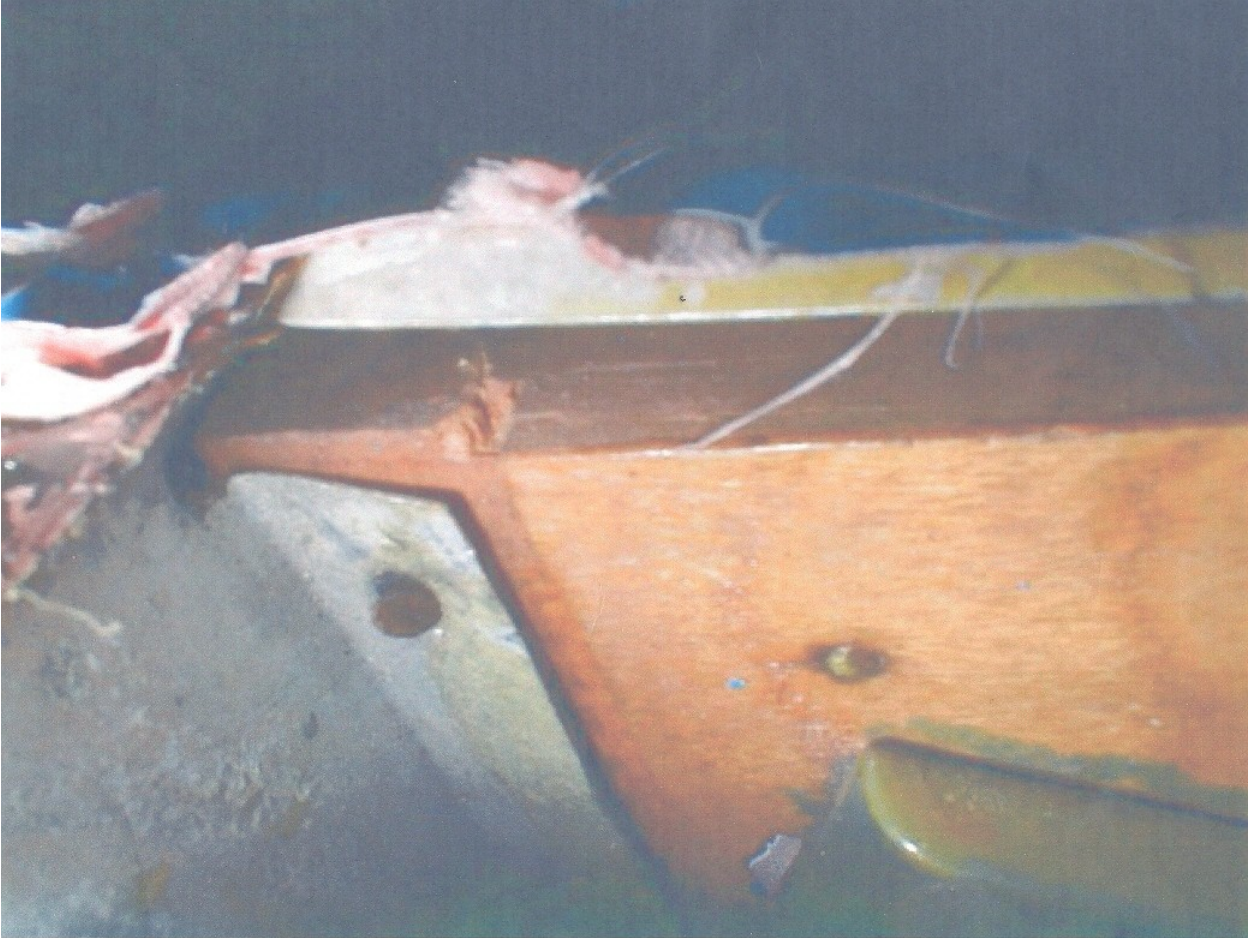
A repair station technician writes, "A required inspection of wooden wing spars in accordance with AD 2000-25-02 revealed a compression crack in the left wing forward spar at the top, O/B of the wing-strut attach doubler-plate." (*The part number listed is 5-271L.*)
