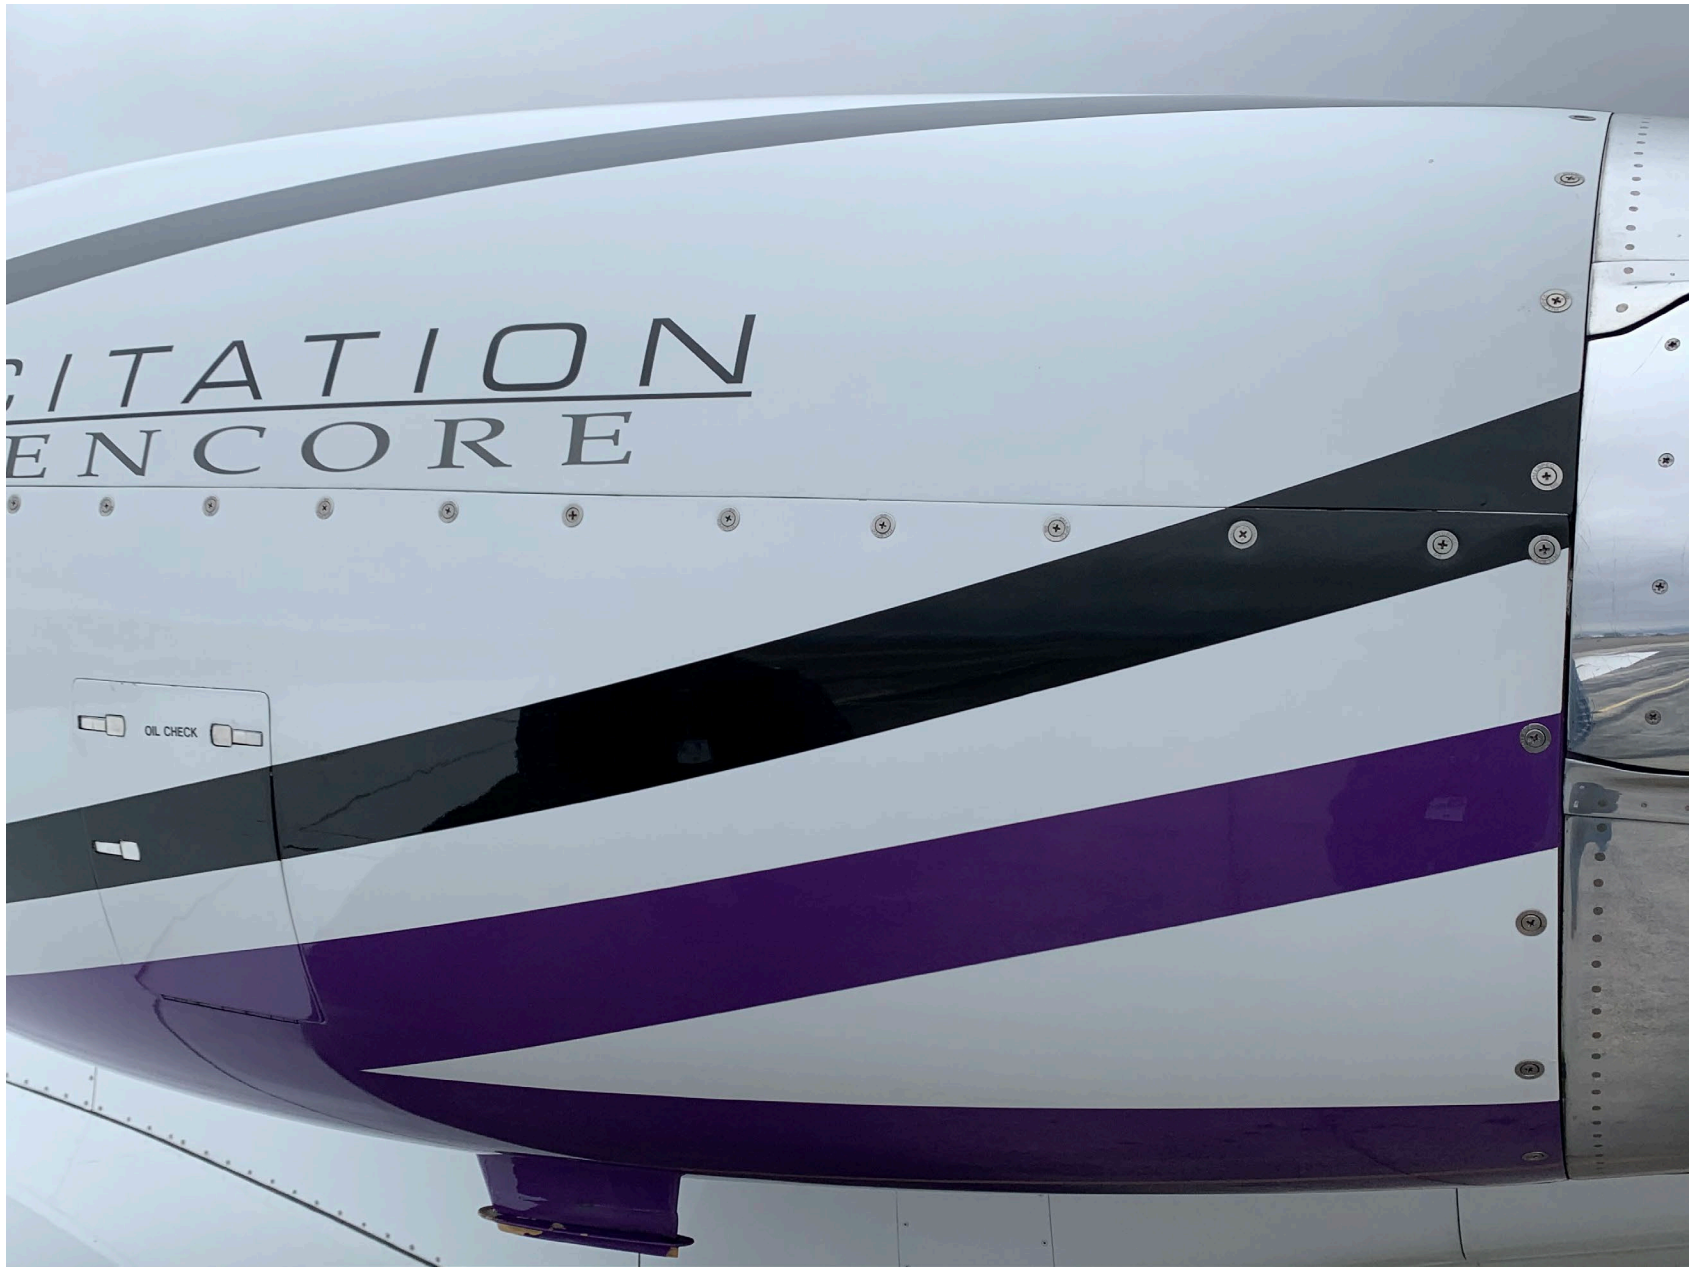
Photo 5 – View of the exemplar upper and lower left side engine cowlings (courtesy of the Federal Aviation Administration).
