# Aviation Investigation Final Report

| <b>Location:</b> | San Diego, California | <b>Accident Number:</b> | WPR15MA243 |
| <b>Aircraft:</b> | Cessna 172M | <b>Aircraft Damage:</b> | Destroyed |
| <b>Defining Event:</b> | Midair collision | <b>Injuries:</b> | 1 Fatal |

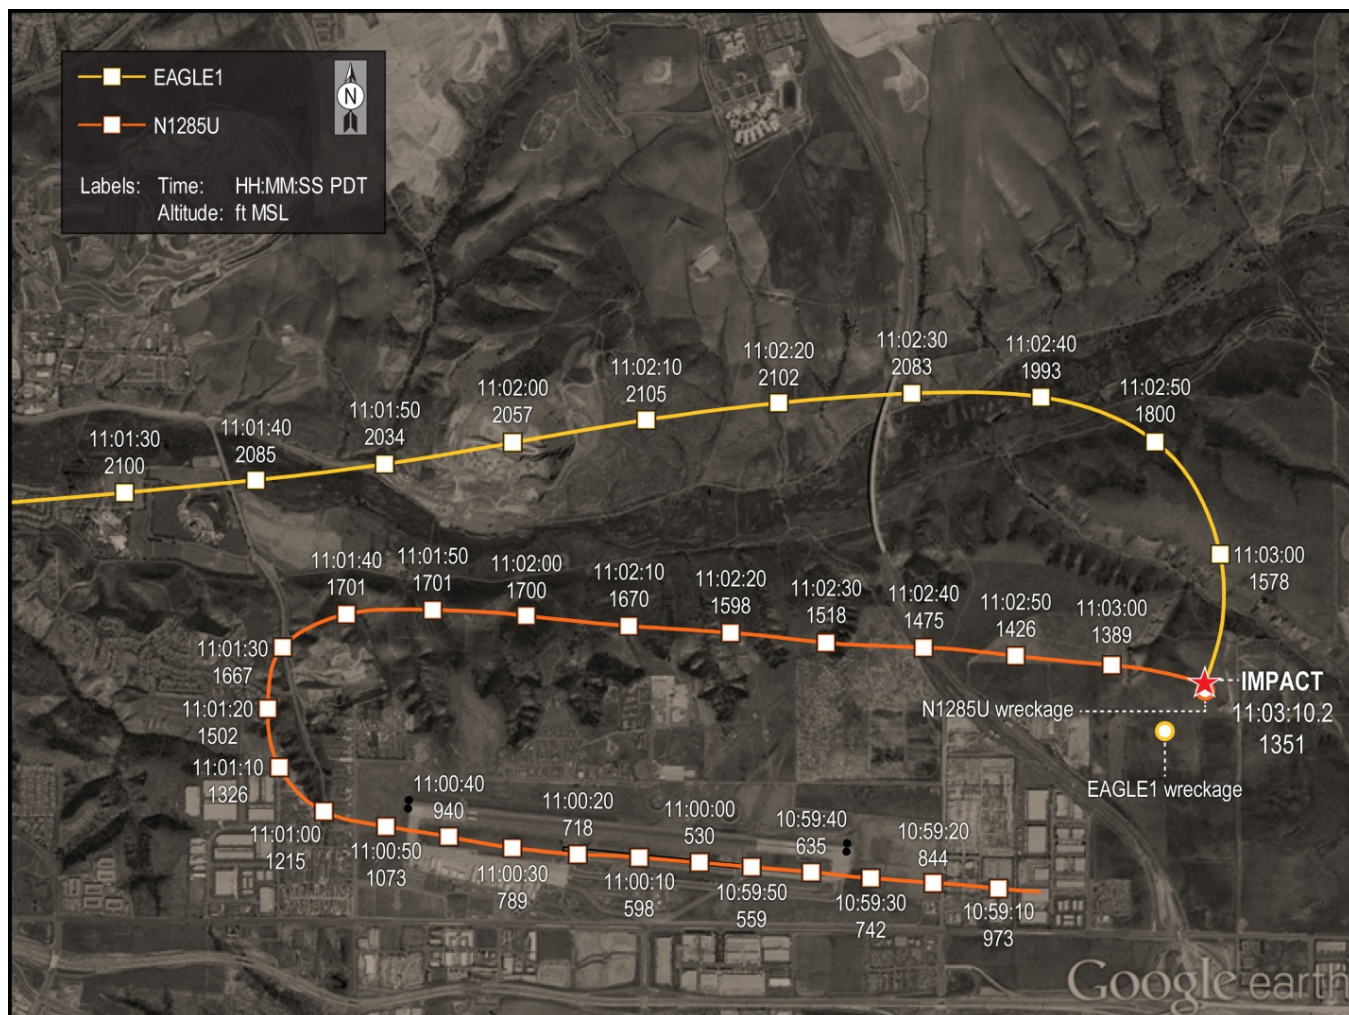
**Figure 3.** Calculated flight tracks of Eagle1 and N1285U.

traffic alert; however, the moment he realized that Eagle1 was turning into N1285U, it was too late to help. Figure 3 shows the calculated flight tracks of Eagle1 and N1285U. Figure 4 shows the aircraft under SDM ATCT control from 1049 until the time of the collision.

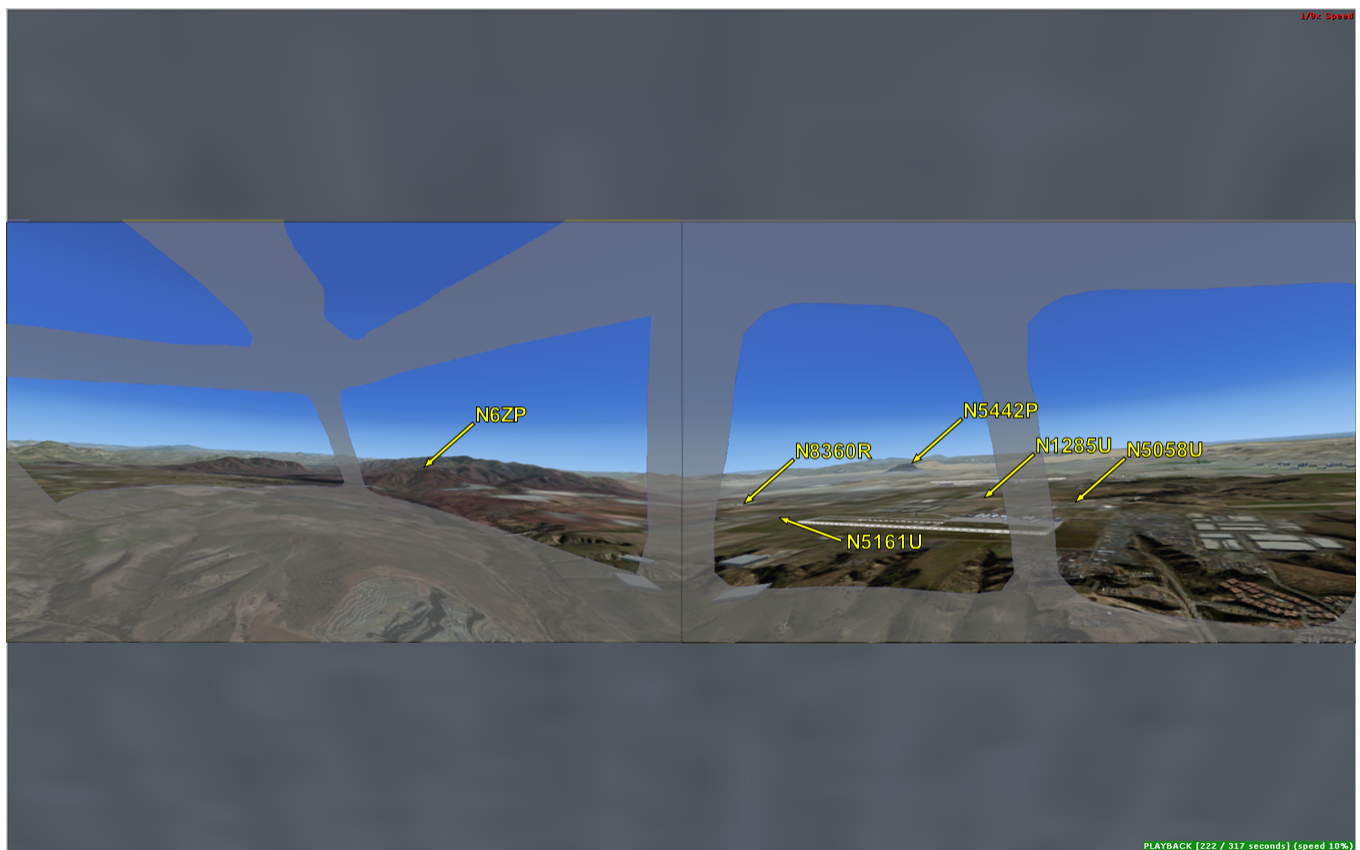
**Figure 7a.** View from the copilot seat of Eagle1 at 1101:43.1, when the airplanes were 0.5 nm apart.

At 1101:43.1, N1285U would have been located just to the left of the window post separating Eagle1's R2 and R3 windows, and N5058U would have been just to the right of this post (see figure 7a). Eagle1 would have appeared in the left window of N1285U, just below the wingtip (see figure 7b). Eagle1 and N1285U were both on the right downwind leg for runway 26R, with Eagle1 about 0.4 nm north of N1285U.

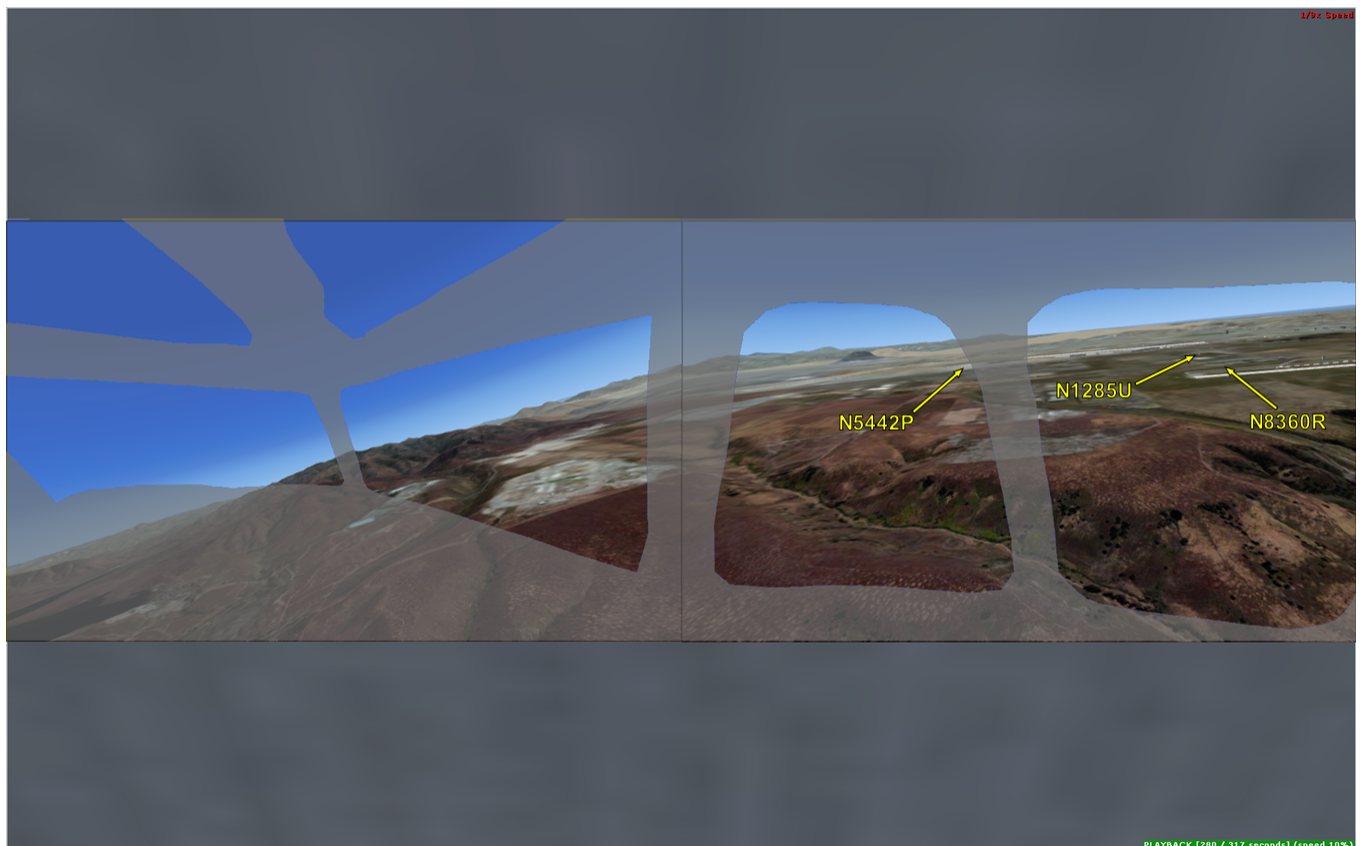
**Figure 8a.** View from the copilot seat of Eagle1 at 1102:32.4, when the airplanes were 0.8 nm apart.

N1285U was 0.8 nm away and would have appeared in Eagle1's R3 window (see figure 8a). Also to Eagle1's right were N8360R (on short final approach for runway 26L), N5442P (on a left base leg for runway 26L), and N5058U (which was climbing through 1,500 ft about 2.6 nm to the west of the runway 26R threshold). Eagle1 would have been obscured from the N1285U pilot's field of view by the left wing and strut (see figure 8b). Eagle1 started banking to the right, turning toward right base, shortly after this time.

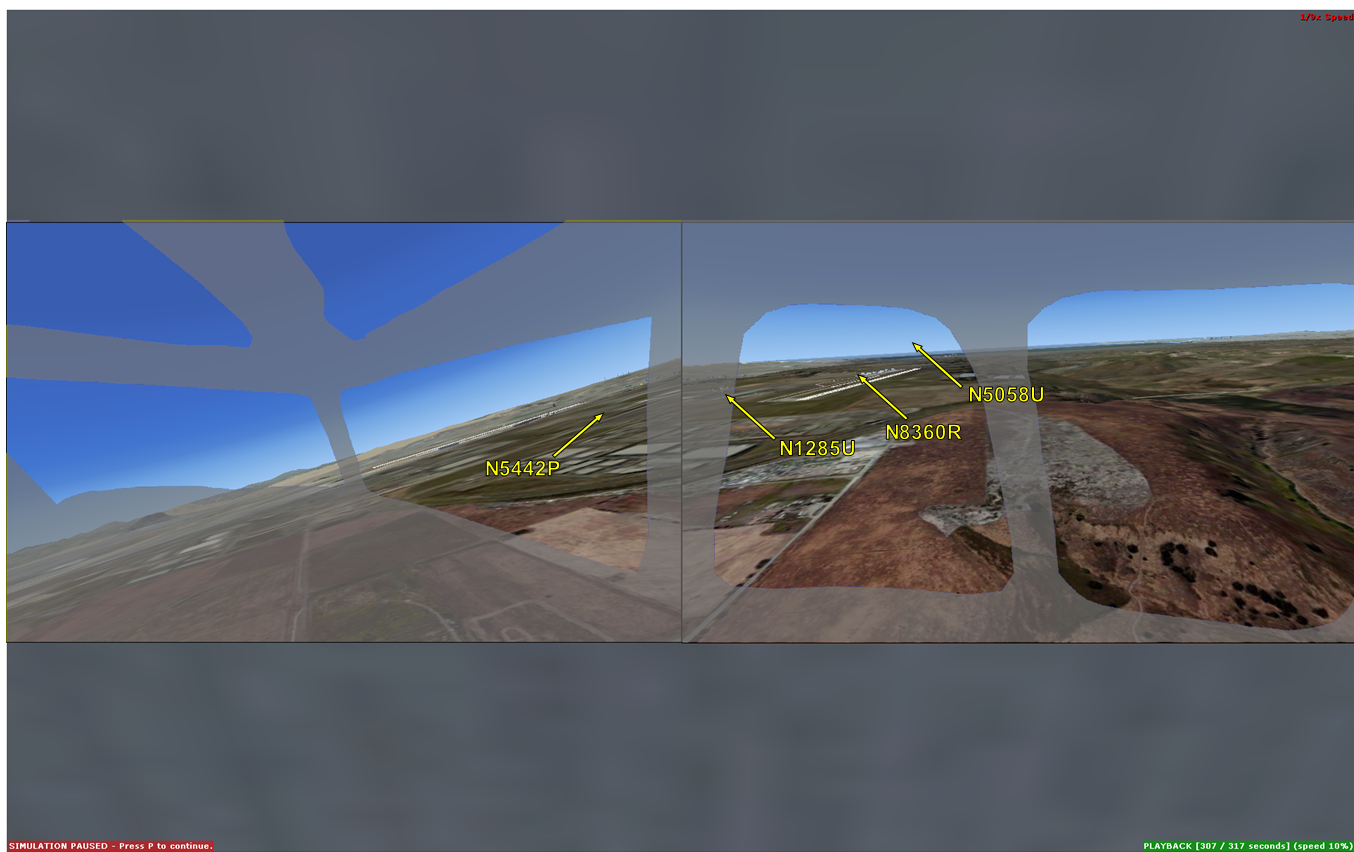
**Figure 10a.** View from the copilot seat of Eagle1 at 1103:08.0, when the airplanes were 0.1 nm apart.

At 1103:08.0, when the controller asked the N1285U pilot if he was still on downwind, Eagle1 and N1285U were about 0.1 nm apart. N1285U may have been obscured by the post between Eagle1's R1 and R2 windows, and Eagle1 may have been obscured by N1285U's window post (see figures 10a and 10b).

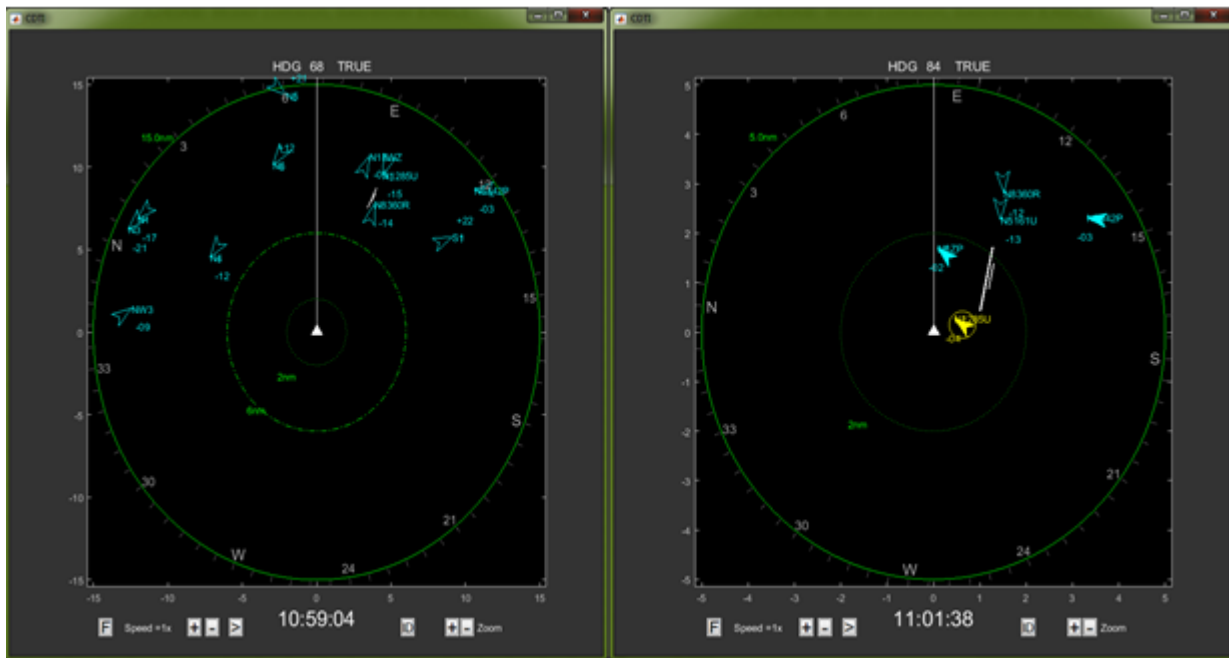
**Figure 11.** Simulated in-cockpit traffic display for Eagle1 at 1059:04 (left) and 1101:38 (right).

The NTSB's in-cockpit traffic display simulation for Eagle1 indicates that at 1059:04, open (outlined), cyan-colored, arrowhead-shaped targets representing the local traffic at SDM would have appeared at the 1 o'clock position, 8 nm from Eagle1, and traffic inbound for the San Diego area would have appeared at Eagle1's 9 to 11 o'clock position, 8 nm from Eagle1. N1285U would have been depicted 500 ft below Eagle1 east of the airport on a final approach leg. As Eagle1 continued its east-bound track toward SDM, N1285U would have disappeared from view (loss of radar contact). At 1059:48, as Eagle1 approached 6 nm from SDM, N6ZP would have appeared over SDM as an open arrowhead and turned right to remain in the traffic pattern for runway 26R. At 1100:16, N6ZP would have changed to a filled cyan-colored arrowhead before becoming established on the downwind leg at 1100:49. (N6ZP would eventually cross over the projected flightpath of Eagle1 at 1101:49, headed northeastbound.) At 1100:57, when Eagle1 was about 3.5 nm from the runway 26R threshold, N1285U would have reappeared on Eagle1's display as a filled, cyan-colored arrowhead at Eagle1's 1 o'clock position, about 2.5 nm from and 1,100 ft below Eagle1. At 1101:38, N1285U's symbol would have changed to alert status (a filled, yellow-colored arrowhead, enclosed by a yellow circle), and Eagle1 would have received an aural alert advising, "Traffic, 2 o'clock, low, less than 1 mile, climbing" (see figure 11).

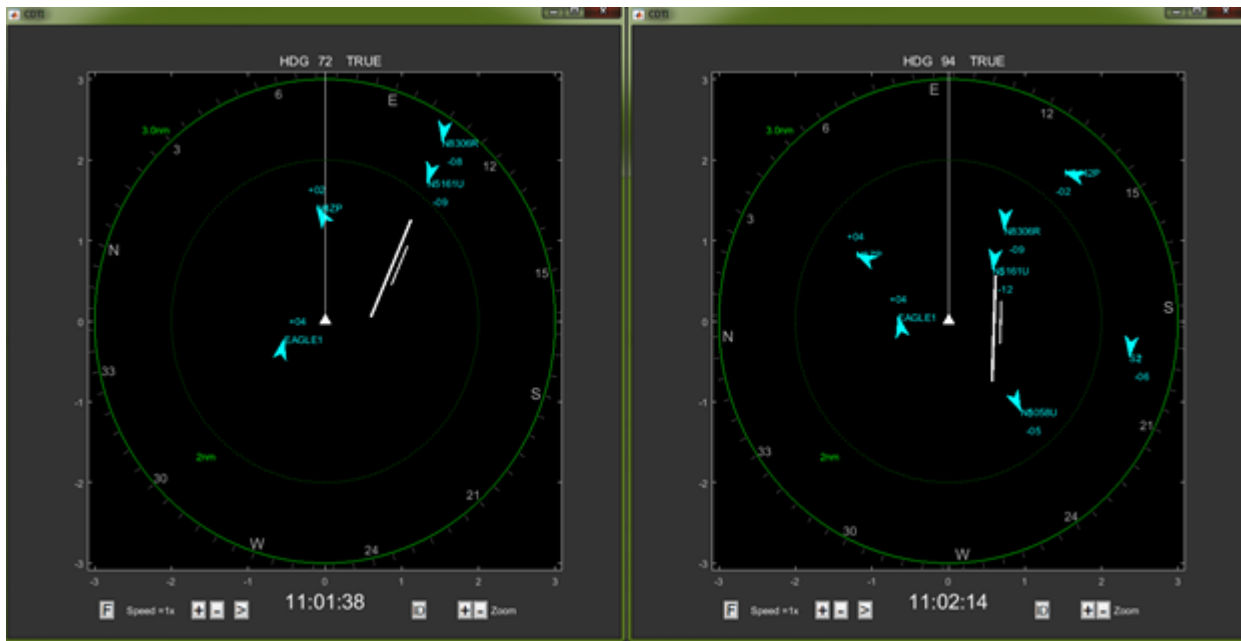
**Figure 12.** Simulated in-cockpit traffic display for N1285U at 1101:38 (left) and 1102:14 (right).

As shown in figure 12, at 1101:38, as N1285U turned onto the downwind leg and as Eagle1 was receiving its aural alert, N1285U's display would have depicted Eagle1 at N1285U's 8 o'clock position, 0.6 nm from and 400 ft above N1285U. At 1102:14, both Eagle1 and N1285U were positioned abeam the tower, and Eagle1 reported traffic to the left and right in sight. N6ZP would also have been shown on the displays departing the SDM area heading in a northeastern direction 400 ft above N1285U and at the same altitude as Eagle1.

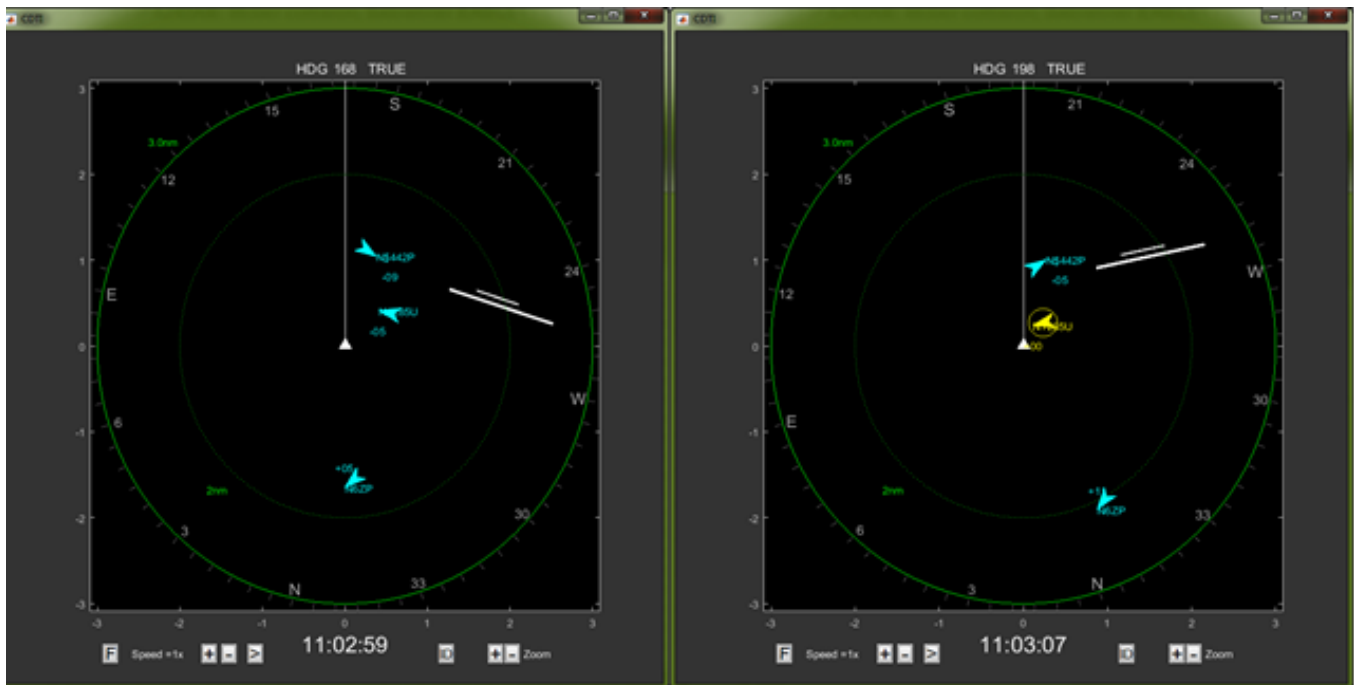
**Figure 13.** Simulated in-cockpit traffic display for Eagle1 at 1102:59 (left) and 1103:07 (right).

At 1102:59.3, during Eagle1's base turn, the pilot stated, "I see the shadow but I don't see him." At this time, N1285U would have been depicted on Eagle1's display at Eagle1's 2 o'clock position, between Eagle1 and the runway 26R threshold, 1 nm from and 500 ft below Eagle1. At 1103:07, about 3 seconds before the collision, N1285U would have again changed to alert status (yellow, circled arrowhead), and Eagle1 would have received a second aural alert advising, "Traffic, 1 o'clock, same altitude, zero miles" (see figure 13). At the same time, Eagle1 would have changed to alert status on N1285U's display, and N1285U would have received an aural alert advising, "Traffic, 11 o'clock, same altitude, zero miles, descending." Additional details about the traffic information that could have been displayed during the accident scenario can be found in the Aircraft Performance and Cockpit Visibility Study.
