FEDERAL AVIATION ADMINISTRATION

Aviation Maintenance Alerts Template

Cracked Upper and Lower Wing Strut Fittings on Cessna 208 Airplanes

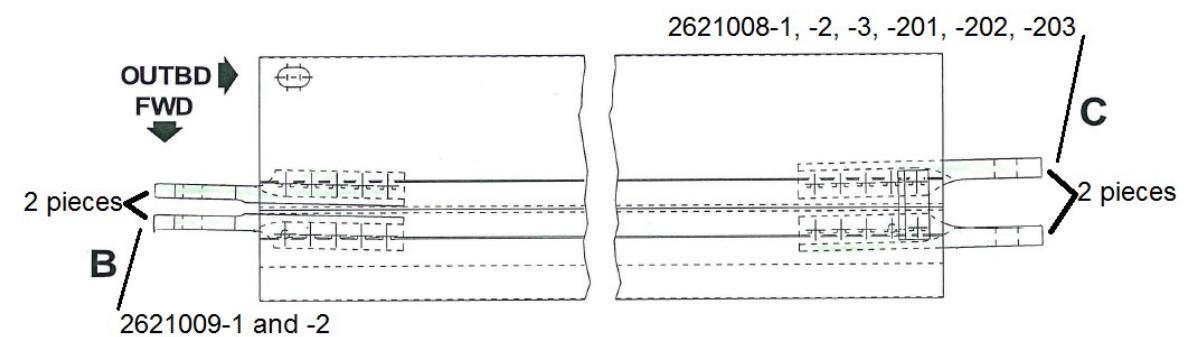
2621009-1 and -2 Figure 6 The Schematic (View B) displays the Right Wing Strut Assembly with view looking up. (Left side of the Schematic (View C) is opposite view)
