OPSB 0166-17R2

To: Operators of Rockwell Collins Flight Management Systems Pro Line 4 and Pro Line 21 FMS 3.3.x through FMS 4.x

Subject: The FMS may turn in the wrong direction after sequencing a “Climb to” altitude that was manually edited or Temperature Compensated

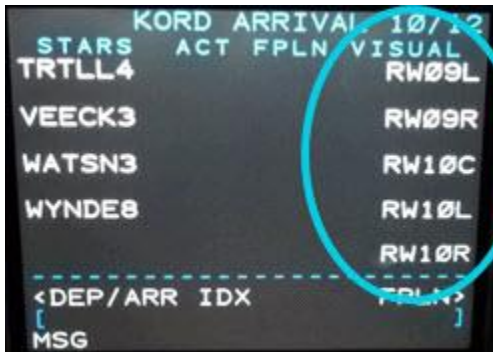
Figure 5a. ARRIVALS page selections for Runway extension in FMS 3.x (Type 6 Navigation databases)

Do the removals affect standard arrivals and departures? There are no STARs or departure procedures removed from the database. Standard Arrivals (STARs) sometimes require an approach selection in order to load the entire arrival into the FMS flight plan. The Runway Extension can be selected instead of the approach in order to load the STAR. The Runway Extensions are listed on the ARRIVALS page, after approaches (circled in the figures):
