FEDERAL AVIATION ADMINISTRATION SAFETY TEAM-SOUTHWEST REGION

A Newsletter Written by Mechanics For Mechanics

Issue: 08-02

Nuts And Bolts

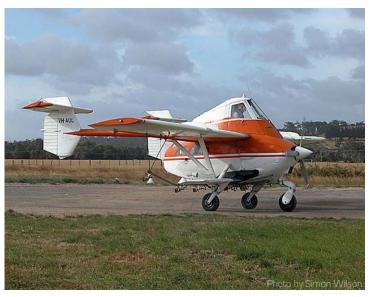
The first correct response to the 08-01 edition photo came from Mr. Joe Christian from Eldorado, Texas. Joe said "It's a Transavia PC-12 Airtruk." The Airtruk was developed from the Bennett Airtruck designed in New Zealand by Luigi

Pellarini. It has a 1 ton capacity hopper. It can be used as a cargo, ambulance or aerial survey aircraft, and carry one passenger in the top deck and four in the lower deck. This aircraft was featured in 1985 movie "Mad Max Beyond Thunderdome.
