NTSB National Transportation Safety Board

General Aviation Accidents

The NTSB
Most Wanted List

Cessna Flight Operations
Safety Standdown
January 19, 2012

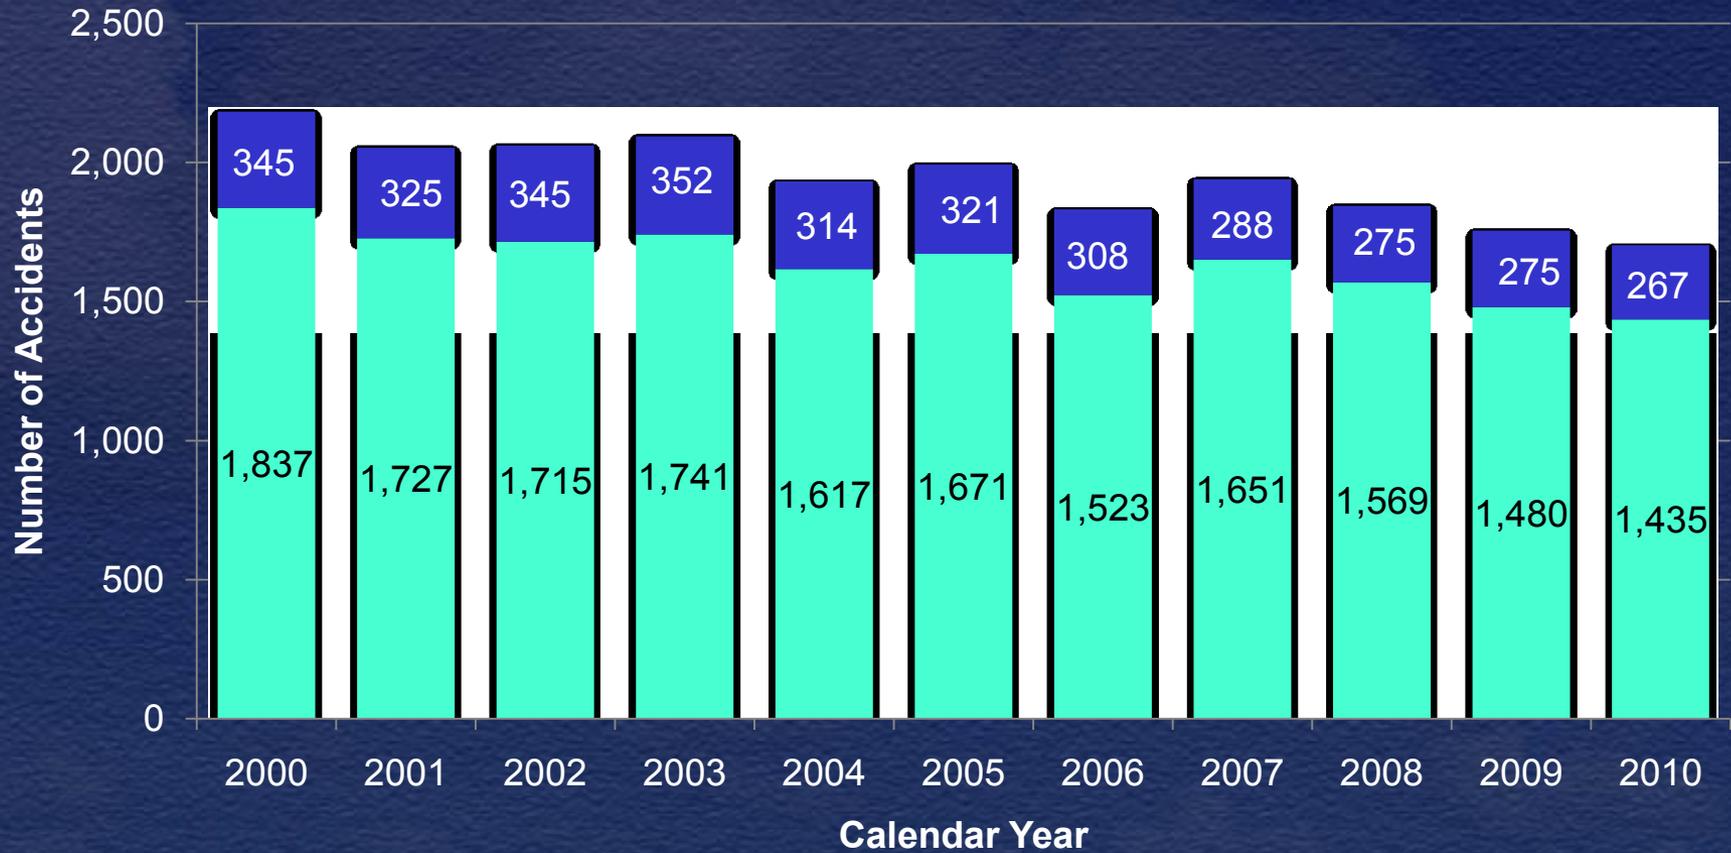
All GA Accidents

Total Fatal

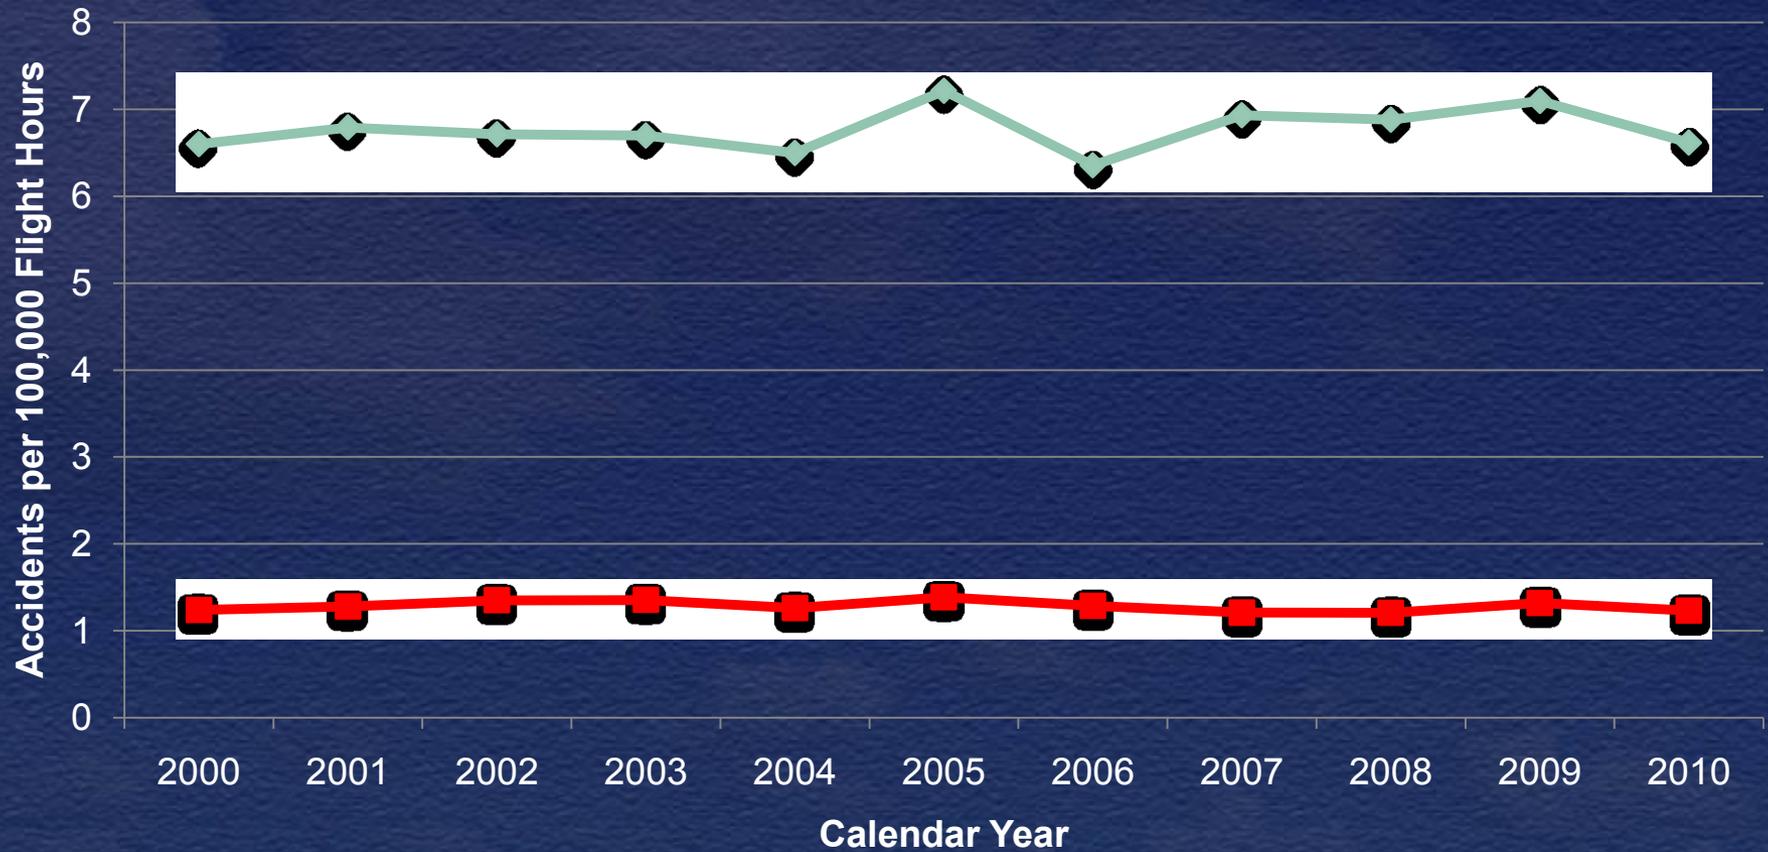
GA Accident Rates

◆ Total ■ Fatal

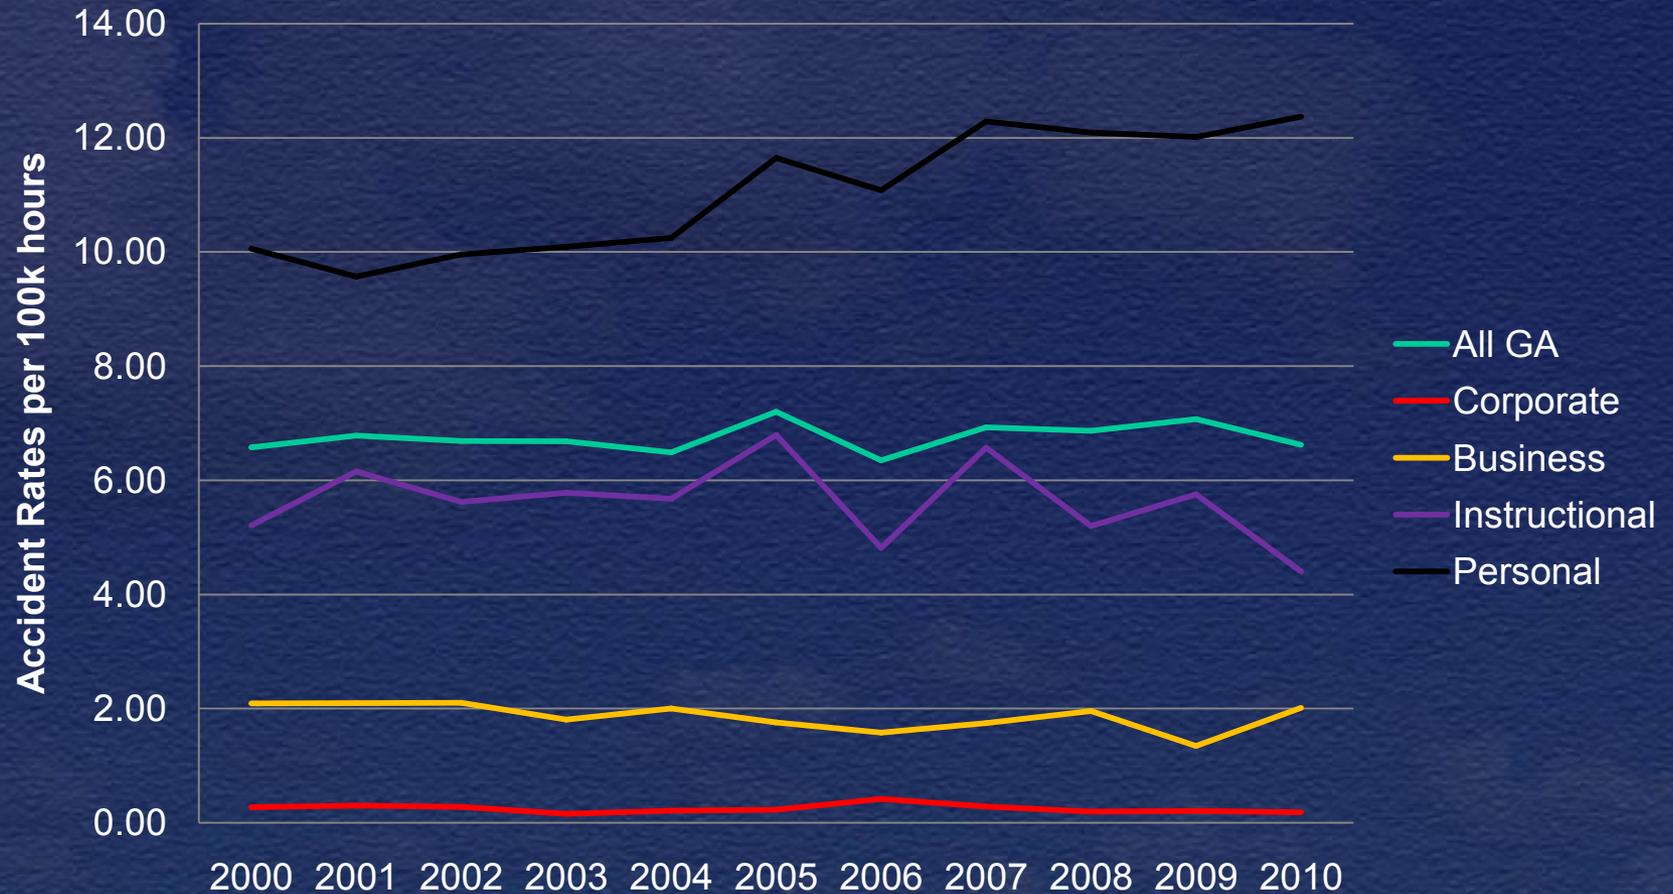
Accident Rates per 100k Flight Hours
2000-2010

- Corporate
 - Accident rates approaching that of the airlines.
- Business
 - Total and fatal accidents show a modest decline, substantially below the overall GA accident rates.
- Instructional
 - Total accident rate is slightly below the average for all of GA, the fatal rate is substantially lower.
- Personal
 - Total and fatal accident rates have risen, both rates are substantially above the average of all GA flying.

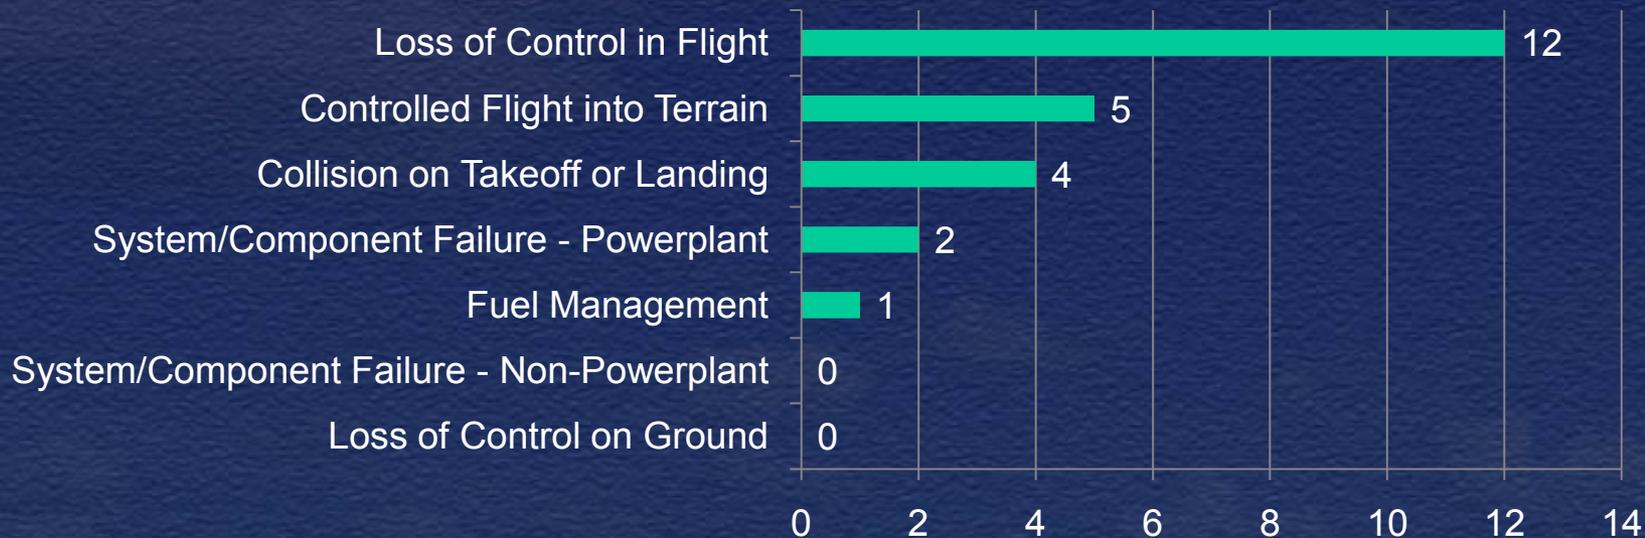
Number of Fatal Accidents

Business Flying, 2007-2009

All accidents – Loss of control (in-flight or on the ground) accounted for the largest portion, followed by system/component failures.

Fatal accidents - Loss of control in flight accounted for the greatest proportion, followed by controlled flight into terrain and collisions on takeoff or landing.

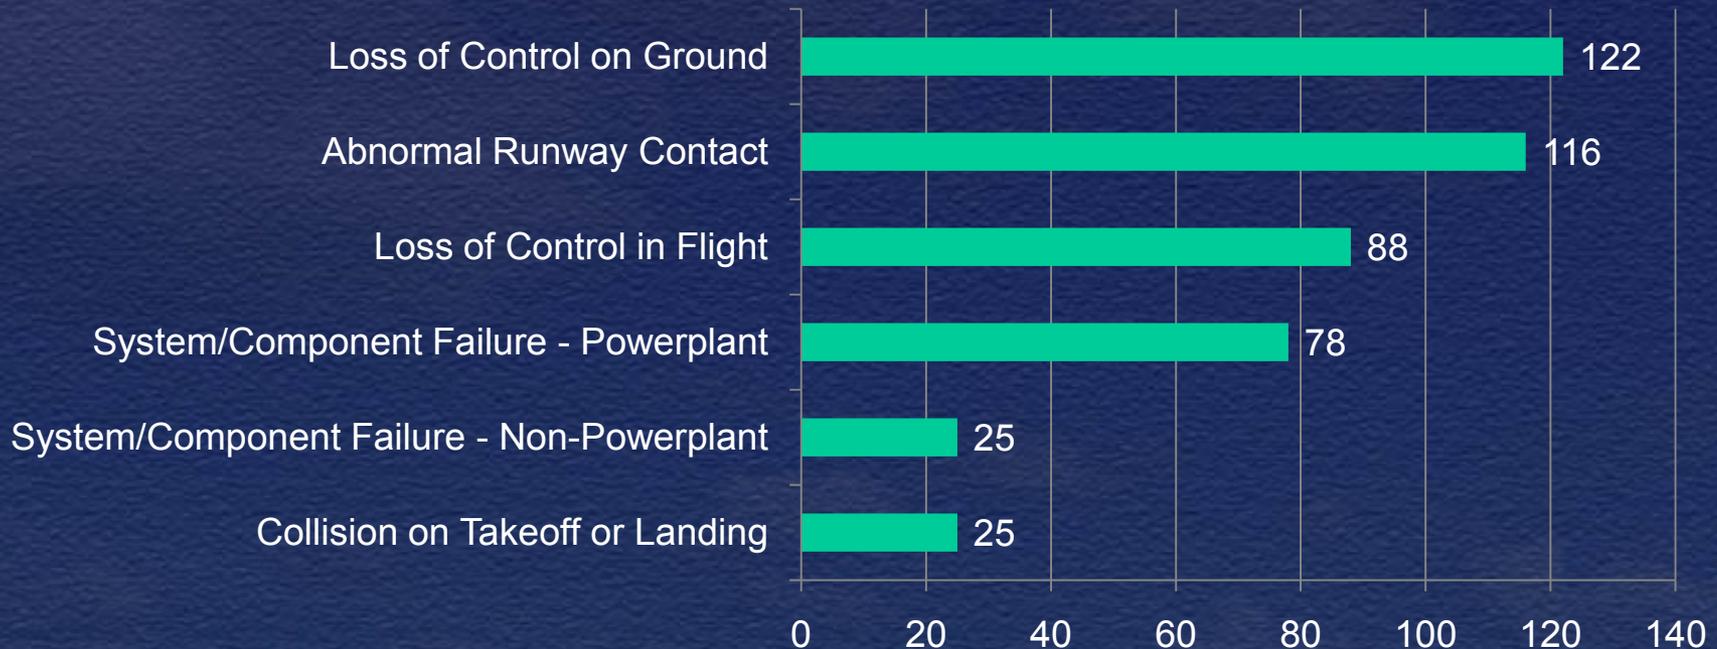
Number of Fatal Accidents

Instructional Flying, 2007-2009

Loss of control on the ground or in flight and abnormal runway contact (e.g., hard landings) accounted for the great majority of defining accident events for instructional flying accidents in both fixed-wing airplanes and helicopters.

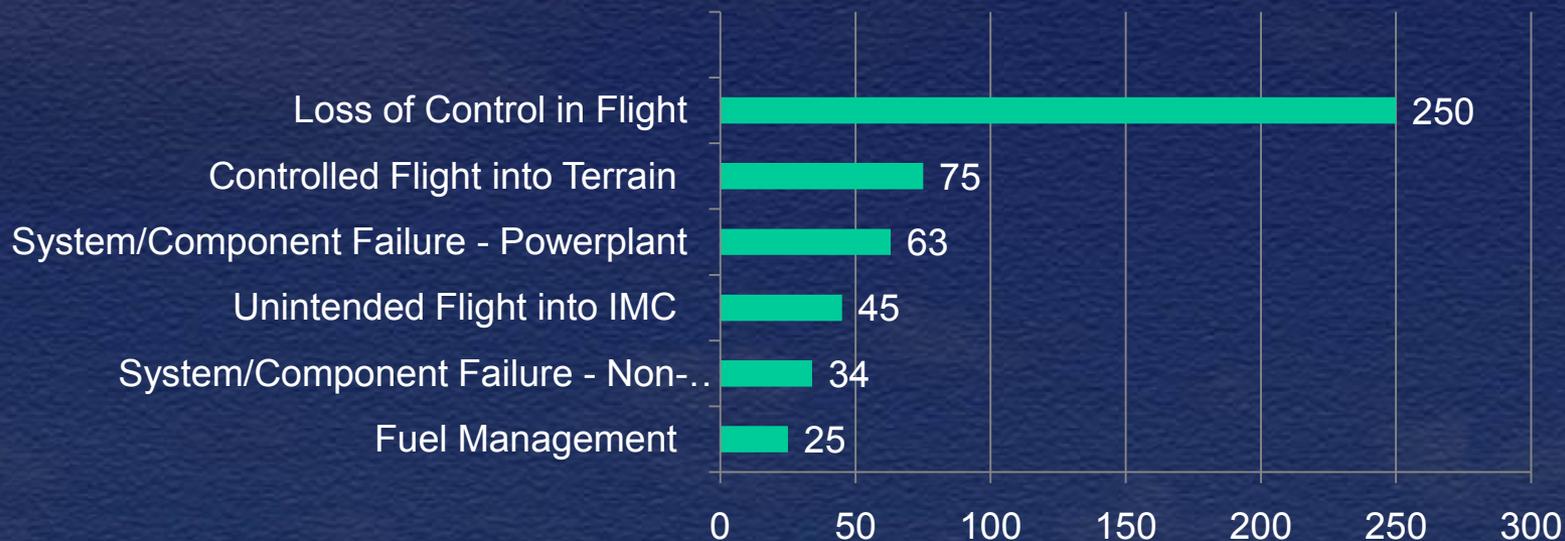
Number of Fatal Accidents

Personal Flying, 2007-2009

Total accidents - loss of control in flight and on the ground and power plant failure were the most common defining events.

Loss of control in flight accounted for the greatest proportion of the fatal personal flying accidents.

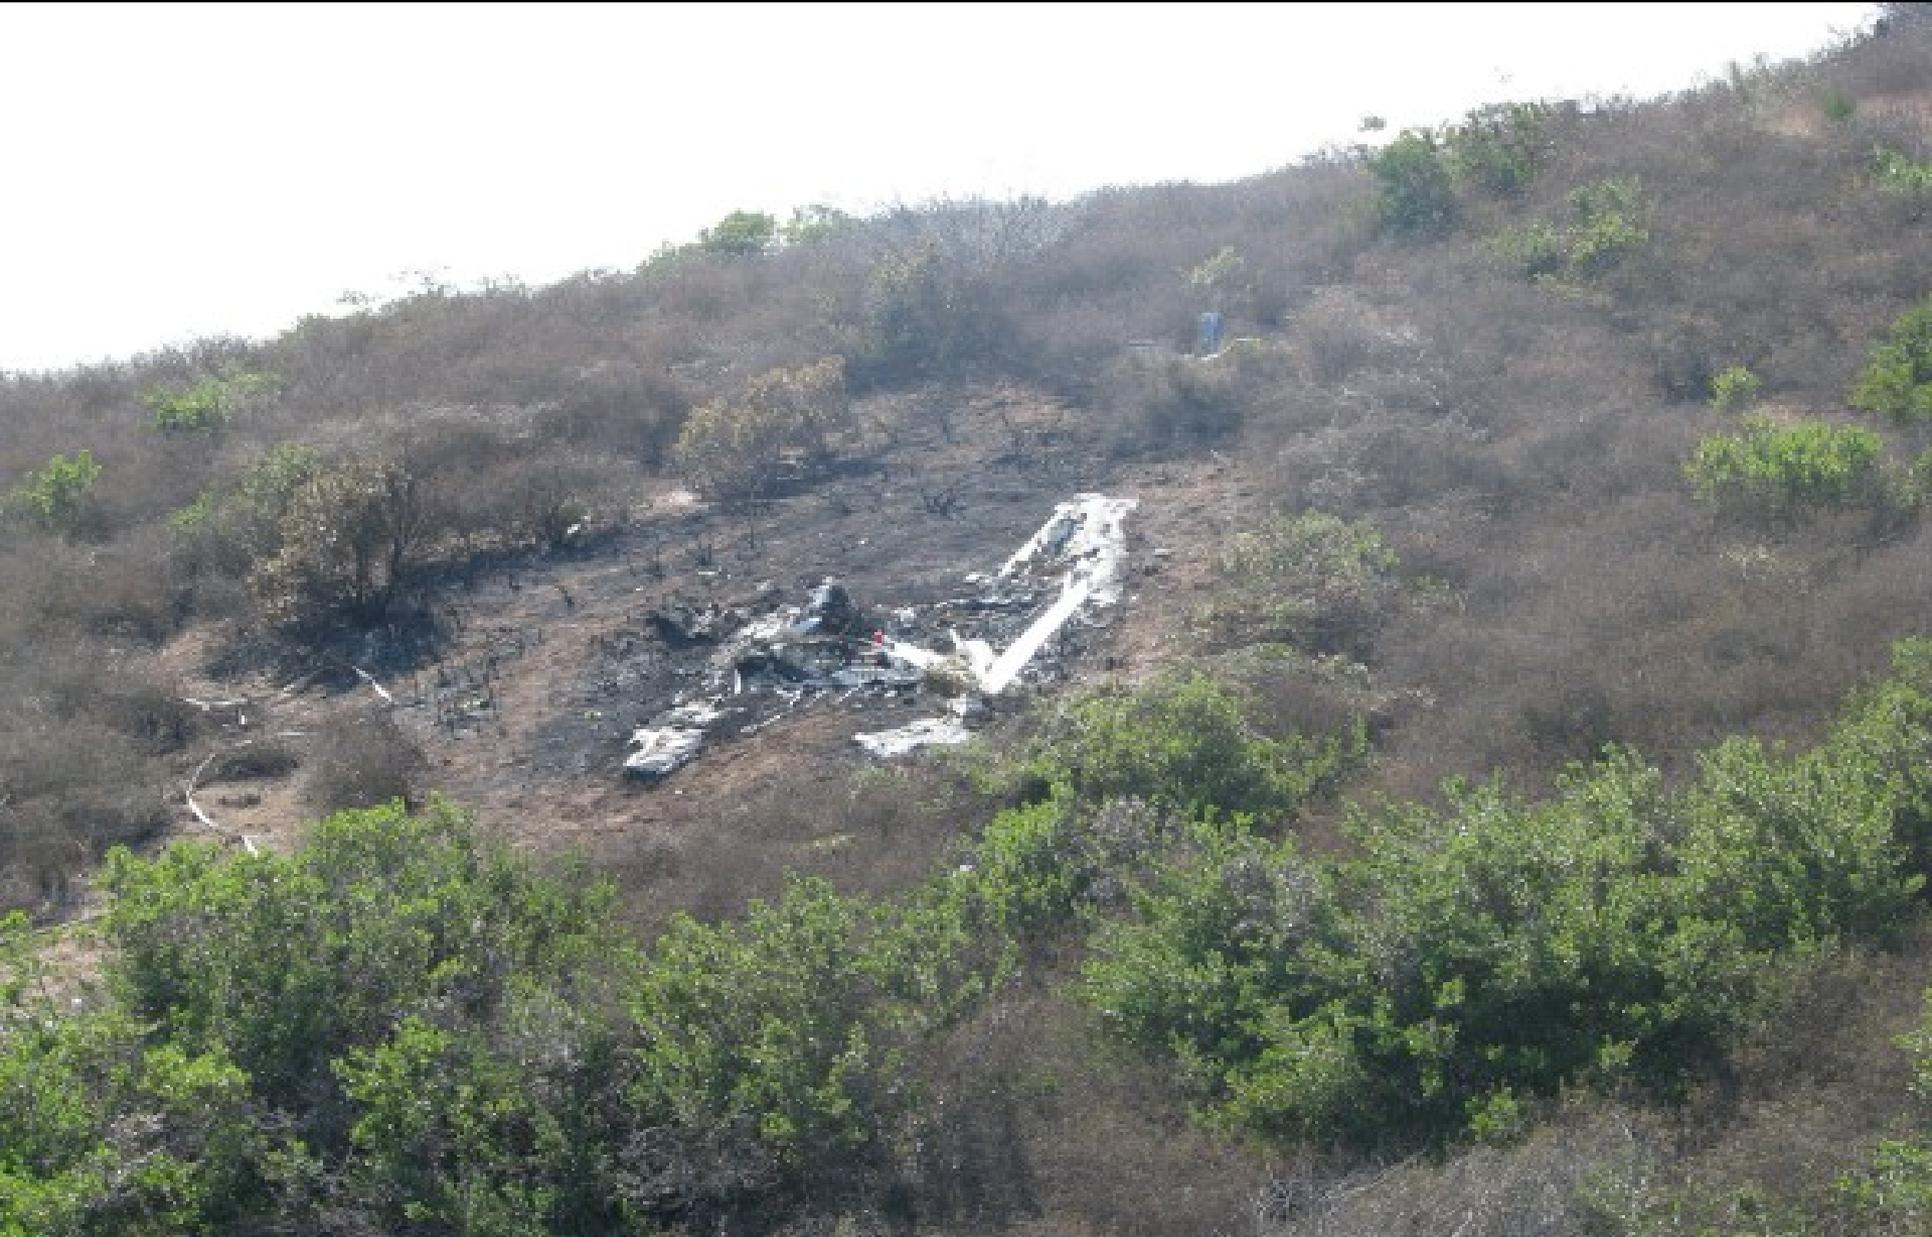
Loss of Control in Flight

- Accident #LAX08FA300
- Beechcraft A36
- Approach to KCRQ, Carlsbad CA airport, 331 ft msl
- One person onboard, fatal
- Weather – 100 ft ceiling, $\frac{1}{4}$ mi visibility, wind 280 degrees at 5 kt
- ILS 24 minimums 200 ft ceiling, $\frac{3}{4}$ mi visibility

- Accident sequence
 - ATC cleared for ILS approach RW 24
 - Tower issued “low altitude alert” and advised pilot he was south of localizer
 - Two minutes later pilot stated he was “aborting” the approach
 - One minute later pilot stated “I’m in trouble”

- Radar tracks
 - Two miles from approach end RW24 airplane crossed LOC at 800 ft heading south
 - Track started tight left-hand turns
 - Altitude fluctuated between 600 and 1100 ft msl
 - Last radar return showed airplane at 900 ft msl and 56 kt ground speed
- Wreckage confined to initial impact area

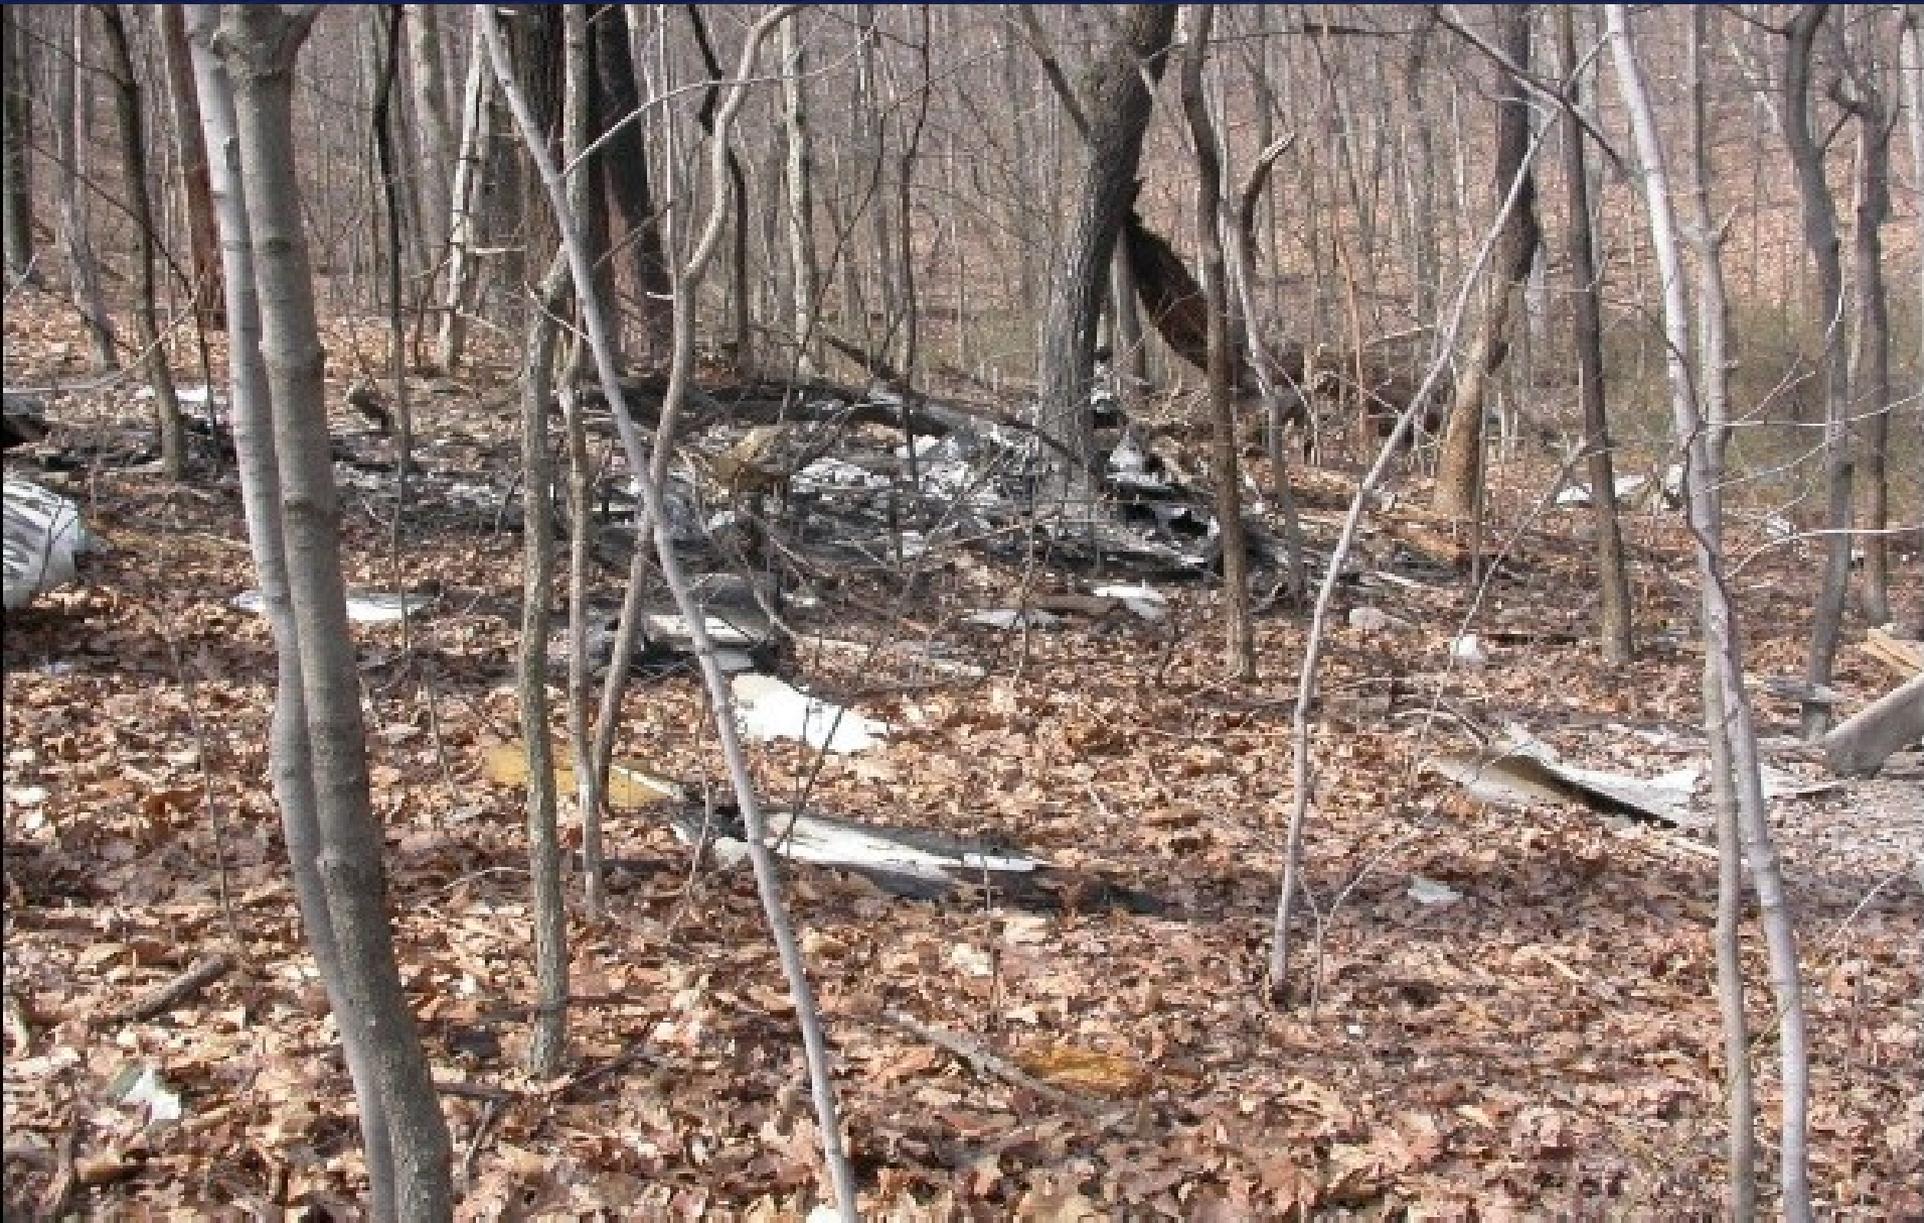
Controlled Flight into Terrain

- Accident NYC08FA138
- Cirrus SR22
- Night IFR Departure Front Royal Virginia, KFRR, 709 ft msl
- Two fatalities – pilot & son
- Weather – Winchester, KOKV, 15 mi S
 - Wind 340 deg at 4 kt
 - 3 mi visibility in rain
 - Broken 2,400 ft, overcast 3,000 ft

- Accident sequence
 - IFR clearance – direct COGAN intersection, climb and maintain 4,000, expect 5,000 10 minutes after departure
 - Prior to takeoff, Desired Course set to 050 deg, approximate direct course to COGAN
 - Airplane departed RW27
 - GPS waypoint COGAN selected during takeoff roll
 - Aircraft path continued west, consistent with GPSS not selected

- Flight path
 - Total time of flight 80 seconds
 - First 40 sec, runway heading, climbing 900 to 1,000 fpm
 - 25 sec, vertical speed decreased to 0 fpm,
 - then up 2200 fpm,
 - then decreased to 700 – 750 fpm up
 - Airplane reached 2,200 ft msl and 140 kt ias
 - Last 6 sec, steep descending turn to left, roll to 95 deg and pitch to 27 deg down

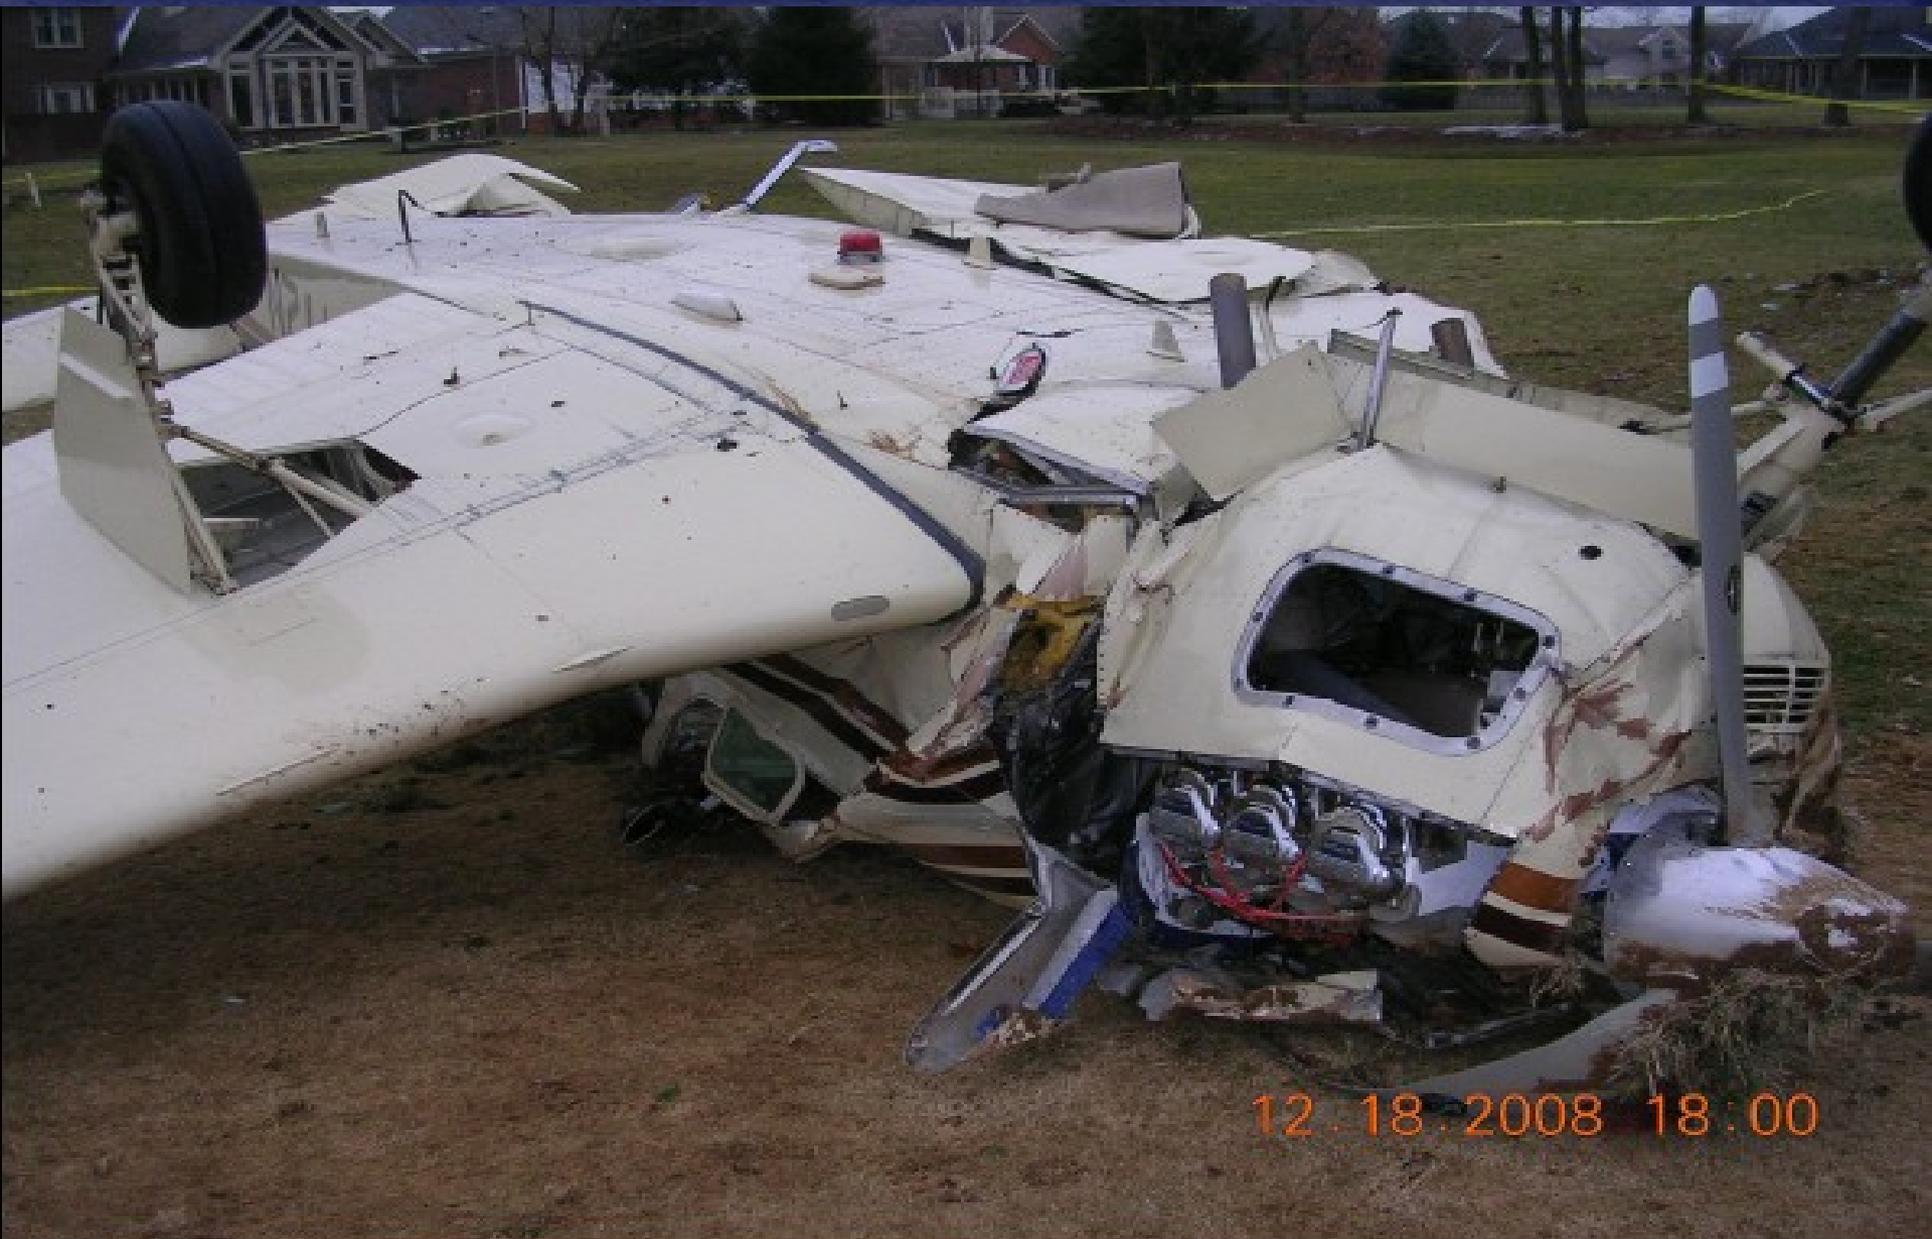
System Failure – Powerplant

- Accident ERA09FA093
- Beechcraft 36
- Night IFR approach, Bowman Field, KLOU, Louisville, KY
- One fatality – pilot
- Weather
 - Winds 330 degrees at 3 kts
 - Ceiling overcast at 800 ft
 - Visibility 6 miles in mist

- Aircraft right wing struck tree at height of about 30 ft along side a golf course
- Aircraft came to rest inverted approximately 175 ft from tree
- Front section of cabin roof crushed in
- Fuel recovered from left tank, right tank separated from aircraft
- Initial examination revealed engine would not rotate

- Engine teardown
 - Crankshaft and counterweight assembly fractured through at forward fillet radius of #2 main bearing journal
 - #2 main bearing journal showed scoring consistent with bearing rotation
 - #3 main bearing journal fractured at rear fillet area

- NTSB Materials Lab found presence of silk thread patterns and gasket making material on sealing surfaces of the main bearing bosses
- Material not part of engine manufacturer maintenance documentation, TCM SIL 99-2B
- #2 main bearing boss severely damaged on both halves, including rotation mechanical gouging and deformation of the boss area behind the bearing, including mushrooming deformation of the boss

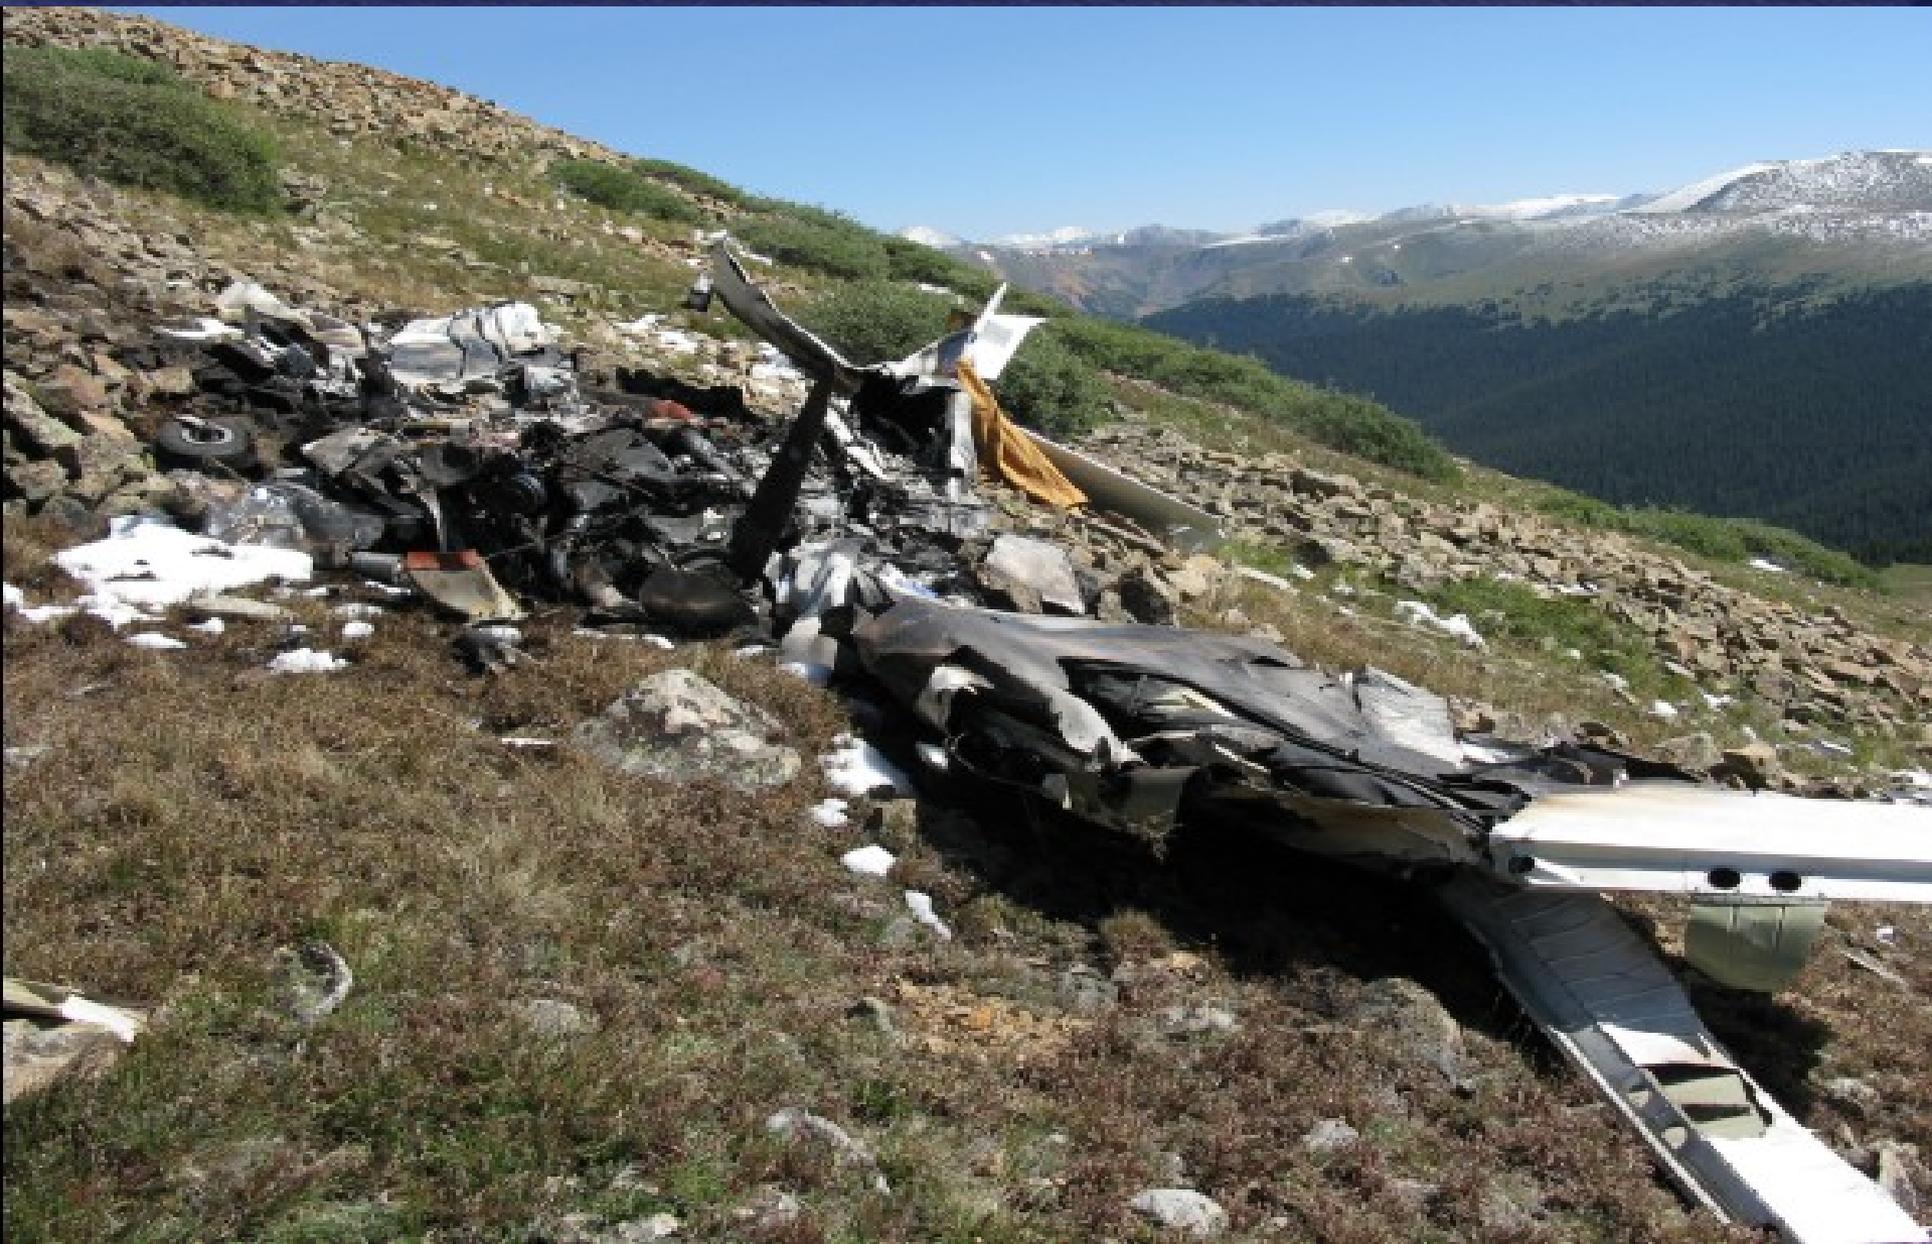
Unintended Flight into IMC

- Accident DEN08FA141
- Cessna 182T
- Four fatalities – pilot and 3 passengers
- VFR flight from Steamboat Springs Colorado to Brenham Texas
- No record of weather briefing or flight plan
- Impacted terrain on Mt Guyot, near Georgia Pass, Park County, Colorado
- Weather – IMC in general area

- Accident flight – NTSB meteorology analysis
 - At departure marginal VMC with overcast above and scattered clouds at and below flight level
 - Weather at accident site deteriorated rapidly after departure
 - Pilot likely encountered level 2 thunderstorm
 - Lost control and impacted terrain
 - Approximately 55 degrees nose down
 - Wings level
 - Wreckage located at 12,300 ft msl

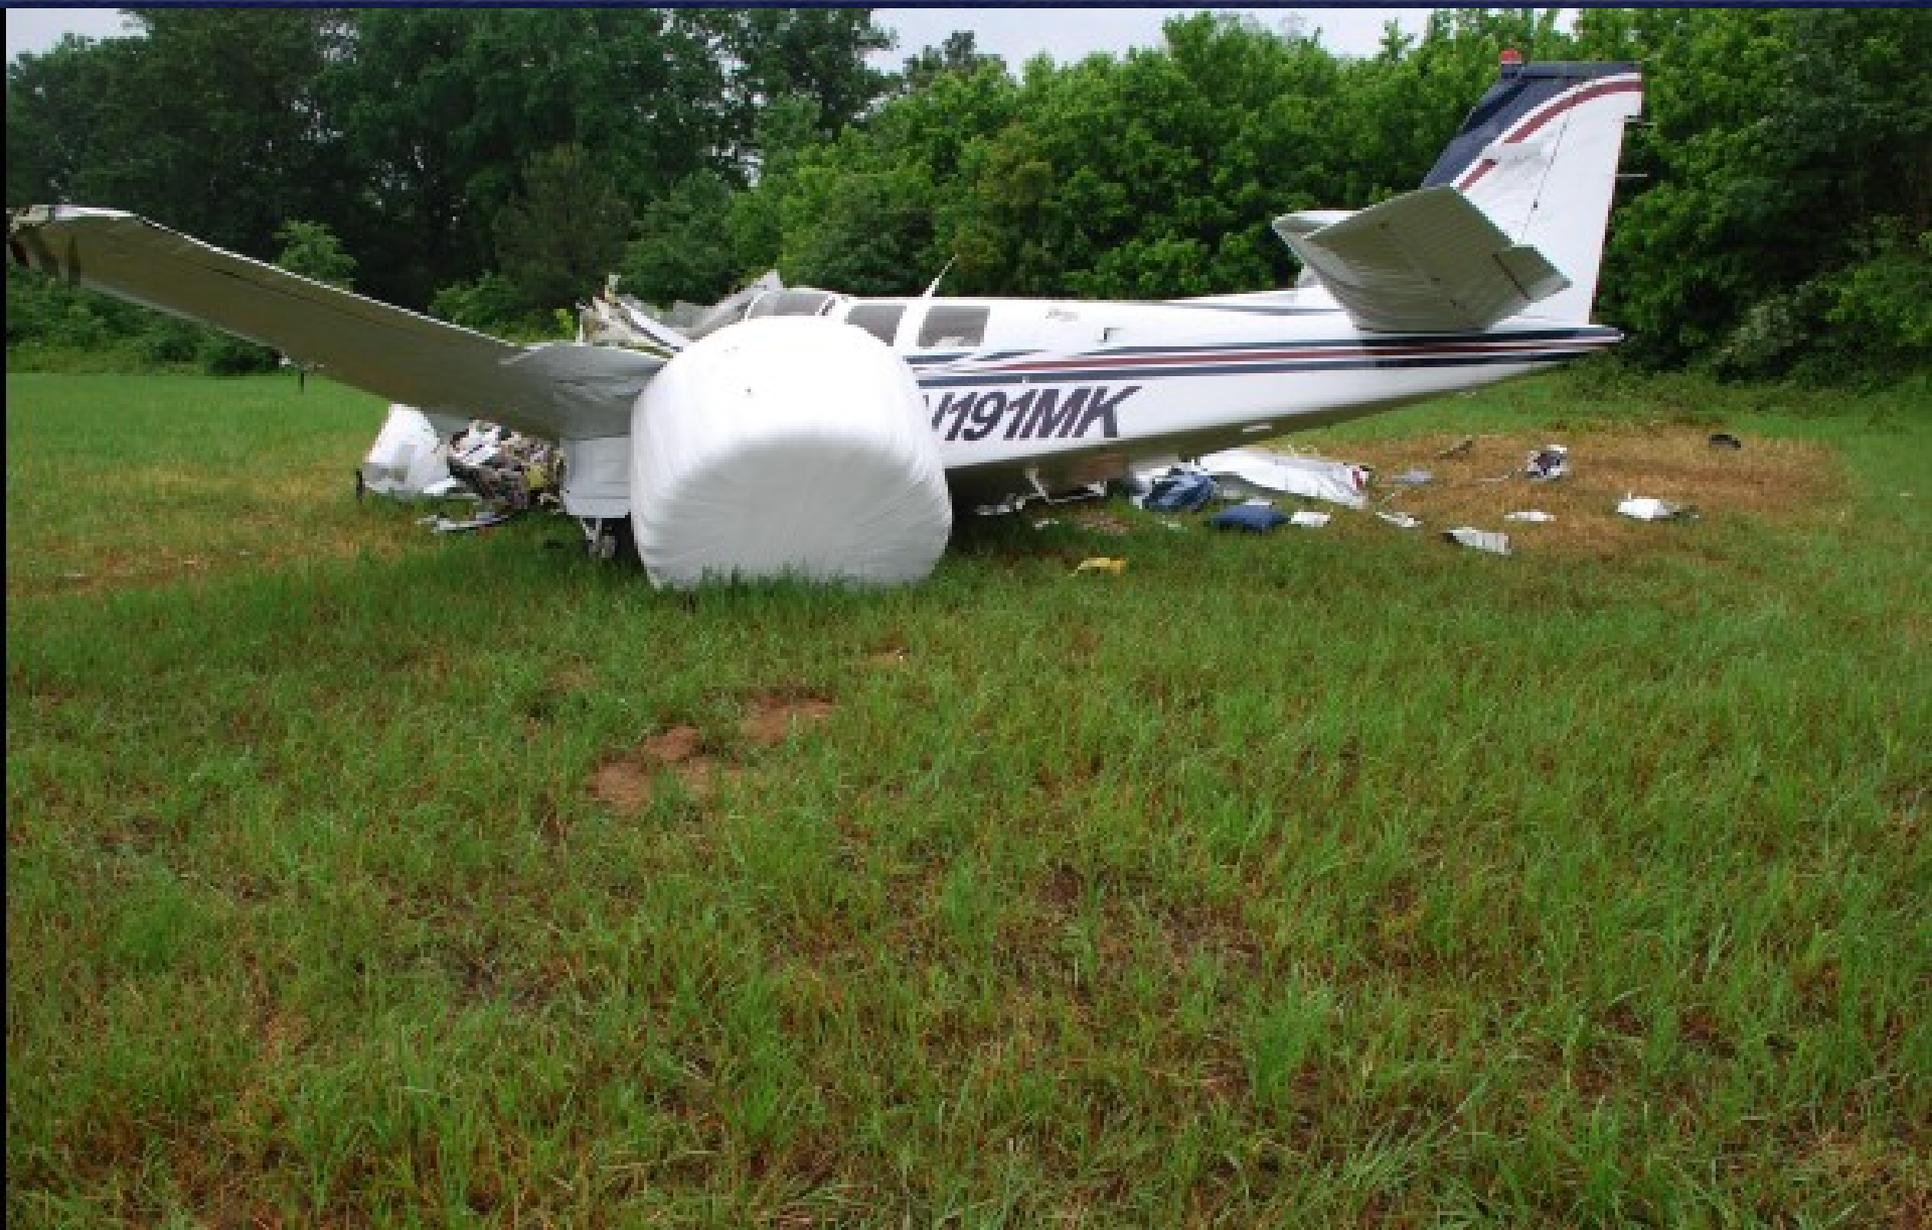
Fuel Management

- Accident ERA09FA289
- Beechcraft A36
- Pilot & fwd passenger – fatal; two aft passengers received minor injuries
- IFR flight plan; VMC conditions
- Flight from Destin, FL to Newnan GA
- Accident location was Beauregard, AL
- Weather – scattered at 3,900 ft, 10 mile visibility, winds 120 degree at 5 kts

- Accident sequence
 - Second leg of trip
 - Picked up 3 passengers at intermediate airport
 - In cruise at 7,000 ft, engine lost power
 - Restarted, but subsequently lost power again
 - Forced landing approach to pasture
 - Collided with trees and large rolled bale of hay

- Post accident investigation
 - Fuel selector to right tank – 1 qt fuel present
 - Right tip tank breached but contained 4 ½ gal
 - Left fuel tank separated from airplane
 - Left tip tank breached but contained ½ gal
 - Before trip
 - 74 gal usable in main tanks
 - 20 gal usable in combined tip tanks
 - 25.4 gal drained to make weight & CG

- At takeoff for 2nd flight leg, about 48.6 gal in mains and 20 gal in tip tanks
- Performance calculations indicated that more than 48.6 gal would have been used by point of initial loss of power
- Likely used all main fuel but not tip fuel
