THAT SLOW SINKING SENSATION

Statistics say a partial power failure is three to five times more likely than a complete power failure. But that might mean three times as many options and a paralysis of indecision. How will you weigh your options to take the best prompt action without simply making a snap judgment?

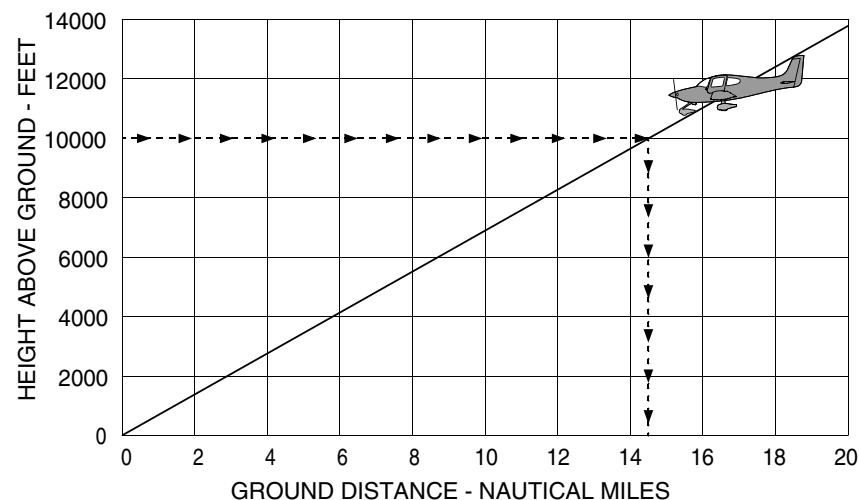
Figure 3-1: Maximum Glide Ratio ~ 8.8 : 1

Glide

Conditions		Example	
Power	OFF	Altitude	10,000 ft. AGL
Propeller	Windmilling	Airspeed	Best Glide
Flaps	0% (UP)	Glide Distance	14.5 NM
Wind	Zero

Best Glide Speed

3600 lb (1633 kg) 92 KIAS
