Cessna 208B, Cracked Bulkhead, ATA 5312

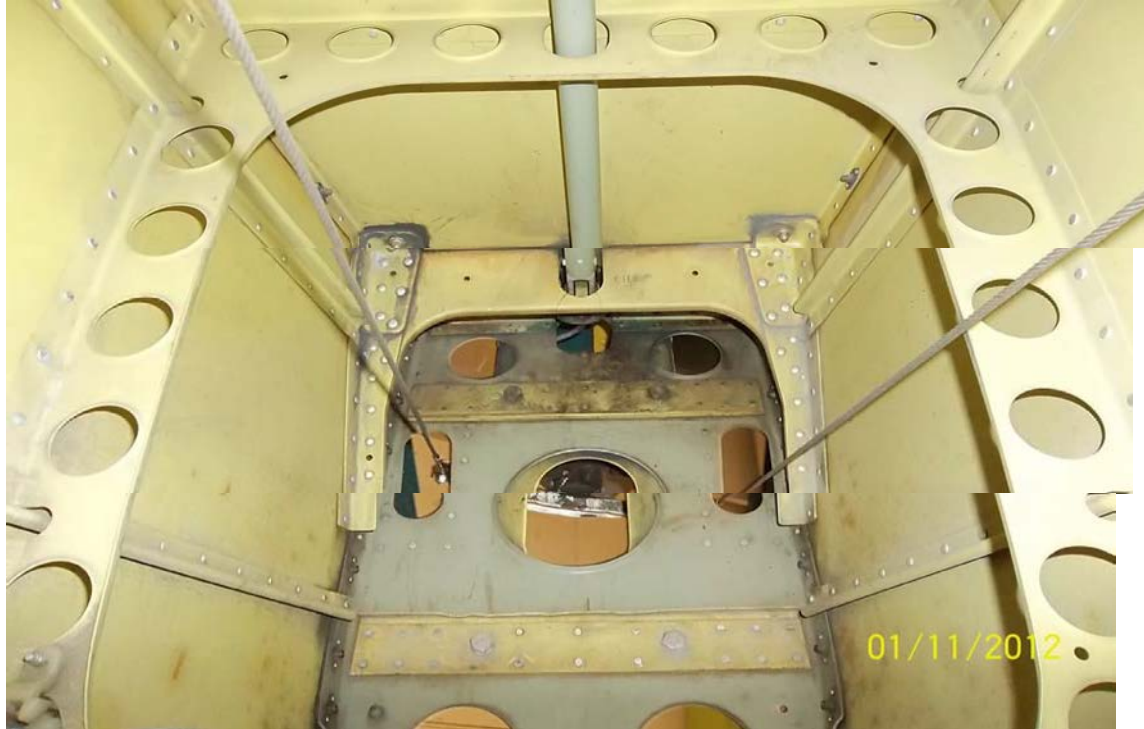
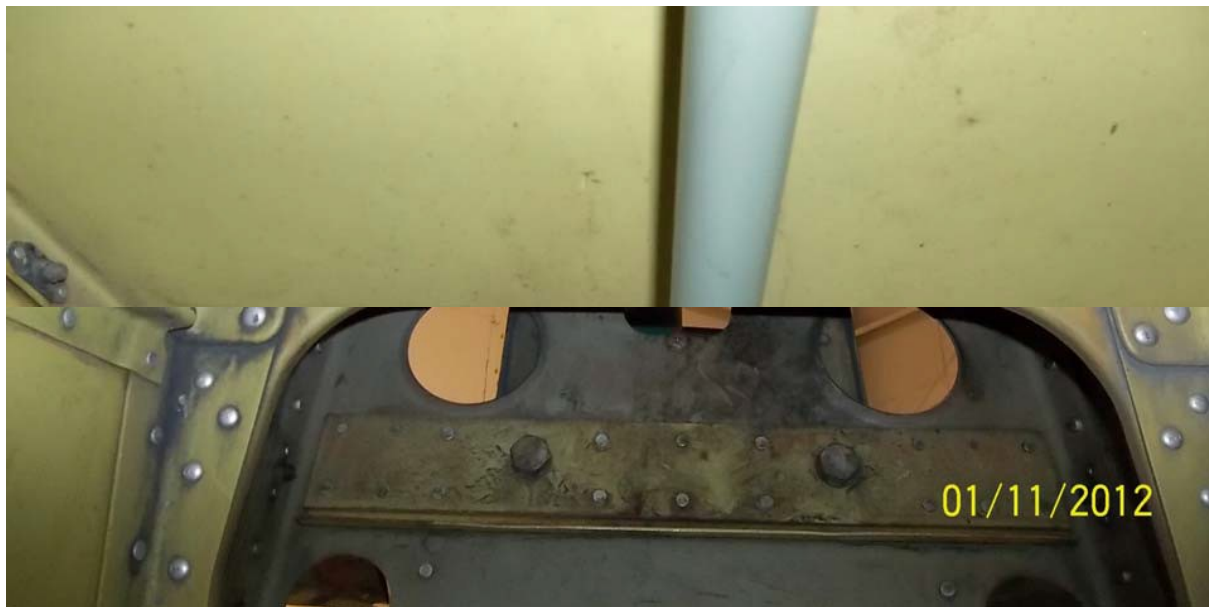
This submitter states, "The aft canted bulkhead (P/N 2612060-5) at station 474.40 has two cracks, each approximately 1.5 inches in length. During removal of this part, other damage was found. Both vertical stabilizer webs (P/N's 2631021-15 and 2631022-2) were replaced because of significant fretting, (*so too*) the aft bulkhead assembly (P/N 2612059-1)."
