Lighter than Air: Cameron A315, Failed Blast Valve, ATA 5102

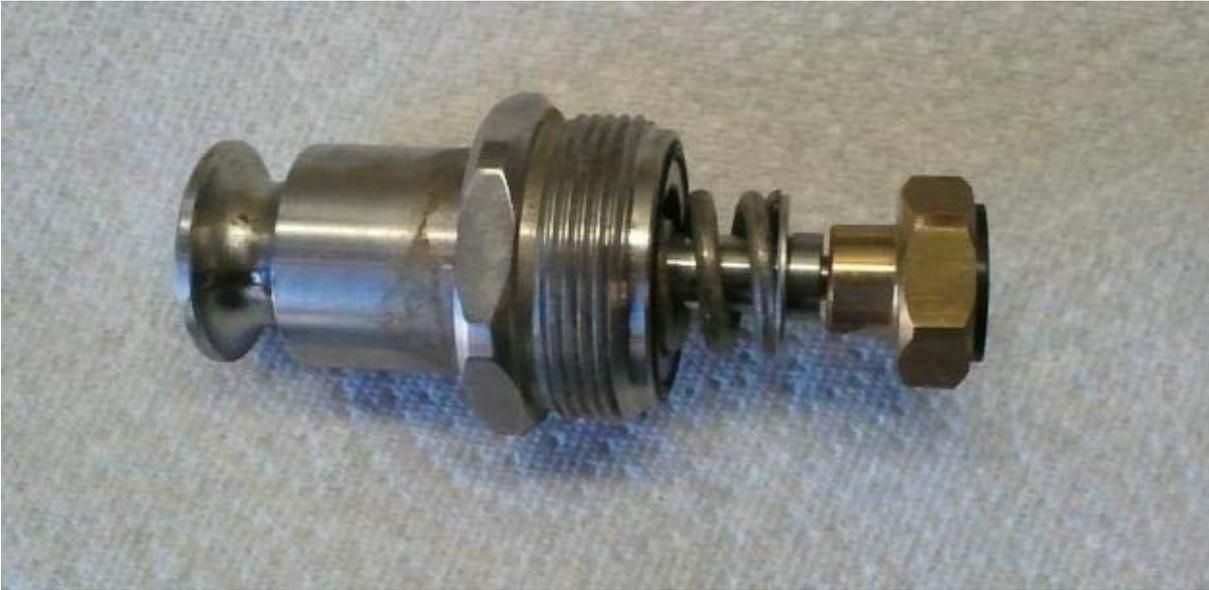
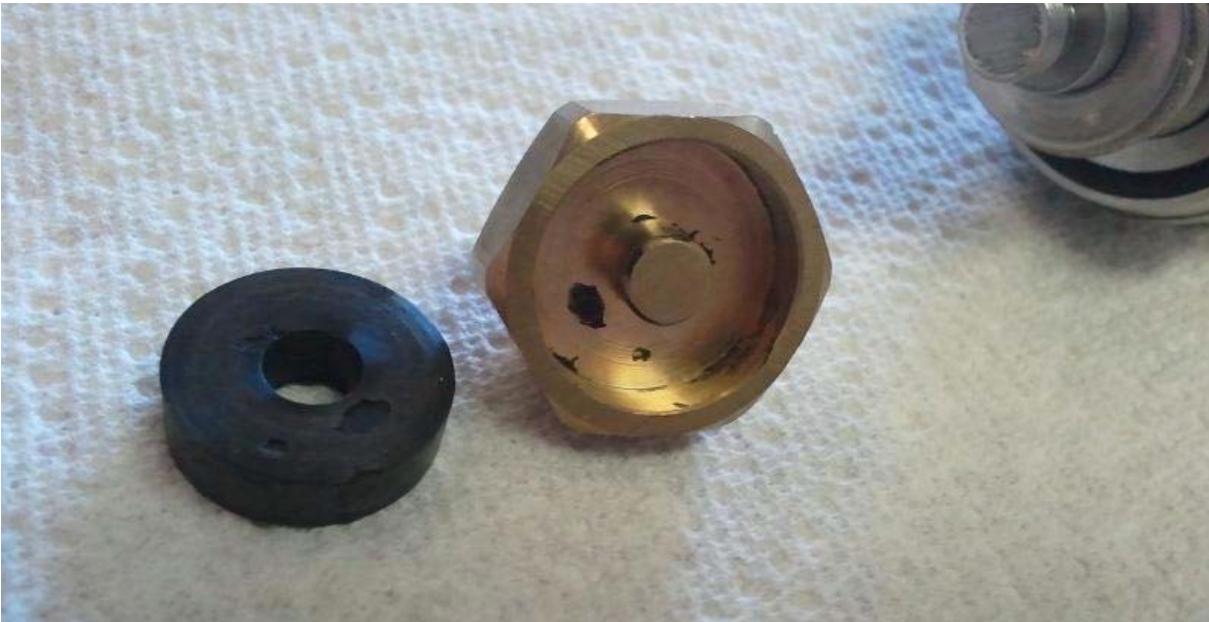
A repairman/pilot states, "The blast valve (main burner valve; P/N F8612) no longer functioned. Upon disassembling the blast valve from the burner, the shutter valve was visually inspected. The adhesive compound bonding the brass to the rubber ring was found to have failed, and the amount of adhesive bonding the two pieces also seems to be inadequately or unevenly applied. The rubber ring separating from the brass housing resulted in complete blockage of fuel (propane) to the burner coils—ultimately resulting in failure of the blast valve."
