(The following description references a Bombardier BD1001A10.)

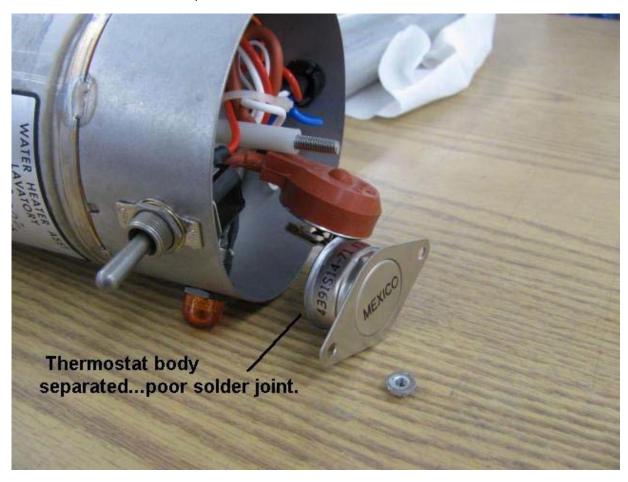
"The 'Lavatory Water' circuit breaker popped," says this writer. "(We) found the water heater to be at fault. We removed the plastic cover on the heater and found the thermostat body had separated (from a poor solder joint) which exposed the contacts and shorted-out the unit. The heater was manufactured in May of 2008." (Goodrich Water Heater P/N: 4E31762. Klixon Thermostat P/N: 4391S1471.)

Part Total Time: 563 Hours
