The APU *(auxiliary power unit)* goes off line as soon as it is loaded. The APU generator spline shaft *(was found)* sheared off."

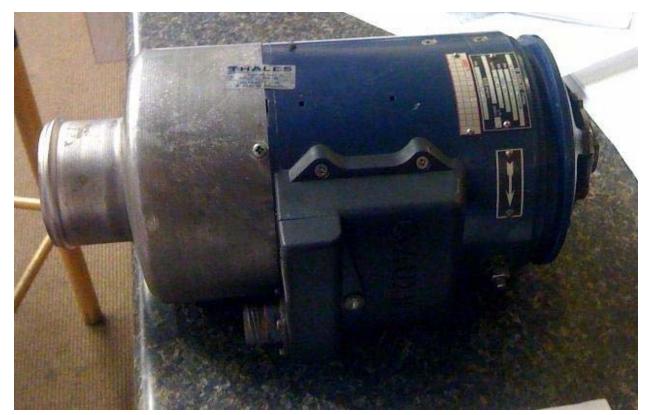
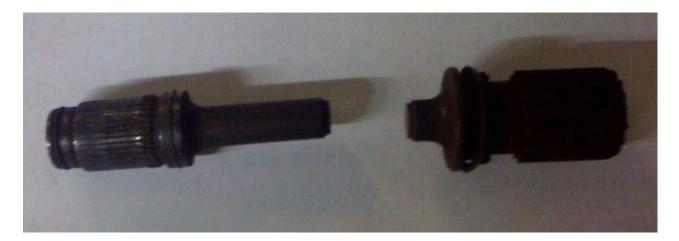
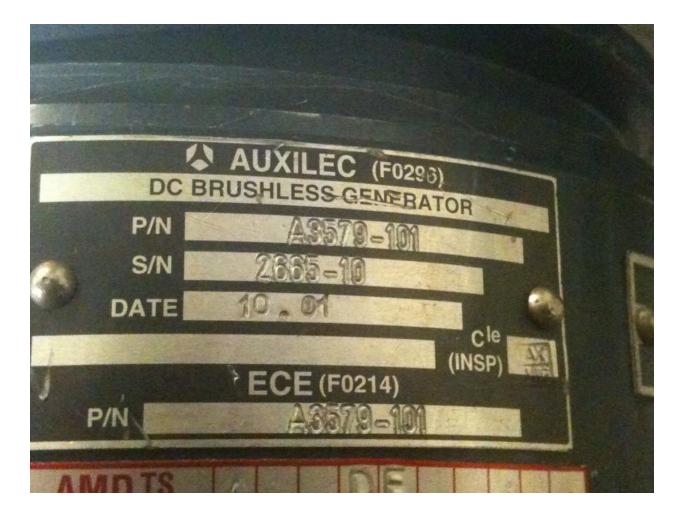
Part Total Time: 1,492.0.0 Hours
