CASA C212CC, Cracked Horizontal Stabilizer Attach Fittings, ATA 5551

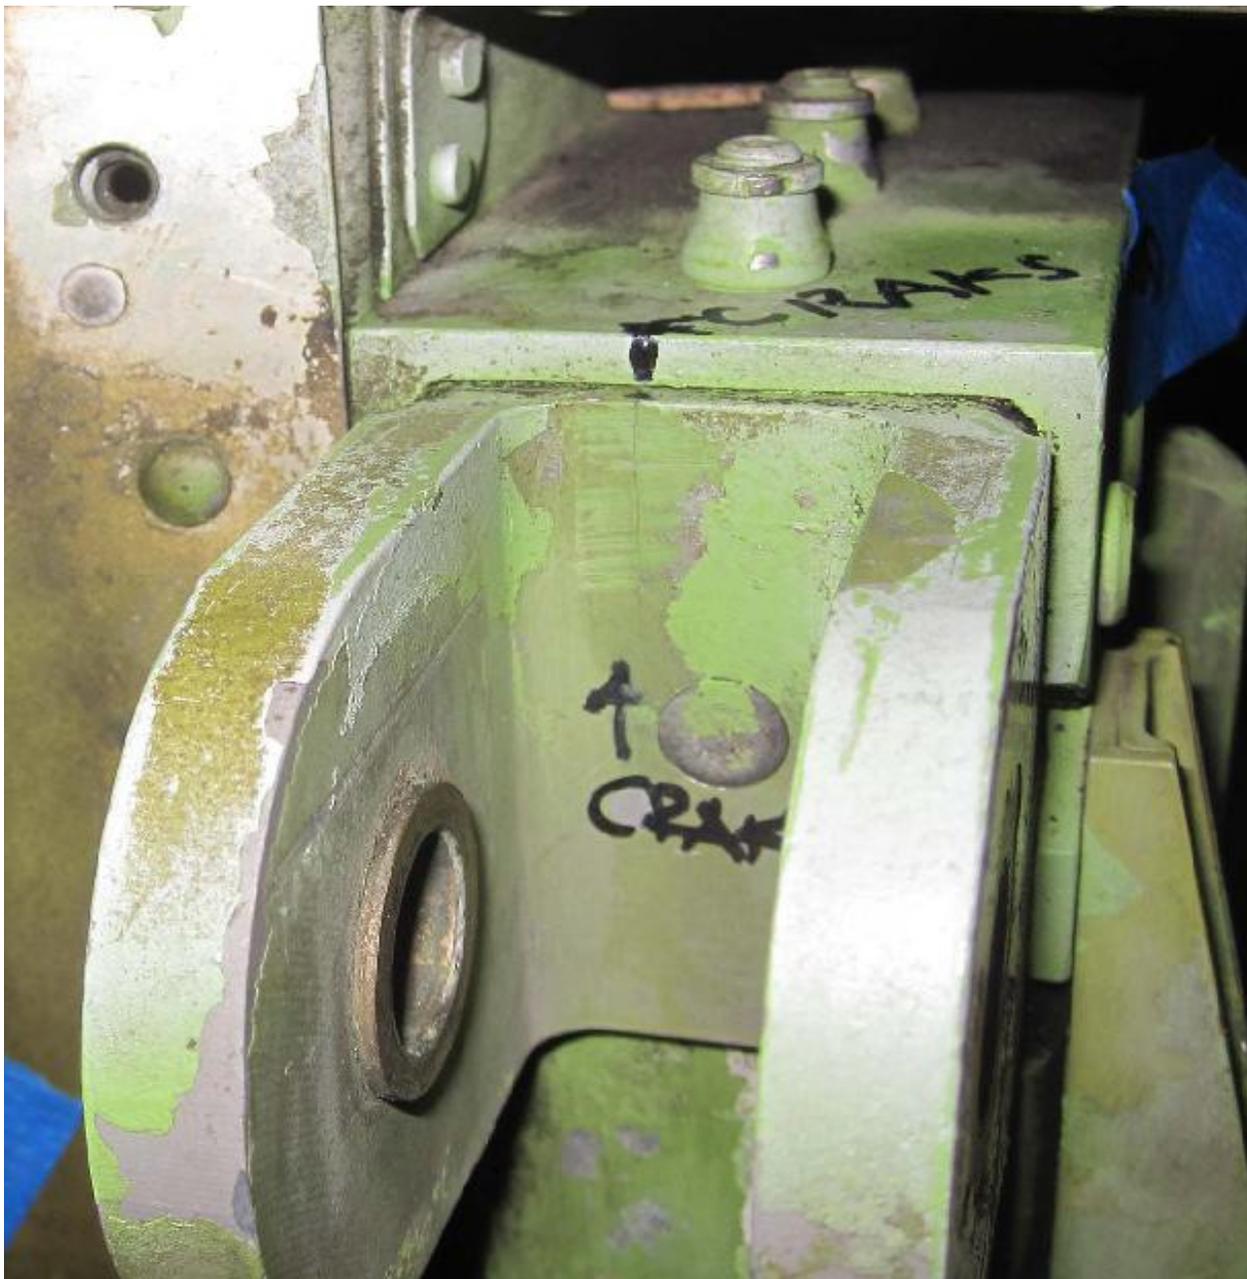
The aircraft, which was previously reported for a different defect, has another defect. The submitter states, "Three each horizontal stabilizer attach fittings (fuselage side) were found to be cracked, and three others were found with inter-granular corrosion. Six of the eight (fittings) are beyond limits (P/N 2122415XX)."
