Stabilized Approaches Lead to Safe Landings

The problem

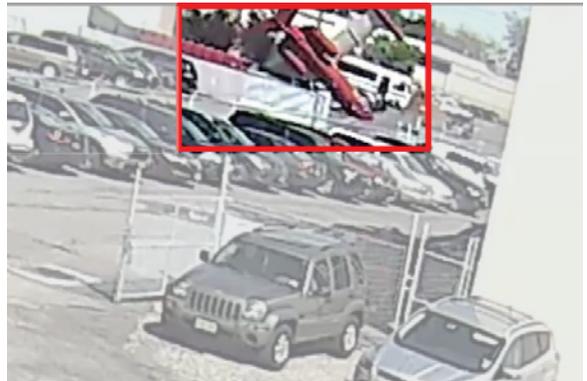
- A Learjet 35A airplane departed controlled flight while on a circling approach and impacted a commercial building and parking lot. The two pilots died. Because neither pilot realized that the airplane's navigation equipment had not been properly set for the instrument approach clearance they received, the flight crew improperly executed the vertical profile of the approach. When the crew initiated the circle-to-land maneuver, the airplane was so close to the airport that it could not be maneuvered to line up with the landing runway under the company's stabilized approach criteria. Neither pilot called for a go-around, and the pilot-in-command continued the approach by initiating a steep turn to align with the landing runway. Radar data indicated that the airplane's airspeed was below the approach speed dictated by company standard operating procedures (SOPs). During the turn, the

airplane stalled and crashed about 1/2 nautical mile south of the landing runway threshold. ([CEN17MA183](#))

Security video image of the accident airplane at ground impact ([CEN17MA183](#)).

- **Follow SOPs and industry best practices for stabilized approach criteria, including a normal glidepath, specified airspeed and descent rate, landing configuration (flaps, gear, etc.), appropriate power setting, landing checklists, and a heading that ensures only small changes are necessary to maintain runway alignment. Guidance and tips (see the “Interested in more information?” section) indicate that, in most cases, the approach should be stabilized by 1,000 ft in instrument conditions or 500 ft in visual conditions. If the approach becomes unstabilized at any time after that, go around.**

- **Never attempt to “save” an unstabilized approach. If the approach becomes unstabilized, conduct an immediate go-around. Remember, when two pilots are on duty, either crewmember may call for a go-around at any time.**

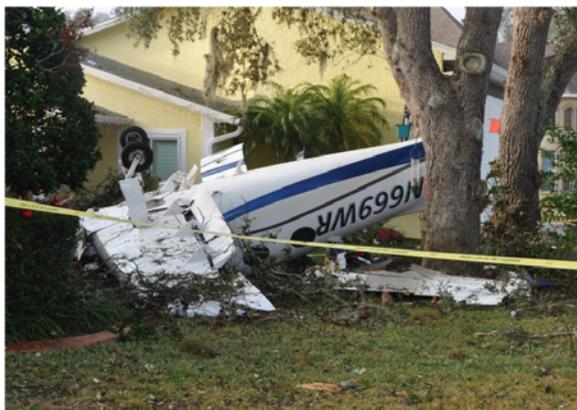
- An experimental, amateur-built Epic LT airplane sustained substantial damage when it impacted terrain during an instrument approach. The private pilot and passenger were fatally injured. Based on radar information and witness statements, the airplane's approach to the airport was unstabilized; the airplane was far left of the runway centerline and had descended below the minimum descent altitude of 440 ft. After breaking through fog about 100 ft above ground level, the airplane reentered the fog and completed a 360° right turn near the approach end of the runway, during which its altitude varied from 100 ft to 300 ft. The airplane then climbed to about 800 ft before radar contact was lost. The airplane stalled and came to rest inverted, consistent with one witness's statement that it descended through the clouds in a spin before impact. (ERA17FA074)

Postcrash photograph of Epic LT airplane (ERA17FA074).

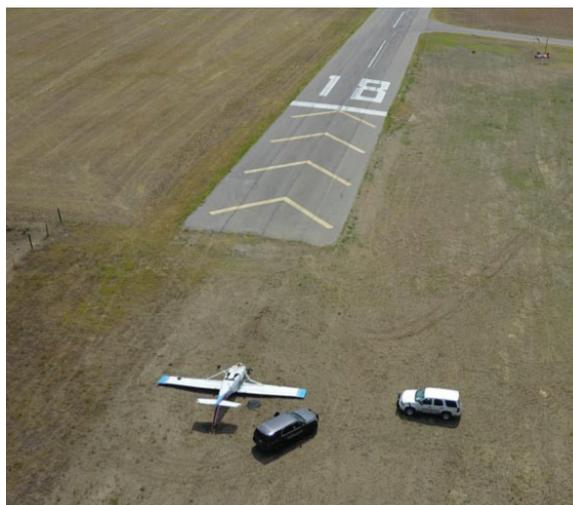
- A Cessna 210 airplane sustained substantial damage during a runway excursion. The pilot reported that he "didn't get the flaps down" before landing. He further reported that the airplane "didn't want to stop" and it then "ran off the runway." During the runway excursion, the nosewheel collapsed, and the airplane nosed over. A witness reported that the airplane was "high, fast, and downwind." (GAA17CA531)

Overhead view of Cessna 210 and runway (GAA17CA531).
