Nuts And Bolts - A Newsletter Written By Mechanics For Mechanics

Accident Case Study

A Fatal Case of a Little Corrosion in the Worst Place

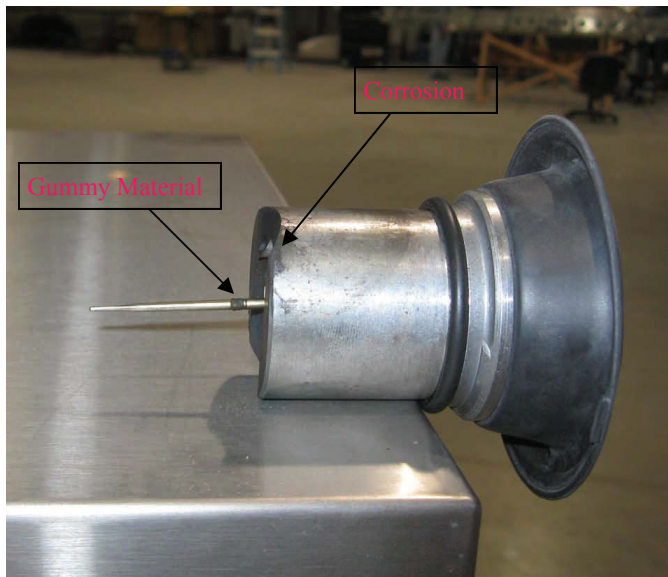
Corrosion was also observed on the carb slide itself (sometimes called piston) as well as some buildup of a varnish like substance.

The jet needle has a ring of gummy build up around it which may have affected the engine's ability to idle smoothly.

No defects were found in the diaphragm. The diaphragm was installed correctly in the carb dome.

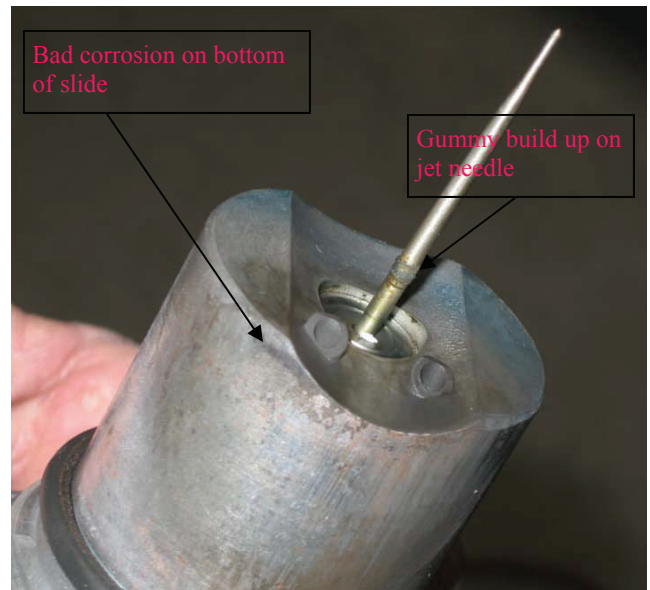
Inspection of the slide revealed significant build ups of corrosion on the slide. The corrosion was especially thick on the bottom edge of the slide.

In addition to the corrosion there was a build up of a varnish like residue on the sides of the slide.

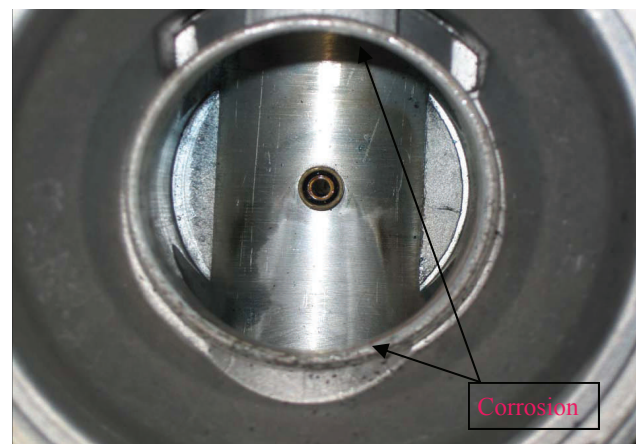
The slide is attached to the diaphragm and the jet needle is attached to the slide. The net result is the more open the throttle the higher the diaphragm will pull the needle. Since the needle is tapered the orifice size increases as the smaller diameter of the needle is pulled into place.

If the slide sticks in the open position but the throttle is pulled back, airflow would slow but fuel delivery would stay at a high rate (because of the smaller end of the jet needle remaining in the orifice). The result would be an excessively rich mixture at any throttle setting other than full open.

In a normally operating Bing carburetor the slide would always be pushed down to the bottom of the carb body by a combination of gravity and pressure from a compression spring in the carb dome that pushes down on the slide itself.

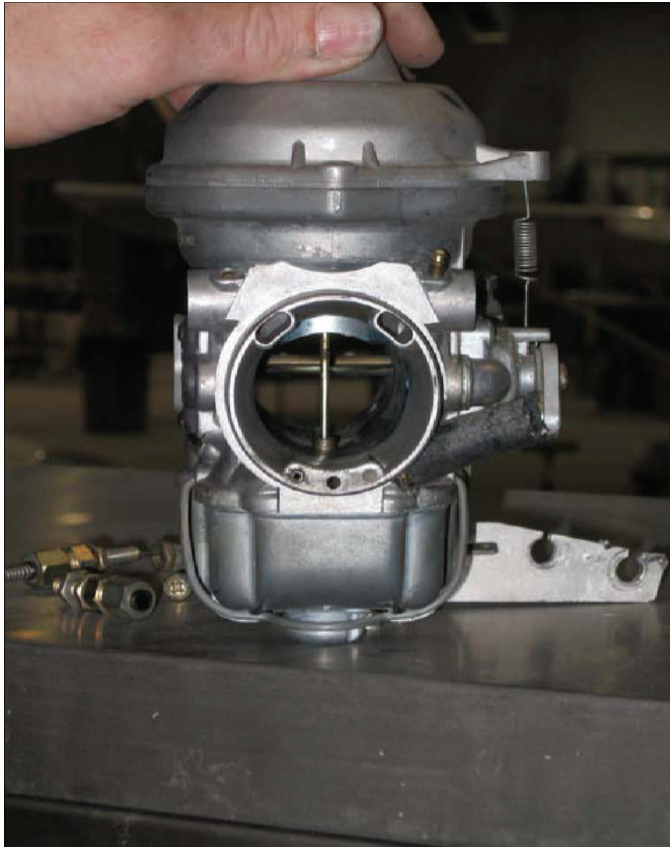
As the photo above shows, the slide sticks open. Even a sharp bang downwards on the counter top did not displace the slide back to its normal position.

It is safe to assume the pilot used a full throttle setting for take off from the pancake breakfast. It is likely that the carburetor did what it was supposed to do and pulled the slide to the full open position where it stuck due to the corrosion in the body and on the slide as demonstrated in the above photo. From this point to the crash site the engine ran roughly due to an excessively rich mixture. When the pilot decided to turn back to an airport he had just flown over to make a precautionary landing he would have at some point had to pull the throttle back to a reduced power setting, thus creating such an overly rich mixture that the engine flooded and quit running. Unfortunately the rest of the flight is in the NTSB history books.

Maybe that's wishful thinking, I'm sure there is more than meets the eye to get a good look at the slide. I do know that if I were "FAA King For A Day", I'd issue an Airworthiness Directive that required us to inspect all Bing carburetors for corrosion on the slide and body, but that probably won't happen. At least I can hope that you, who have read this article, will remember this and if given an opportunity to share this information with the owner of an experimental aircraft that has Bing carburetors installed you will tell this story.

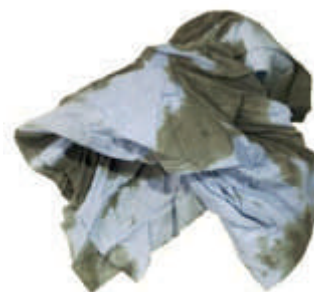
The helicopter landed heavily on soft ground and **rolled over** onto its left side," said the report by the Irish Air Accident Investigation Unit. During the initial examination of the wreckage, **"some cleaning-cloth material** was found that the drive shaft had completely severed just forward of the second bearing, thus cutting off the vital drive to the tail rotor gearbox.

Investigators were unable to "absolutely determine when and by whom the cloth was left in the area of the tail rotor shaft," the report said.
