## ARE YOU READY FOR THE FUTURE?

## SAFO 10016

### A Closer Look at SAFO 10016 – Missing or Improper Seat Stops in Cessna Models

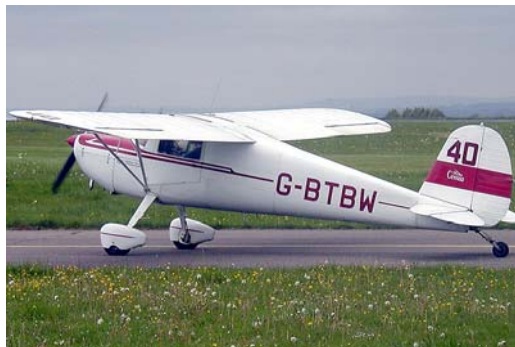
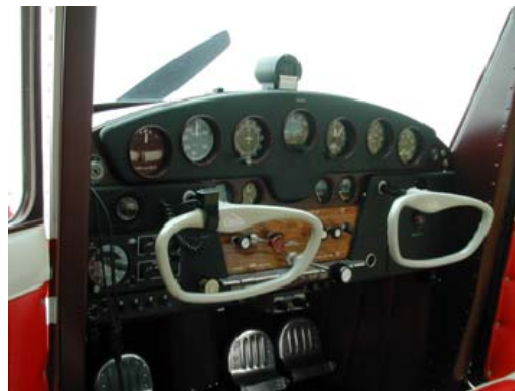
The first really successful single engine production aircraft in my opinion was the Cessna 120/140 pictured below.

Built in 1947 it came with a Continental C-85 engine and a very basic analog instrument panel and sold for \$3,495.00.

This did not include any radios. The 140 was rated at a max speed of 125 mph with a range of 450 miles. The 140

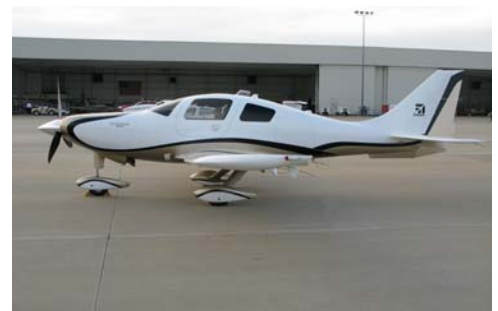
The fastest fixed gear single engine piston aircraft in production.

The Corvalis has a maximum cruise speed of 270 mph. The four-seat composite aircraft has a range of 1,438 miles, and is powered by a Continental TSIO-550-C six-cylinder, fuel-injected, twin turbocharged engine with dual intercoolers. **Wow, that sounds like a Hot Rod car enthusiast describing his engine.** The new Corvalis features state of the art standard and optional equipment, and, perhaps most important, the IntrinziC flight deck that uses the new touch-screen Garmin G2000 avionics system as its platform.

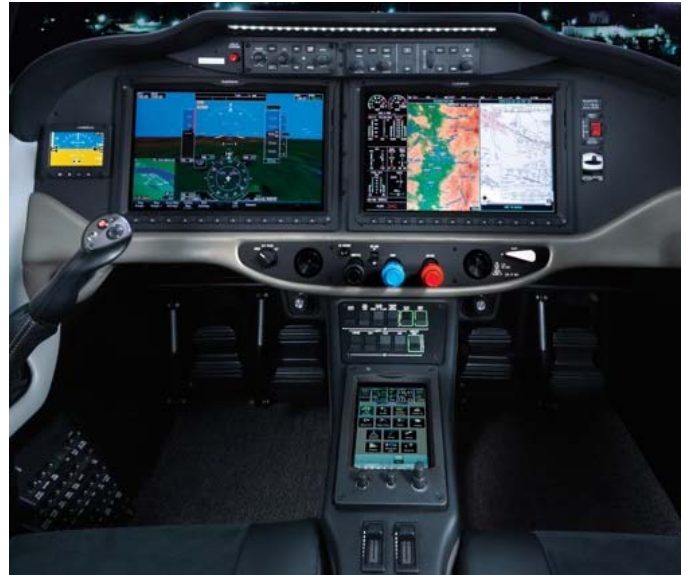
The Corvalis TTX also has the L-3 Trilogy glass

panel standby instrument system, making it the first Cessna piston with **no analog instruments**. A standard pulse oximeter is available to monitor pilot blood-oxygen levels, with the real-time data displayed on the Multi Function Display.

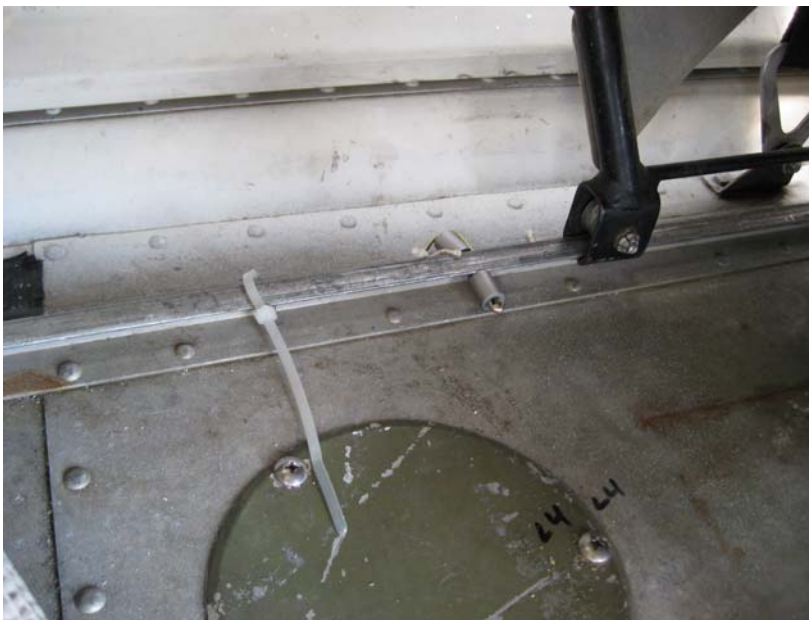
Cessna 182 with cotter pin and spacers installed for pilot Seat, aft seat stop (The tie wrap was “extra”).

Cessna 206 with an extra-long bolt and nut installed finger-tight for the pilot seat, front seat stop.

(the aft seat stop was also a bolt/nut combination).

The above photographs are a sampling of those taken during the normal course of surveillance (ramp inspections) of aircraft being operated for hire in various types of operations. While somewhat comical, with the tendency to evoke the comment: “really?!”, the fact of the matter is, the owner’s of these aircraft had no problems with these “hardware” installations. The reasoning presented, more often than not, was the cotter pin or bolt/nut combination, by all accounts, appeared to be “stronger” than the original Cessna seat stops called out for in the Illustrated Parts Manuals (IPC). All of these aircraft had been returned to service in these conditions following an Annual inspection by a mechanic with an Inspection Authorization; however, it was unknown as to when the “stops” were installed, or by whom.

With that in mind, a quick search of the NTSB accident database brings up the following accounts: **non-fatal, 2 uninjured, aircraft substantially damaged:** “...Two bolts were installed through the seat track; one through the most forward hole and one through the most aft hole. The purpose of the bolts was to serve as the fore and aft seat stops. The bolts fit perpendicular to the seat track and were secured to the track using nuts. The most forward hole contained a bolt used as a forward seat stop to prevent the seat from coming off of the seat track. When the seat pin was engaged in this hole, full depth engagement was not possible. Rub marks were present on the bolt shank that was visible through the seat track hole. The pilot normally flew the airplane with the seat in its forward most position. The airplane manufacturer did not design the seat stop and there was no installation record of the bolt used as a seat stop in the airplane maintenance records. According to Cessna Aircraft Company, the approved seat stop uses a U-shaped piece of metal that fits over the seat track and is held using a pin through the side hole. This is secured using a cotter pin. The design does not allow the seat lock pin to engage in the hole through which it is secured.” **Non-fatal, 2 uninjured, aircraft substantially damaged:** “Ground-loop during takeoff run causing gear collapse. Probable cause: Pilot’s inadequate preflight preparation of the fuselage seats; ... missing seat stop and lock screw allowing seat to slide back.”

The initial thought would be that compliance with the well-known AD87-20-03 R2 – seat rail inspection on Cessna aircraft would cover this issue; however, as pointed out by several industry articles published following the release of the SAFO, that AD does not specifically address the seat stops. We must refer to 14 CFR Part 43.13(b) that states: “...each person maintaining or altering, or performing preventive maintenance, shall do that work in such a manner and use materials of such a quality, that the condition of the aircraft...worked on will be at least equal to its original or properly altered condition...”. As the SAFO states, mechanics need to be diligent in inspection and reinstallation of the *correct* seat stops: U-shaped stop: Cracking/deformity of the u-shaped stop, missing safety mechanisms for the associated pin, etc. Bar-type stop: stripped threads in the screw hole, cracking across the top of the bar, etc. Follow the airframe service manual inspection requirements, and reference the IPC to determine correct seat stop installations. Be the break in the chain of events...safety is no accident.

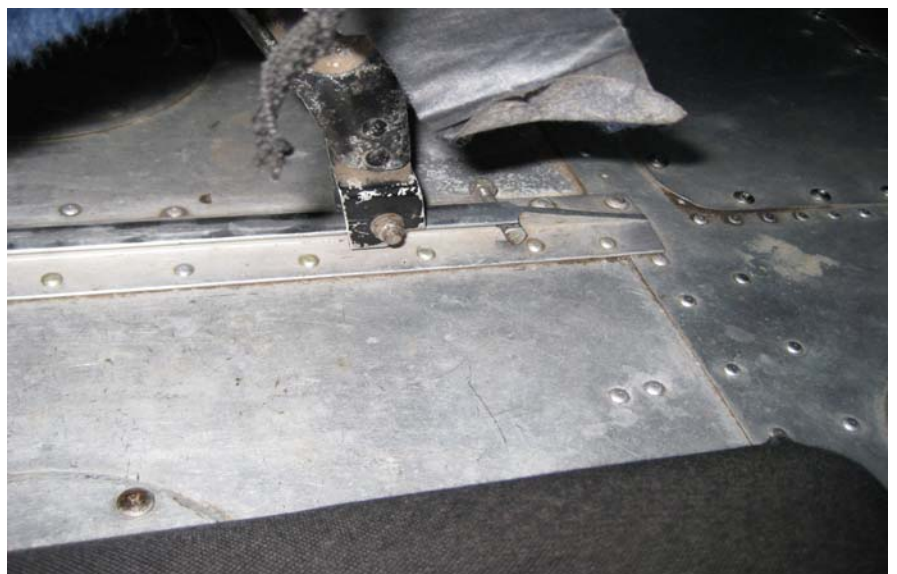
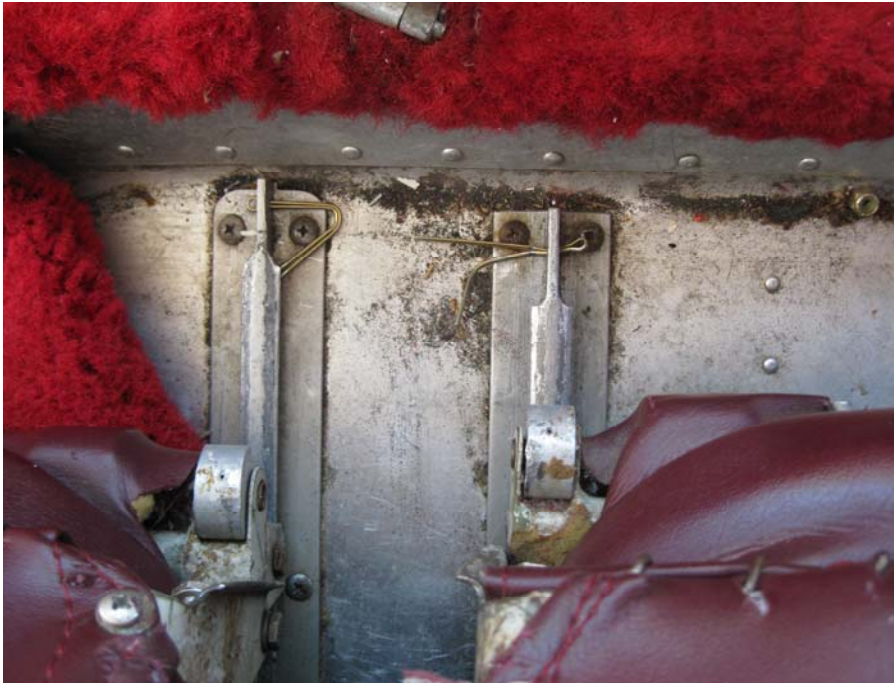
Cessna 150 with cotter pins  
“installed” for aft seat stops.

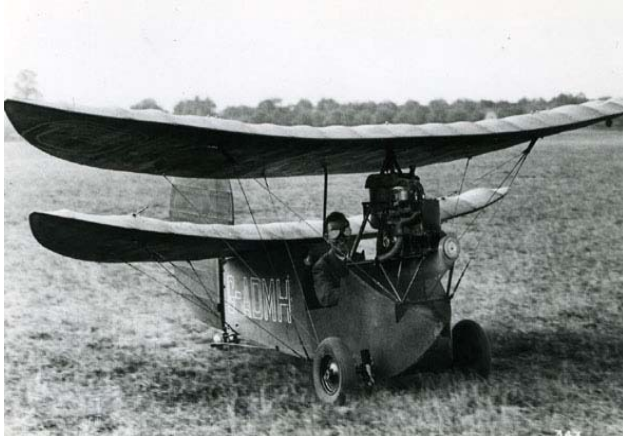
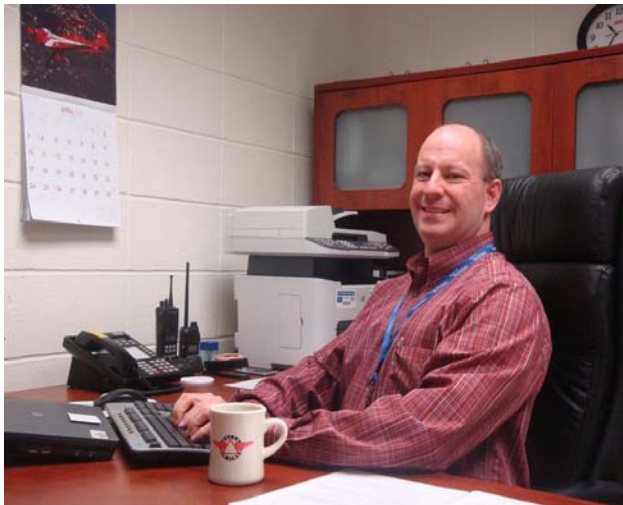
The first correct responder to what is it was Mr. Ed Reinhart who correctly identified the aircraft as the "Flying Flea". Ed Reinhart is the A/C Maintenance Manager with Delta in Cincinnati, Ohio.

Arguably the first homebuilt airplane, the "Flying Flea" was introduced in 1934. It was successfully demonstrated by its designer/builder, Henri Mignet, and with the publication of the plans and instructions soon hundreds of Flying Fleas were being built in homes across Europe and the United States. A temporary set-back occurred when a number of these homebuilt Fleas crashed but detailed investigation by the Royal Aircraft Establishment in England and the French Air Ministry in France revealed the problem and led to the necessary corrections for safe operation. By 1936 Fleas were again flying and have continued to do so ever since. Variations on Mignet's original design can be found in many countries around the world.

The Flying Flea was designed to be an exceptionally easy machine to fly, with no rudder pedals and a simple two-axis control stick. The main forward wing, of the two tandem wings, pivots for ascent and decent while the rudder (and dihedral in the wings) takes care of turns. Mignet claimed that anyone who could put together a packing case could build a Flying Flea and anyone who could drive a car could fly a Flying Flea.
