DEPARTMENT OF TRANSPORTATION
Federal Aviation Administration

Effective: 02/05/2025 0000 (UTC)
Letter to Airmen: LTA-SJU-9

Subject: SJU RWY8/26 AIRPORT DIAGRAM CHANGES

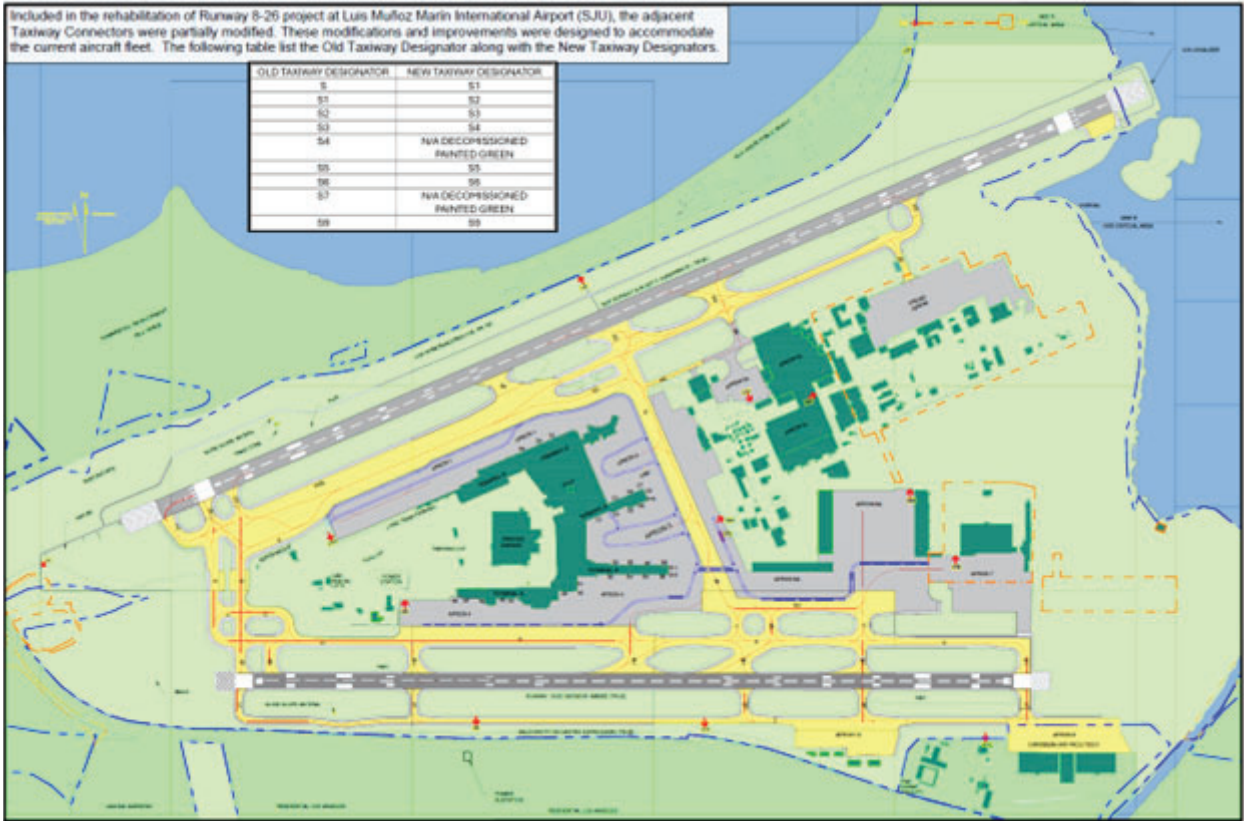
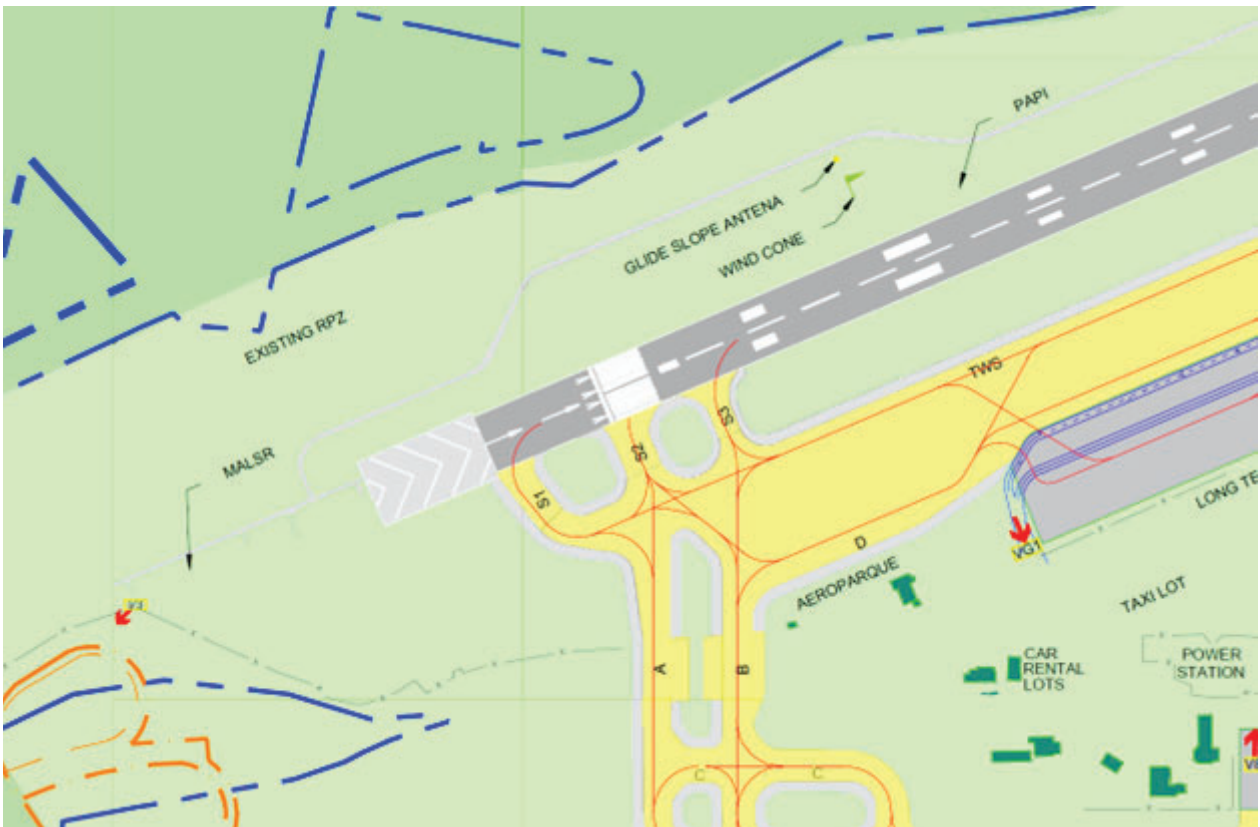
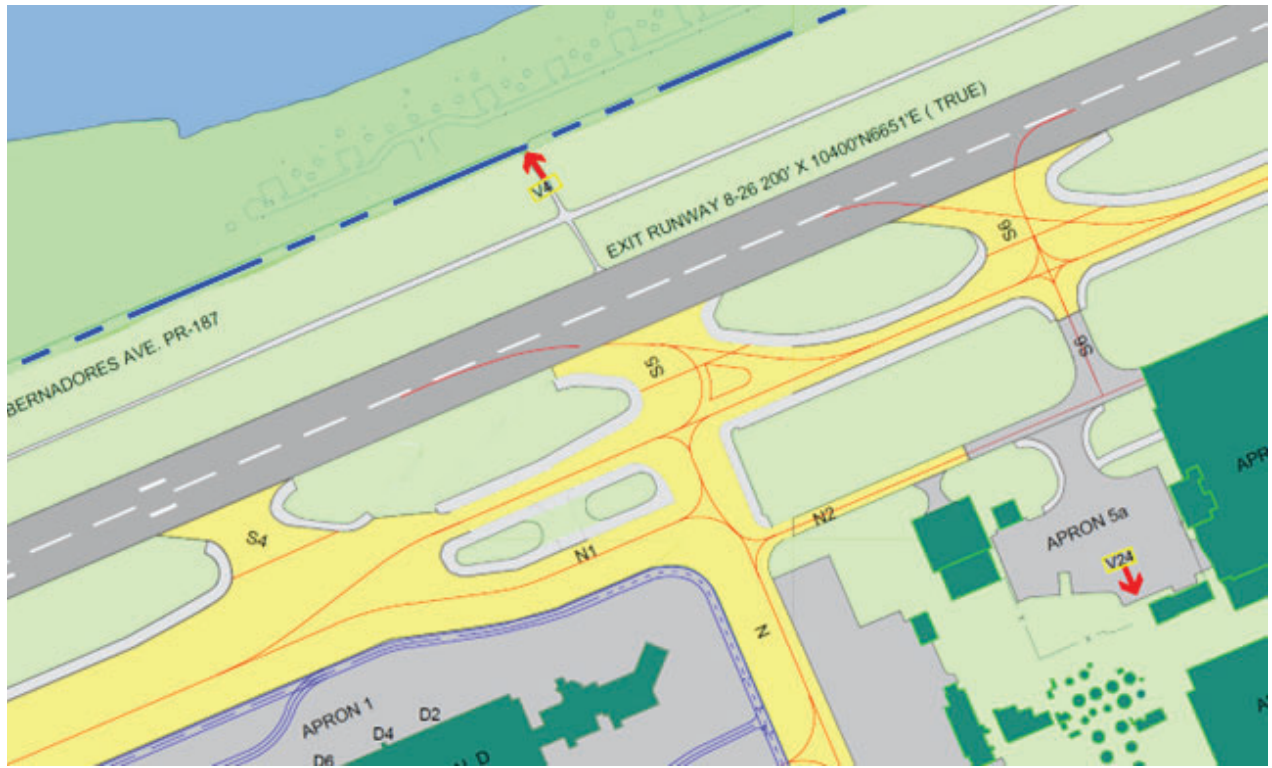
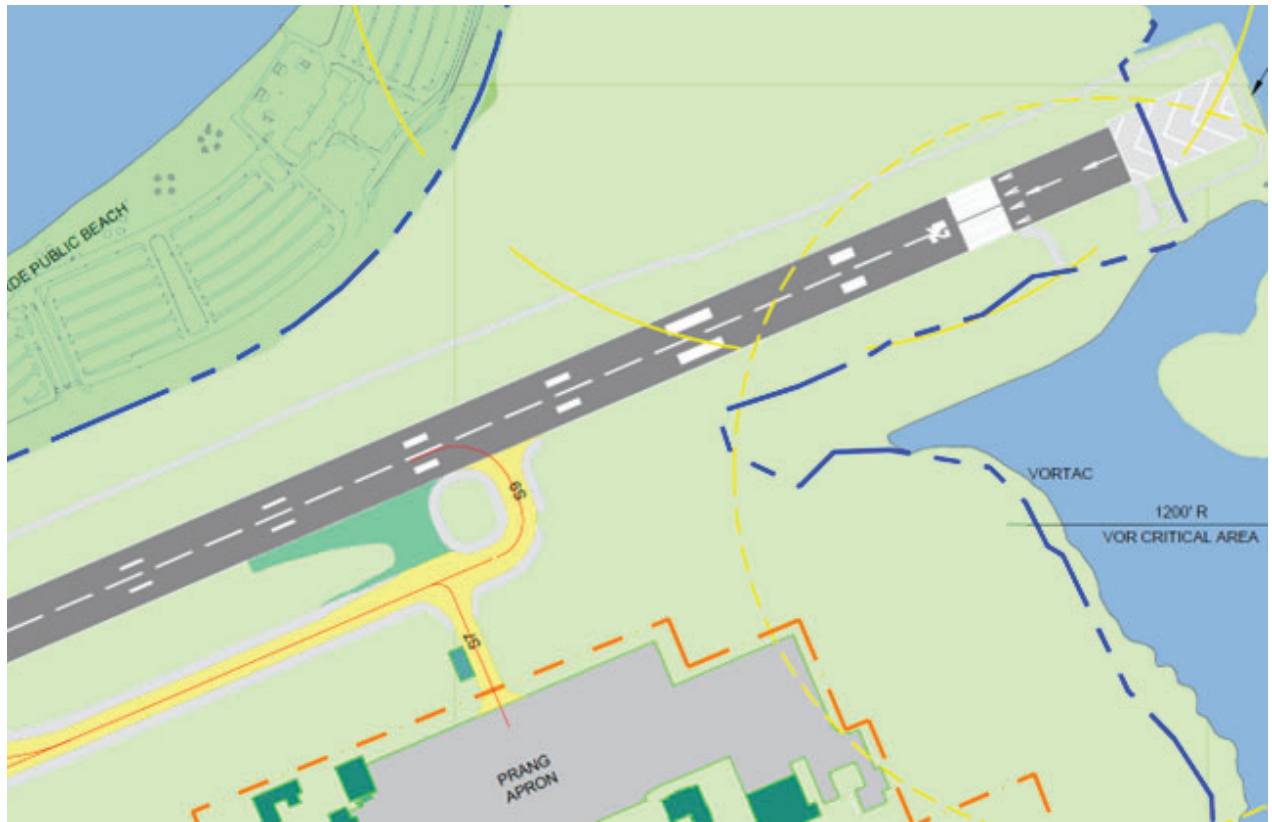
BACKGROUND: The Runway 8/26 Rehabilitation Project included adjacent taxiway configuration changes and taxiway renaming to comply with airport regulations. Please review the updated Airport Diagram included herein for use until published.

Connector Taxiway Sierra between parallel Taxiway S and the Runway 8 approach threshold has been renamed Sierra 1 (S1).

Connector Taxiway Sierra 1 has been renamed Sierra 2 (S2).

Connector Taxiway Sierra 2 has been renamed Sierra 3 (S3).

Connector Taxiway Sierra 3 has been renamed Sierra 4 (S4).

Connector Taxiways Sierra 5 and Sierra 6 have NOT been renamed.

Previous connector Taxiway Sierra 4 and Taxiway Sierra 7 between Runway 8/26 and parallel Taxiway Sierra have been closed permanently.

Runway 8/26 parallel Taxiway Sierra has NOT been renamed.

Included in the rehabilitation of Runway 8-26 project at Luis Muñoz Marín International Airport (SJU), the adjacent Taxiway Connectors were partially modified. These modifications and improvements were designed to accommodate the current aircraft fleet. The following table list the Old Taxiway Designator along with the New Taxiway Designators.
